## Toppling and wedge failures in Malekhu River area, Malekhu, Central Nepal Lesser Himalaya

\*Naresh Kazi Tamrakar, Jaya Laxmi Singh, Krishna Kumar Bista and Prayag Maharjan

### ABSTRACT

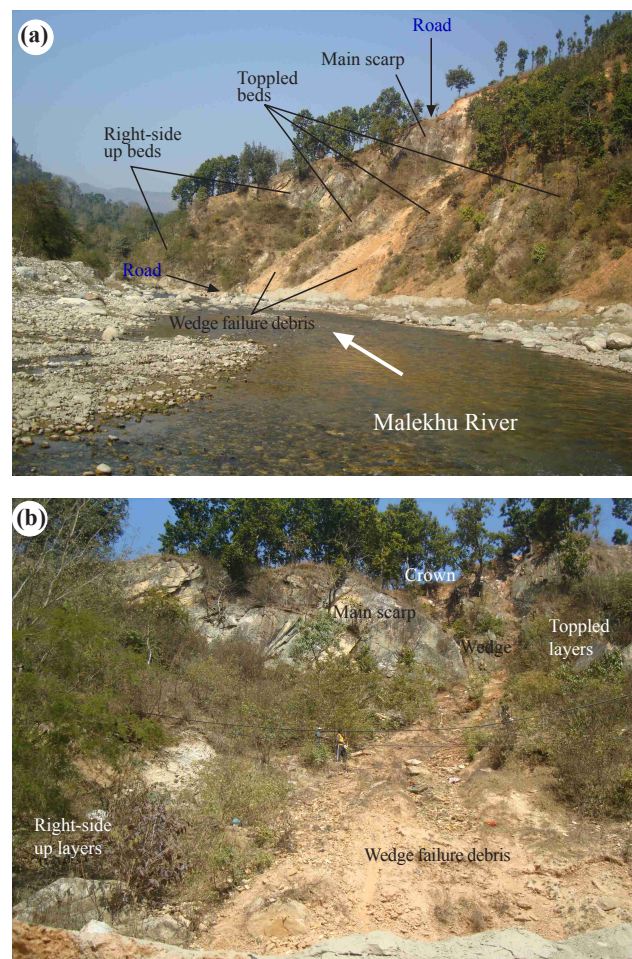
A huge landslide occurs at the right bank slopes of the Malekhu River (Fig. 3), and is named Malekhu Landslide. The landslide area shows two distinct slopes; an original hillslope and an altered hillslope. The former is characterized by original topography in the sense that it has not been actively involved in erosion and slope movement, and therefore contains convex type of slope with well vegetation. The altered slope is characterized mainly by very steep rocky slope with scarp and the portion of the cut slope on the uphill side of the road. The eastern portion of the landslide area containing such slope is of passive scars. The portion of the very steep scarp slope in the central portion of the area is the main scarp (Elv. 390 m to 428 m) (Figs. 3 and 4). The crown and toe are located at Elv. of about 429 m and 361 m, respectively. A numerous wedge failures occurring from this slope towards downslope (Fig. 4). The major portion of the altered slope is occupied by steep slope in which both wedge failure and topple failure have occurred. The eastern portion of the landslide area containing very steep to steep slope however contains no topping and wedge failures, but gully erosion is prominent there. Gullies there are of 5–10 m wide and 3–5 m depth.

Fig. 3 (a) Landslide at the right bank of the Malekhu River; a downstream view of the river and the landslide, and (b) A closer frontal view of the Malekhu Landslide; the upper central portion occupied by the main scarp, above which is a crown along which a gravel road extends; the middle portion of the photograph is a wedge failure debris and toe of the failure.

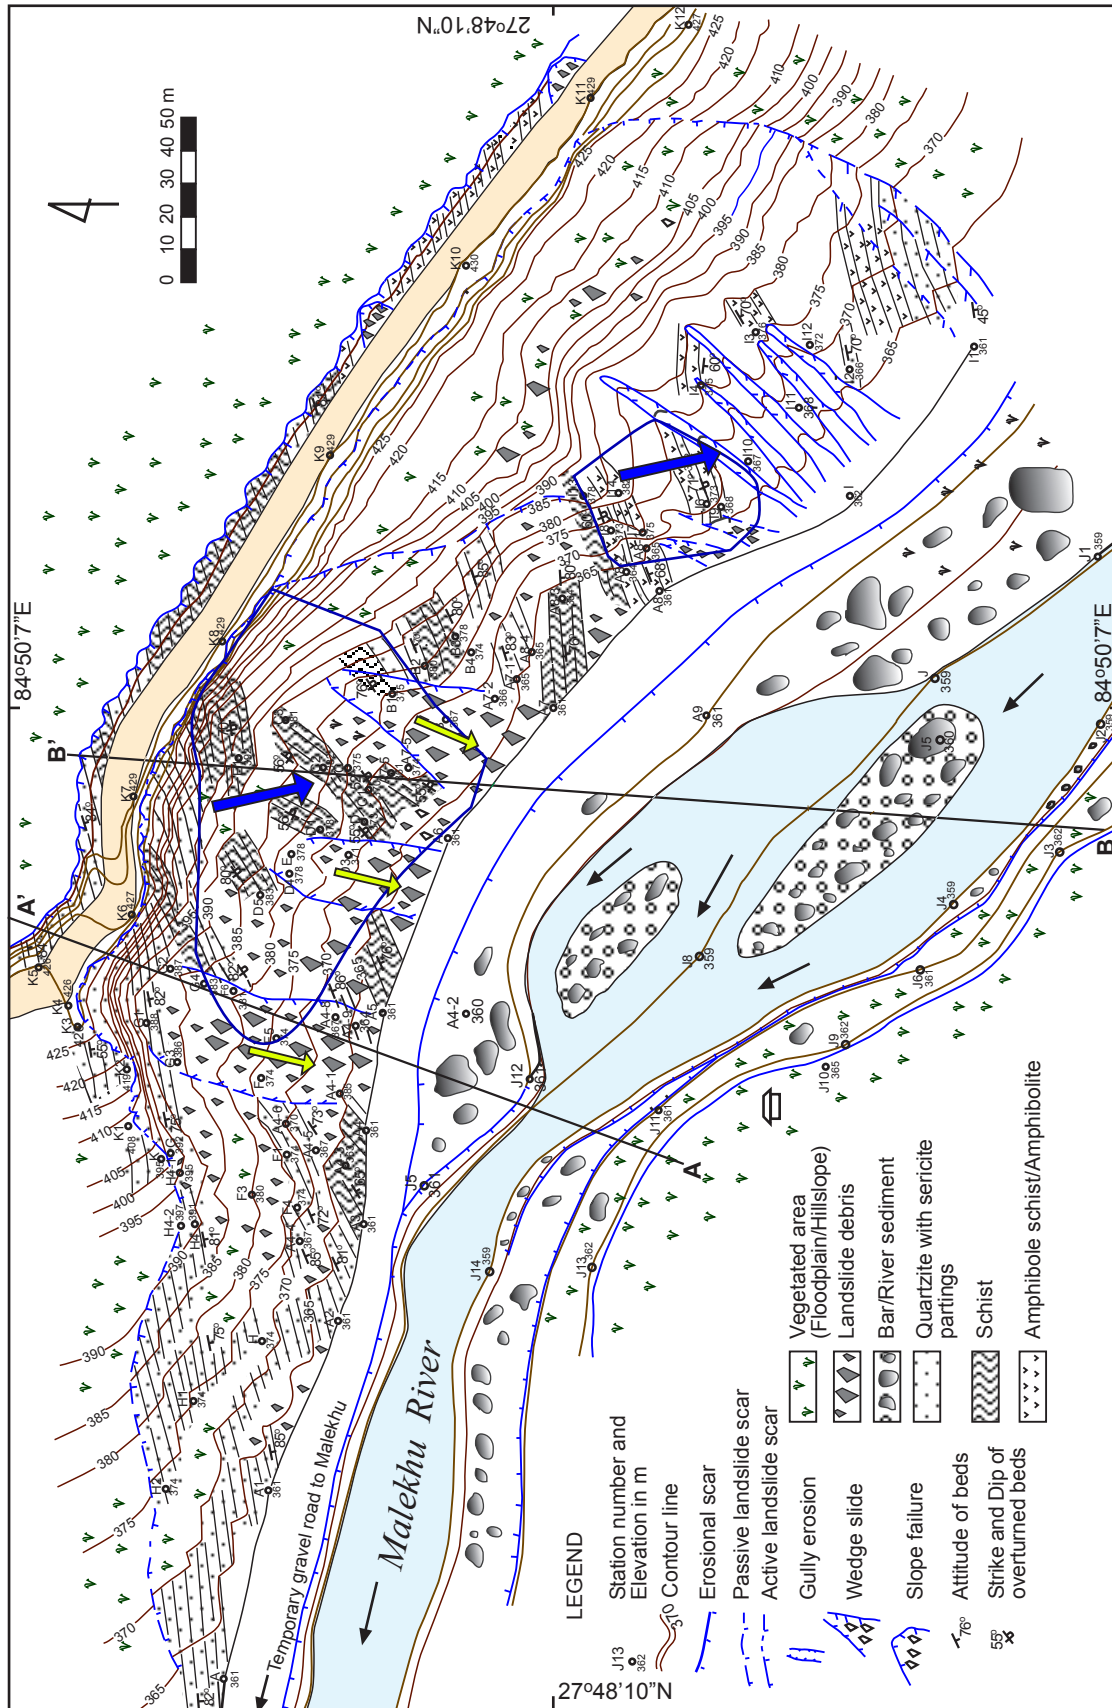
Fig. 5 Engineering Geological map of the Malekhu Landslide.

The Malekhu Landslide is characterized by two major types of failures (Figs. 5 and 6); toppling and sliding, and wedge failure. The former is a prominent structure, the remnant of which has remained on the hillslope. The wedge failure is observed by its geometry on the outcrop and the debris it has yielded.

Two toppling areas have been identified; one in the central portion of the landslide area, and the another one is slightly in the eastern portion (Fig. 5). Rock mass of quartzite, chlorite schist and amphibolite all have experienced toppling and sliding. The major lithology affected by toppling in the central portion of the landslide area consists of the chlorite schist and subordinately quartzite. In the western portion of this large toppling,

the quartzite beds are mostly affected and are toppled at Elv. 370–380 m. The attitude after toppling is about 80° dipping towards NW. Whereas, the rest of the beds lying upslope and downslope are in right side up condition, and dip around 80° towards SE. The crown occurs at Elv. 429 m, whereas the top of the hill is at Elv. around 450 m. The chlorite schist constitutes the major portion of the large toppling in the central portion of the landslide area (Figs. 5 and 6). They are rotated to various degrees and have now the dip amount ranging from 55 to 80°. The beds which are affected by toppling lies mostly between Elv. 365 and 405 m.

The smaller portion of toppling occurs in Elv. between 365 and 290 m, in the eastern portion of the landslide area, and here the rocks are composed mainly of amphibolite, amphibole schist and subordinately of quartzite. The overturned beds show 60 to 70° of dip amount towards NW.

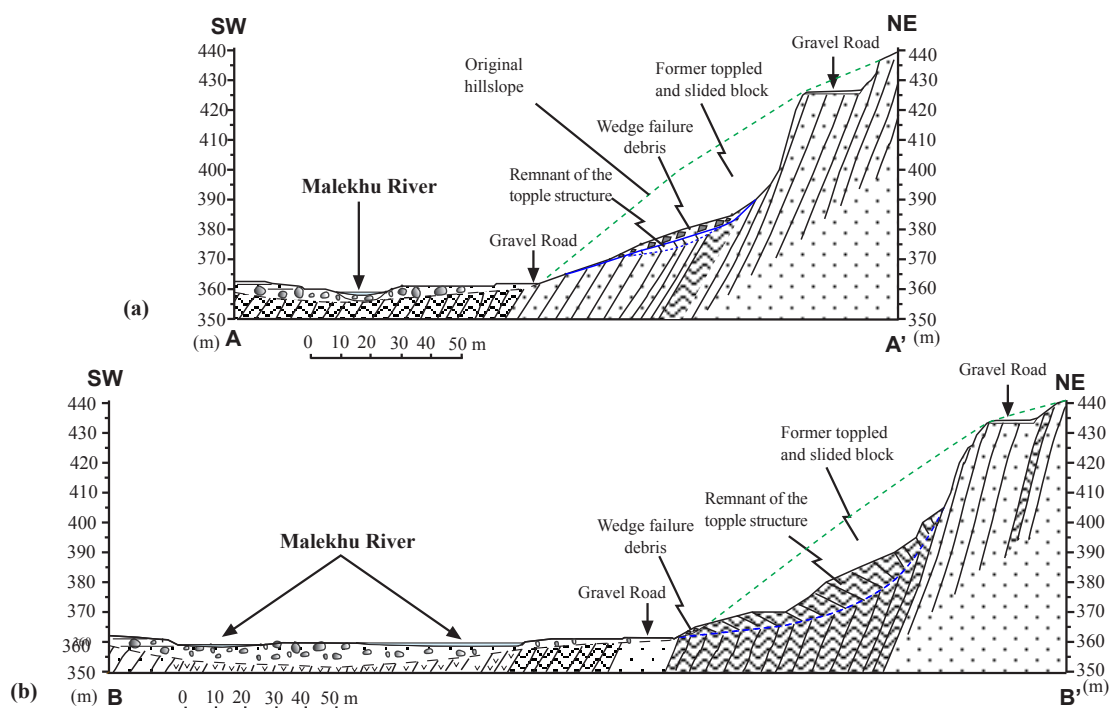
Fig. 6 Cross-sections of the topple structure: (a) The section along the line A-A', and (b) The section along the line B-B'.

The beds distributed in the Malekhu Landslide were measured and analysed for their attitudes to reconstruct the mechanism of landslide phenomenon and the geometrical configuration of rotation of beds through toppling (Figs. 6 and 7). The following are the configuration of the beds:

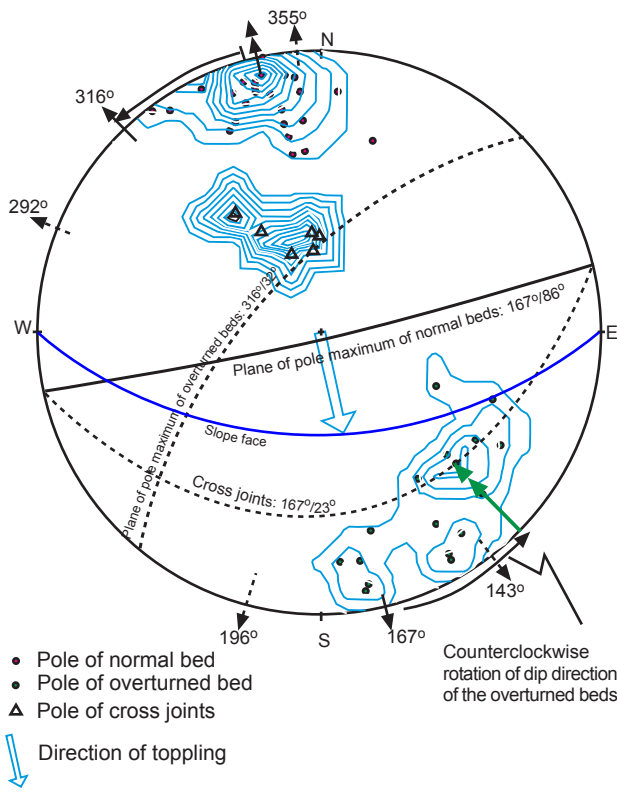
(a) Right-side up beds (hereafter normal beds): The mean azimuth of the normal beds is  $167^\circ$  (with a range  $143^\circ$ – $196^\circ$ ). The range of dip of normal beds is  $56^\circ$ – $90^\circ$ . The attitude of the pole maximum of the normal bed is  $167^\circ/86^\circ$ .

(b) Overturned beds (toppled beds): The mean azimuth of the overturned beds is  $316^\circ$  (the range being  $292^\circ$ – $355^\circ$ ). The attitude of pole maximum of the overturned beds is  $316^\circ/32^\circ$ .

The overturned beds are found to have rotated (change in plunge) from the normal position to the total amount

of  $36^\circ$ . The bed dip direction had rotated counterclockwise to an amount of  $31^\circ$  from the major direction of toppling to  $167^\circ$ . This rotation probably had occurred during sliding. The nature of toppling is described as a flexure toppling of passive mode, in which rocks fail either due to tensile bending stresses upon most probably dynamic loading, since the inclination of layers of rock is greater than the slope angle (Aydan and Amini, 2009). This toppling is different from that of the active mode in which tensile bending stresses of layers occur and some overturn under their own weights (Goodman and Bray, 1976; Goodman, 1989; Majdi and Amini, 2011).

Fig. 7. Stereographic projection of poles of normal and overturned beds from the landslide area showing the direction and amount of rotation of beds.

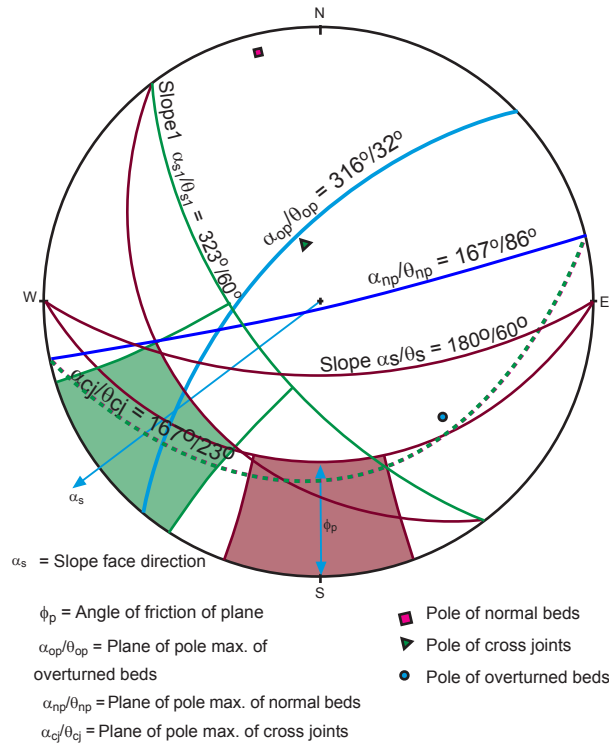
The kinematic analysis for toppling using the Markland's (1972) criteria, exhibits that there is no further possibility of toppling failure (Fig. 8).

Fig. 8 Stereographic projection of poles of discontinuities from the landslide area for kinematic analysis.

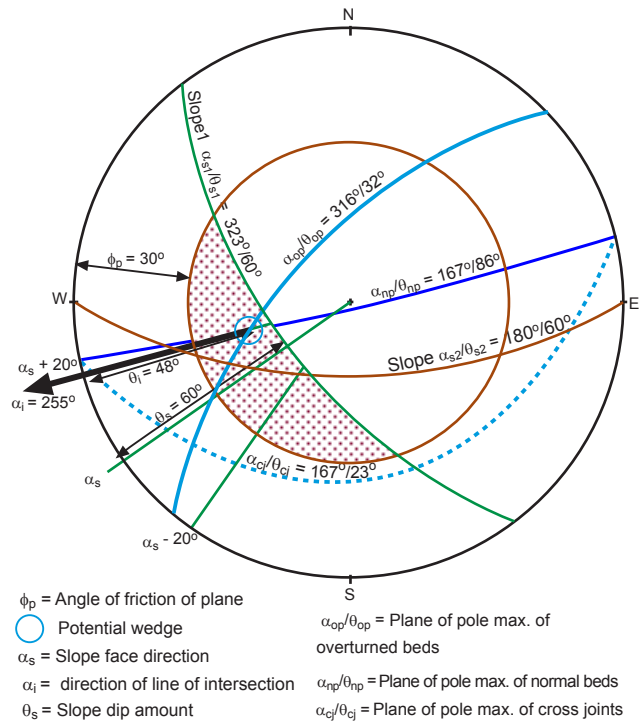
The wedge sliding Kinematic analysis (Fig. 9) shows that there is a potential intersection between the normal beds and the overturned beds, after using Markland's (1972) criteria. Other intersections do not form potential wedges. The presence of a potential wedge indicates that sliding of the toppled mass possibly occurs towards SW, and also had occurred in the past also thus depleting the toppled rock mass of the original hillslope (Fig. 5).

Fig. 9 Stereographic projection of discontinuities from the landslide area for wedge failure kinematics for a multifaced slope. Dark arrow indicates possibility of wedge failure.

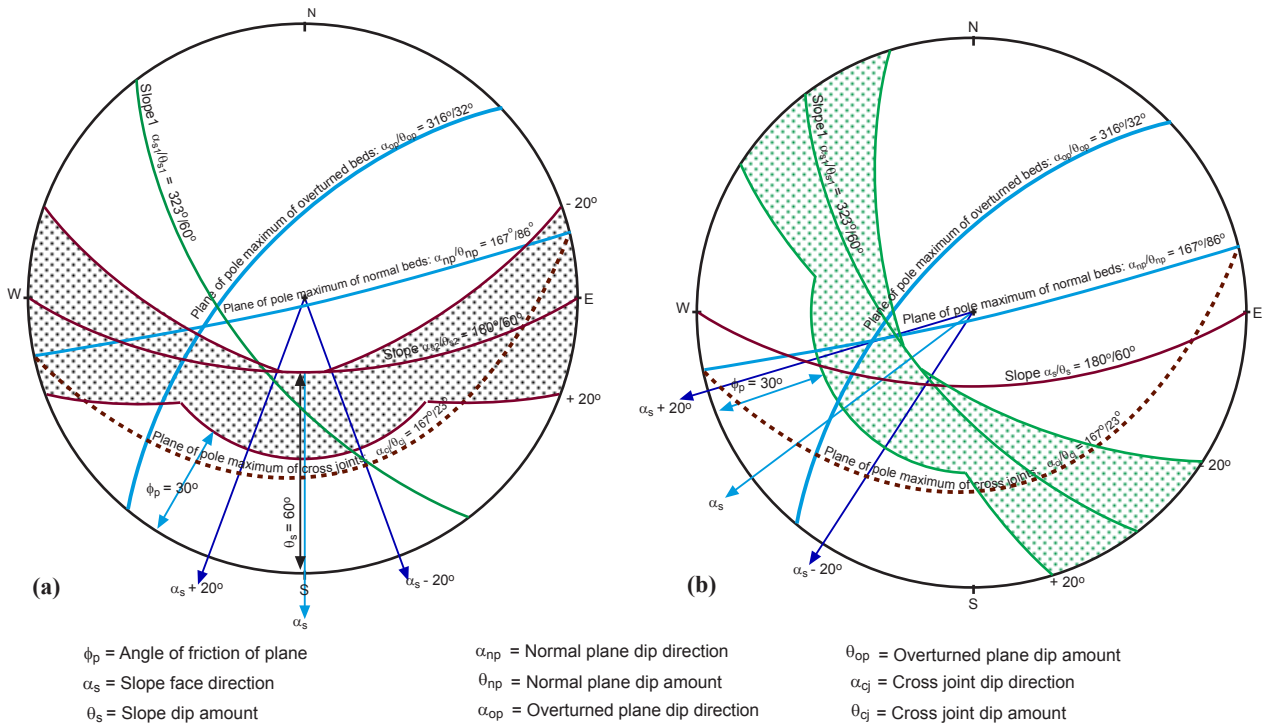
Kinematic analysis of plane failure for the multi-faced slope is performed. The analysis indicates that there is no possibility of plane failure as the plane of discontinuity does not lie within the criteria of Markland (1972), or the shaded area of Fig. 10.

Fig. 10 Stereographic projection of discontinuities from the landslide area showing plane failure kinematics for multifaced slope: (a) Kinematics for the south-facing slope, and (b) Kinematics for the south-west-facing slope.
