# Effect of Sand Erosion on Turbine Components: A Case Study of Kali Gandaki “A” Hydroelectric Project (144 MW), Nepal

Balendra Chhetry and Kumar Rana

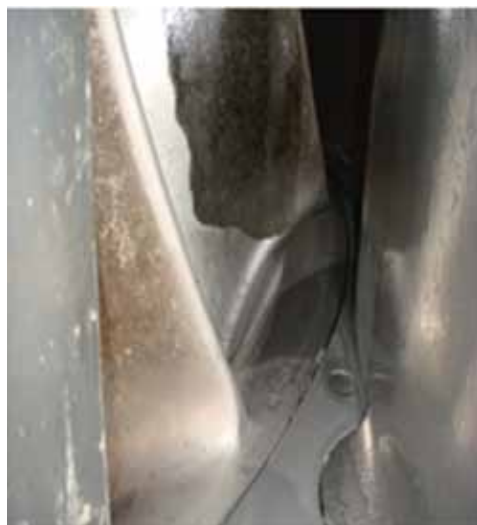
The overhauling of the same unit was carried out after 3 years of operation in 2006 after 14,264 running hours with energy generation of 513.78 GWh. It was observed that the damage of turbine components without HVOF coating were more severe than HVOF coated turbine components due to sand erosion.

Photo 1 (a, b) shows the photos of damages due to sand erosion of non-coated and coated turbine components. Since then practice of applying HVOF coating on under components of all machines has been implemented to resist the sand erosion during maintenance of turbine.

Photo 1.a: Non coated runner

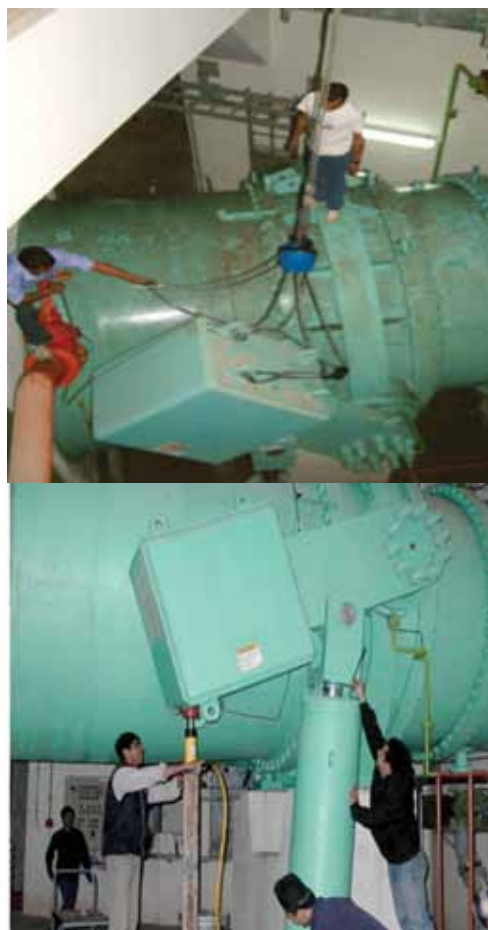
The opening and closing problem of Unit 2 inlet valve had been observed as a major operational problem since from its commissioning time. Since then it had been practiced to open the inlet valve by using chain pulley and hydraulic press as shown in Photo 2.

Photo 2: Photos of opening of inlet valve by using 3 ton chain block and 20 ton hydraulic press.

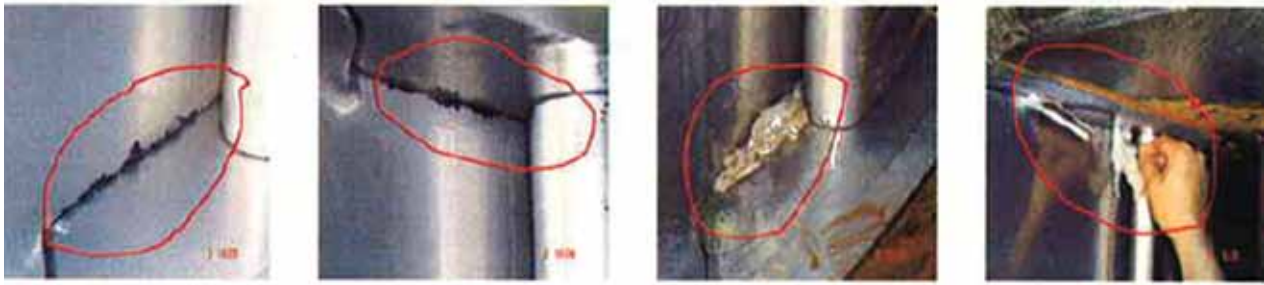
On January 2005, inspection of Unit 2 was carried by dewatering the unit and observed severe damaged on turbine parts. At this time, pieces of clothes were used to stop the water leakage turbine parts and to maintain the upstream and downstream water pressure as shown in Photo 3.

Photo 3: Photos of damaged turbine parts due to sand erosion and placing of cloth pieces.

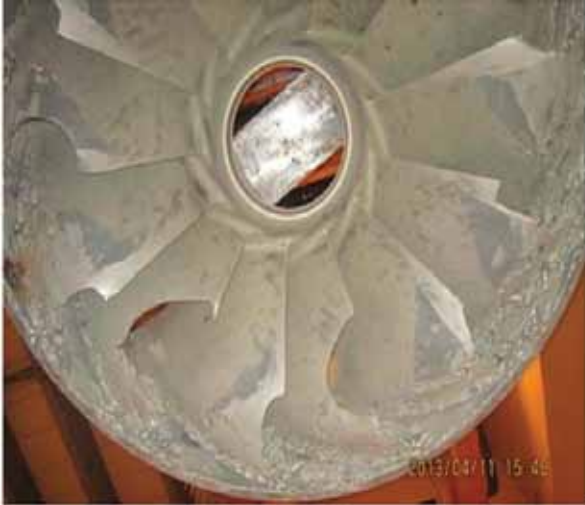
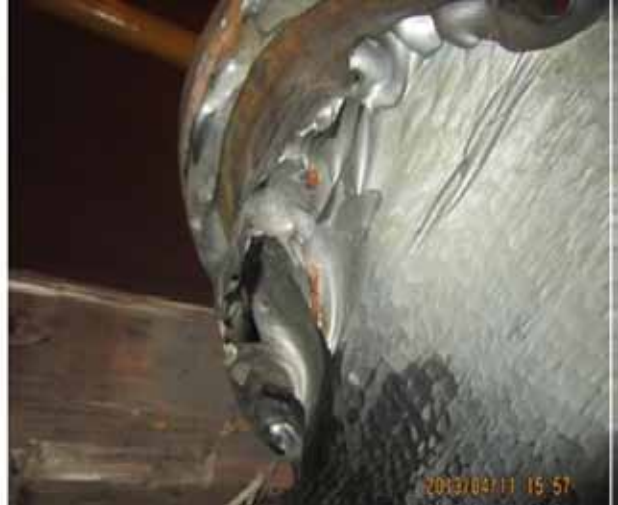
Photo 5: Photos of damage of runner and facing plates of Unit No. 2

During the annual maintenance on year 2013, runner and its accessories were taken out and found there were significant amount of damages of runner, facing plates, labyrinth rings and guide vanes. Photo 5 shows the damages of runner and guide vanes and facing plates.

to sand laden water (Brekke, H 1984). From Photo 4 and Photo 5, it is clearly observed that there is a significant damage of guide vanes and runner outlet. The relative velocity is highest at the outlet of the runner

blade. Hence turbulence erosion is always susceptible at the outlet edge of the blade. Because of the effect of centrifugal force, most of particles will move towards outer diameter in the runner outlet and, hence, more effect of erosion is seen there.

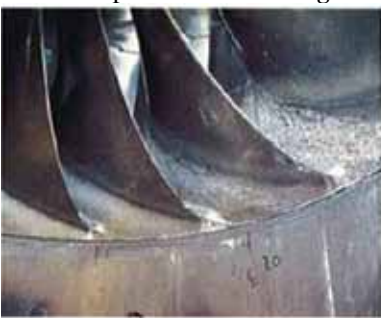
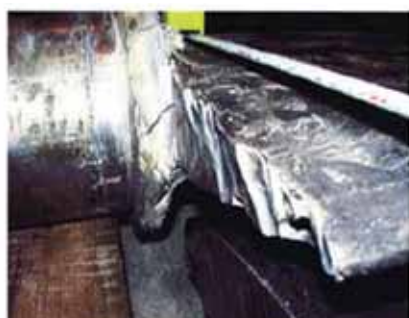
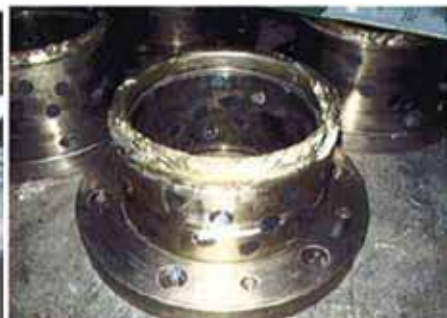
energy generation of 565 GWh after commissioning on 31 March 2002. In Unit 3, the operational problem of inlet valve was also noticed during the operation of the plant due to pressure difference between upstream and downstream of spiral case since commissioning period.

Photo 4: Photos of damaged components of Unit 3

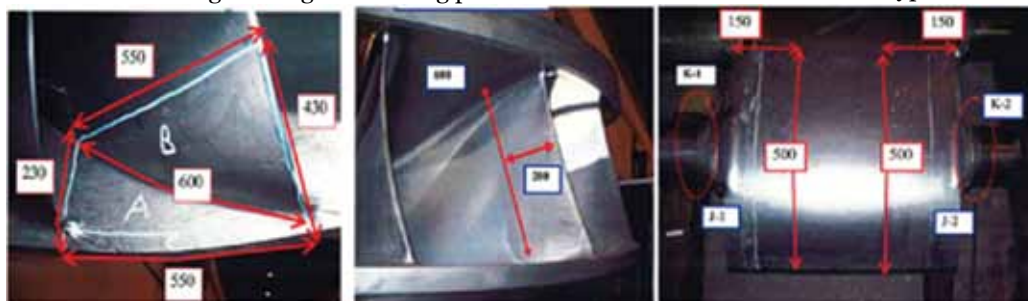
Photo 7: Photos of coating area for runner and guide vanes.

In KGA, HVOF coating have been used in different underwater components of turbine to resist against sand erosion. Photo 7 shows the coating area of runner and guide vane for HVOF coating during the repair works.

Before coating with HVOF, surface preparation was carried out by using special aluminum grits. Pre heating was performed around 40 to 60° C in order to remove moisture content in the coating surface. Finally, powder spraying was carried out by hand to coat out up to thickness 0.3 mm to 0.5 mm with the help of coating machine and rotating turn table. After repair of the damaged turbine parts, assembly of turbine was carried out. Assembly of turbine was done in reverse order of the disassembly.
