PCBS CONTAMINATION AMONG DISTRIBUTION TRANSFORMERS IN THE KATHMANDU VALLEY

Ruska Kattel^{1*}, Bhupendra Devkota²

^{1,2} College of Applied Sciences – Nepal, Tribhuvan University, Nepal

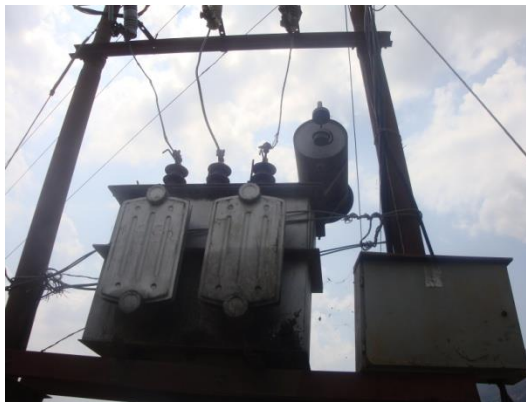
Fig 1: Leaking Transformer

However DTs may suffer from several conditions such as overload conditions, which might lead to transformer failures. The main causes include insulation failure, design/material/workmanship, oil quality and contamination, overloading, fire/explosion, line surge, improper maintenance/operation, flood, loose connection, lightning and moisture. All such causes may result to the leaks in transformers (Bartley, 2003). When a leak or seepage has been detected on a transformer, it is necessary to immediately establish the cause of the leak, contain the oil leaks and take remedial action.
