STRUCTURAL ENGINEERING/PERSPECTIVE DAMAGE PATTERN OF TEMPLES OF KATHMANDU VALLEY AFTER GORKHA EARTHQUAKE 2015

Rajan Suwal

Institute of Engineering, Pulchowk Campus, Tribhuvan University, Nepal

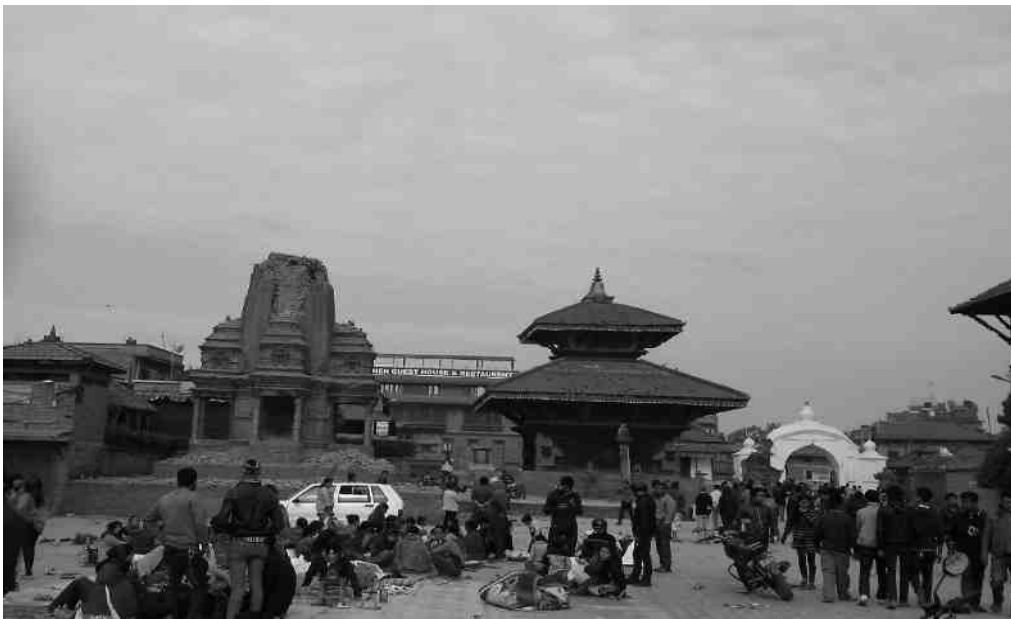
In the Gorkha earthquake, 2015, top part of temple had fallen. Exterior brick walls fell even though interior mud with brick core was partly intact. Shear failure of wall occurred due to the absence of horizontal timber band and vertical timber connection. There was absence of connection between outer brick walls and inner mud with brick core so outer and inner core were separated.

Figure 1: Damage of top part of Kedarnath Temple of Bhaktapur Durbar Square

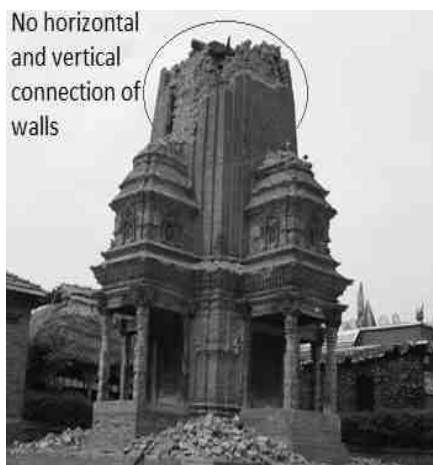
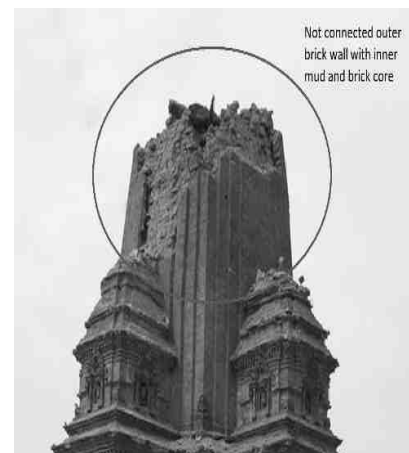
There is an opening to enter inside the temple. Temple is one storied above that almost solid core. The outer brick wall of temple was made of traditional decorated brick with mud mortar and inside of core were filled with mud and local bricks which is shown in Figure 2. The outer pillar of the temple was made of single slender stone. Foundation of the temple is in elevated two tiered plinths. Timber as a structural element is not seen in this temple. Connection between external walls and internal walls are not provided (Figure 2).

Figure 2: Enlarged view of damage of top part of Kedarnath Temple of Bhaktapur Durbar square

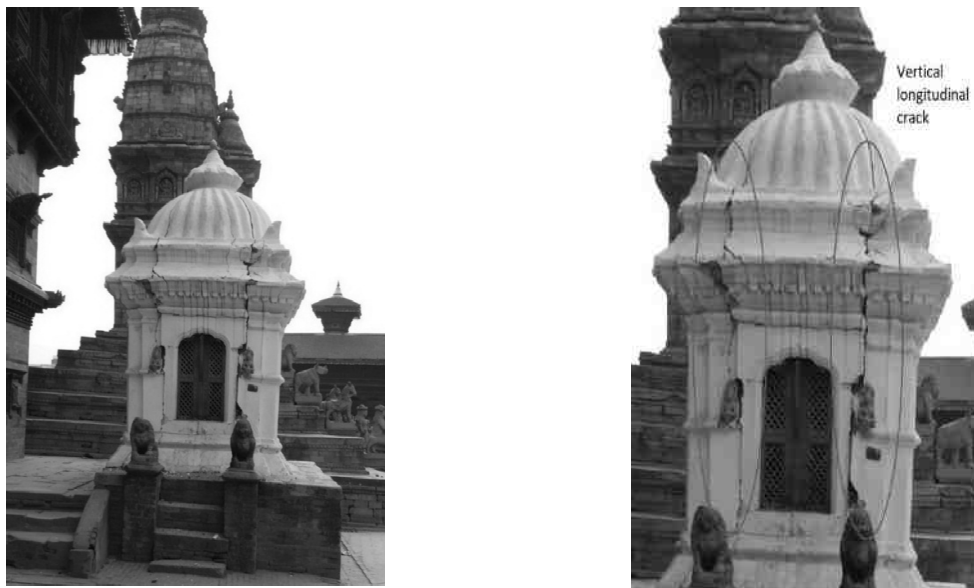
The small Shankernarayan temple was damaged in the Gorkha earthquake, 2015. Temple is almost square in plan. There is a door from front side. From other three side there is masonry wall. It is one storied temple. Even though this temple of Durbar Square of Bhaktapur is small, it was damaged in the earthquake as shown in Figure 3. It is seen that the temple has vertical longitudinal crack from plinth to roof but did not collapse.

The vertical crack failure might be due to weak bonding between brick elements. There is no connection band horizontally in different layers of temple. The locking of bricks in different layer are missing and hence longitudinal vertical cracks were developed.

Figure 3: Longitudinal vertical joint failure of Shankernarayan Temple of Bhaktapur Durbar Square
(Photo source: author)

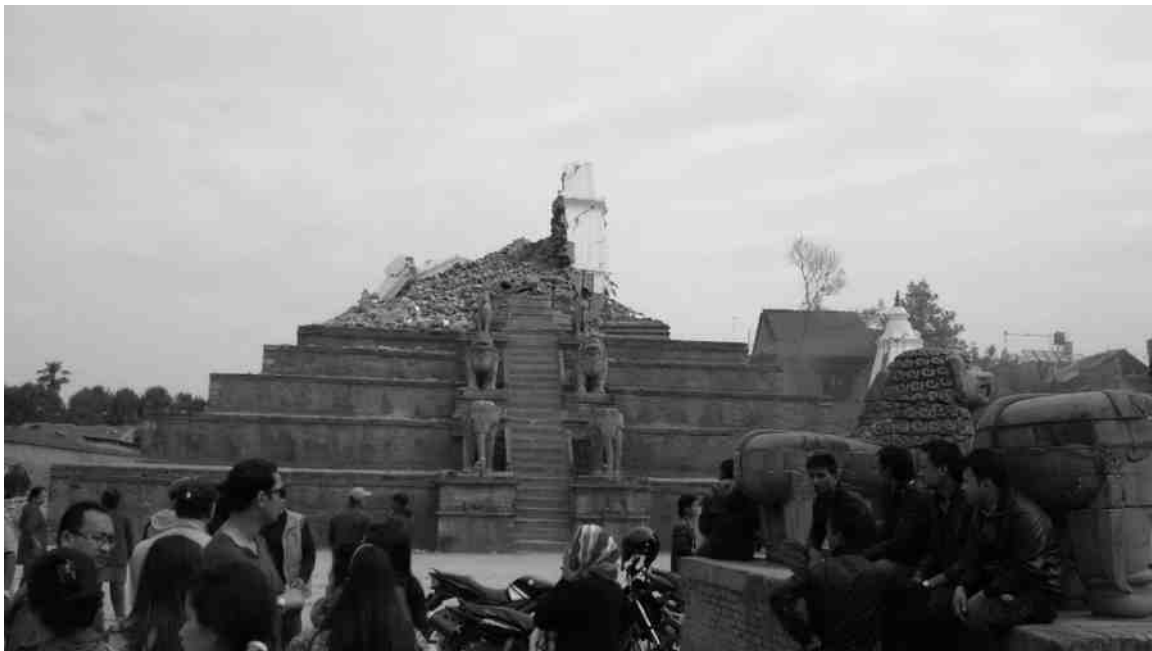
Fasi Dega temple was constructed up to five steps raised platform in Bhaktapur Durbar Square before the Gorkha earthquake, 2015 (shown in Figure 4). One story temple has square in plan and openings from all sides. The structure of this temple was fully collapsed up to raised plinth level in the Gorkha earthquake, 2015 (shown in Figure 5). The temple was rebuilt as brick masonry with mud mortar after it collapsed in Nepal-Bihar earthquake, 1934.

Even though this structure was only around for 75 years, it was again fully collapsed indicating there must be either structural system failure or material quality failure. Structural integrity of masonry wall seems weak. In addition to that, five tired soft plinth steps might have amplified the earthquake effect for the structure.

Figure 5: Fasi Dega Temple collapsed up to elevated top plinth(Photo source: author)

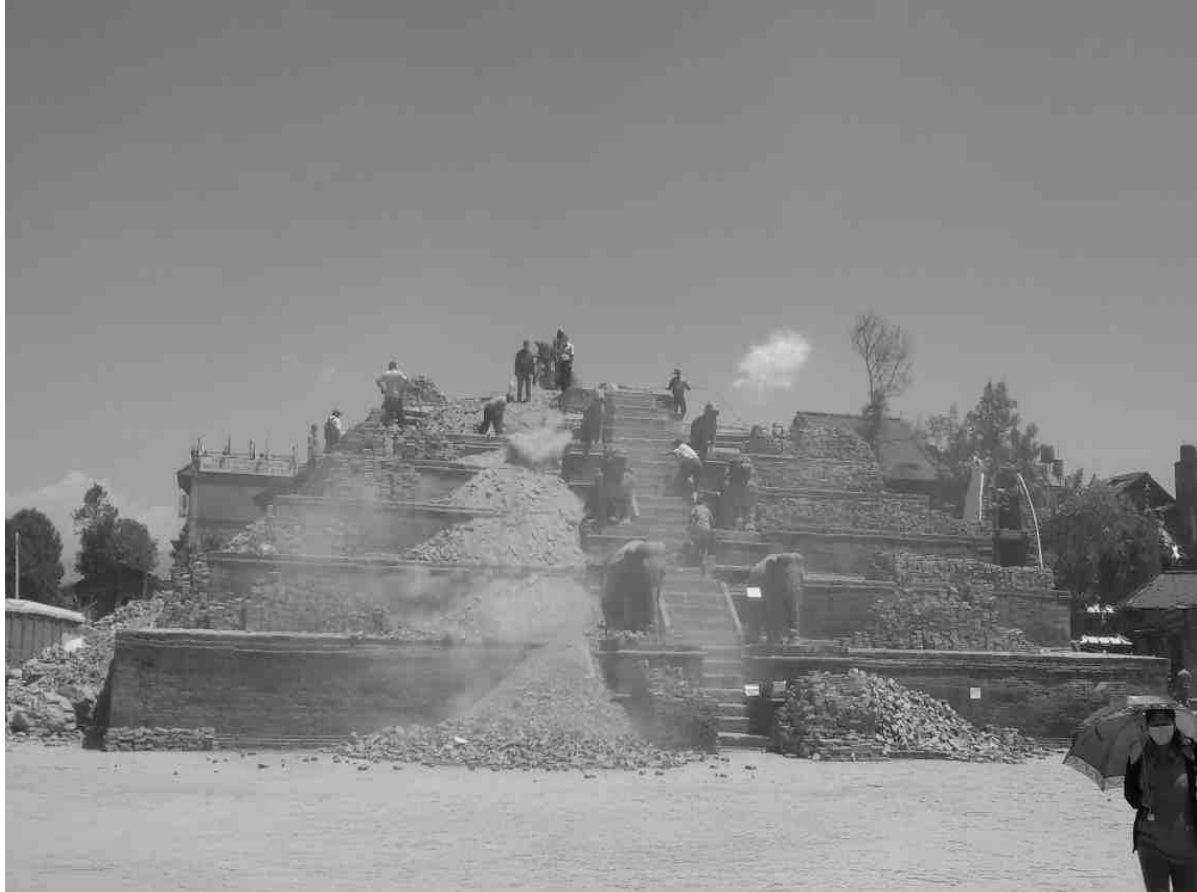
Figure 6: Fasi Dega Temple after Gorkha Earthquake 2015 (in cleaning stage)
(Photo source: author)

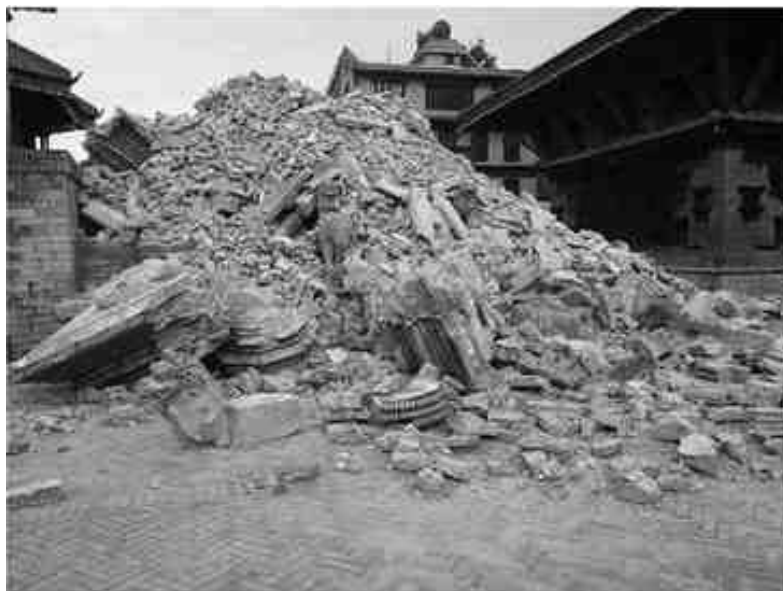
Figure 8: Collapse of Vatsala Durga Temple, Bhaktapur Durbar Square
(Source: researchgate.net)

Measuring height to width of core wall ratio of temple from the judgment of picture, it can be said that temple is slender for stone masonry structure. Interlock of stone masonry might not be provided. From the damaged picture of Figure 8 shows that inner part of temple was filled with mud and stone bats without any integration with outer stone masonry walls. There might be already micro-cracks between mortar and stone block in different previous earthquakes, staying without good bond. Due to this weak bond between stones with mortar, it lead to complete collapse.

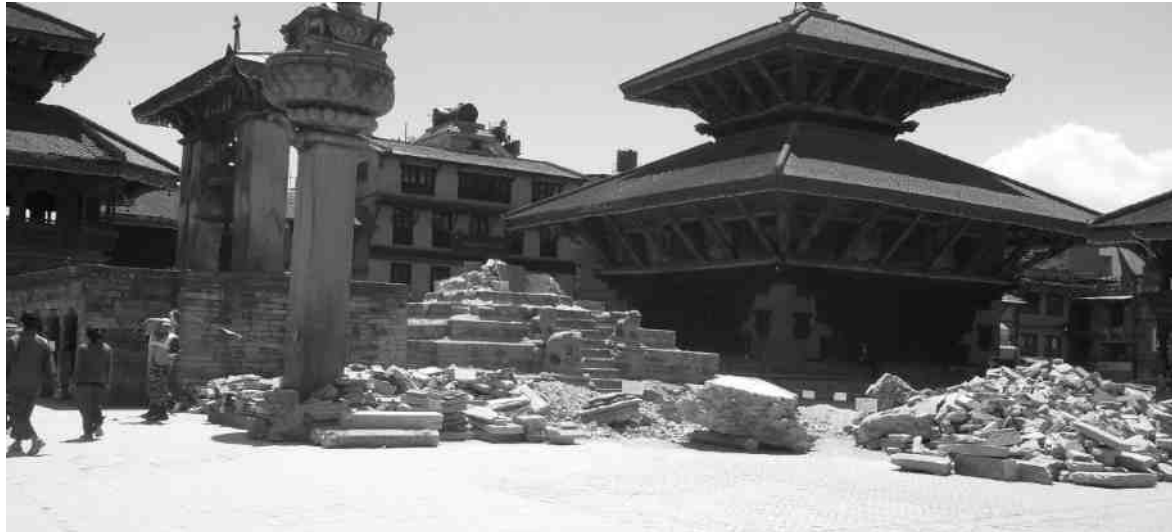
Figure 9: Vatsala Durga Temple, Bhaktapur Darbar Square (after cleaning)
(Photo source: author)

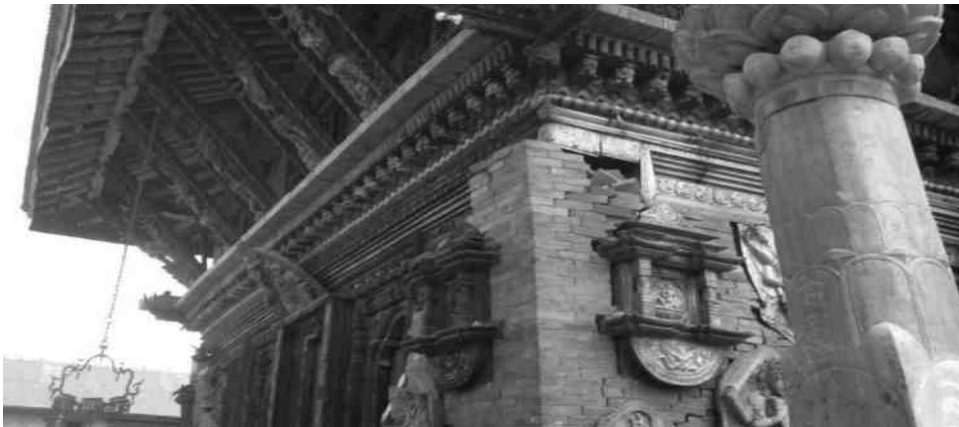
Temple is mainly supported by corner brick masonry and heavy timber openings. On the ground floor, masonry portion of load bearing is less compared to total load-bearing structures. Since heavy panel of opening works as an intact structural element, remaining corner brick masonry is likely to fail in earthquake load. In Gorkha earthquake, 2015, corner masonry walls of the temple failed, which is supported by the computer model analysis (Suwal and Joshi 2021).

Figure 10: Damage in Changu Narayan Temple (North-West corner, top)

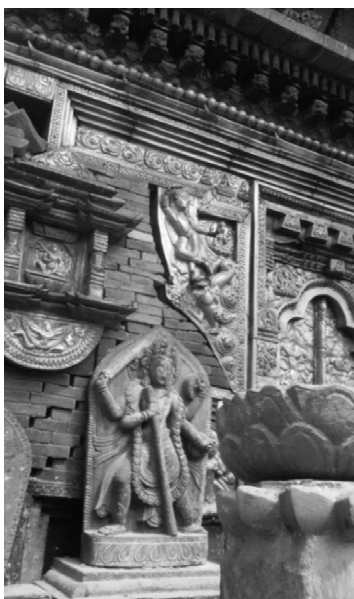
Figure 11: Damage in Changu Narayan Temple (North -West corner,bottom)

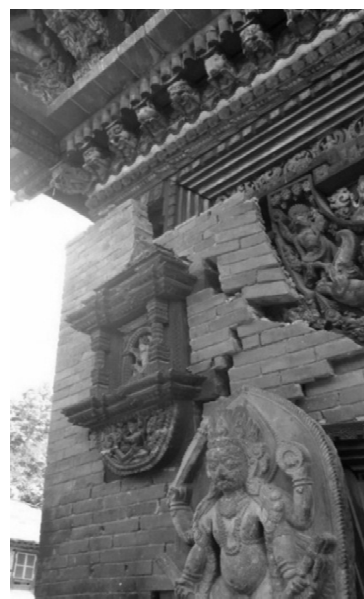
Figure 12: Damage in Changu Narayan Temple (North-East corner)

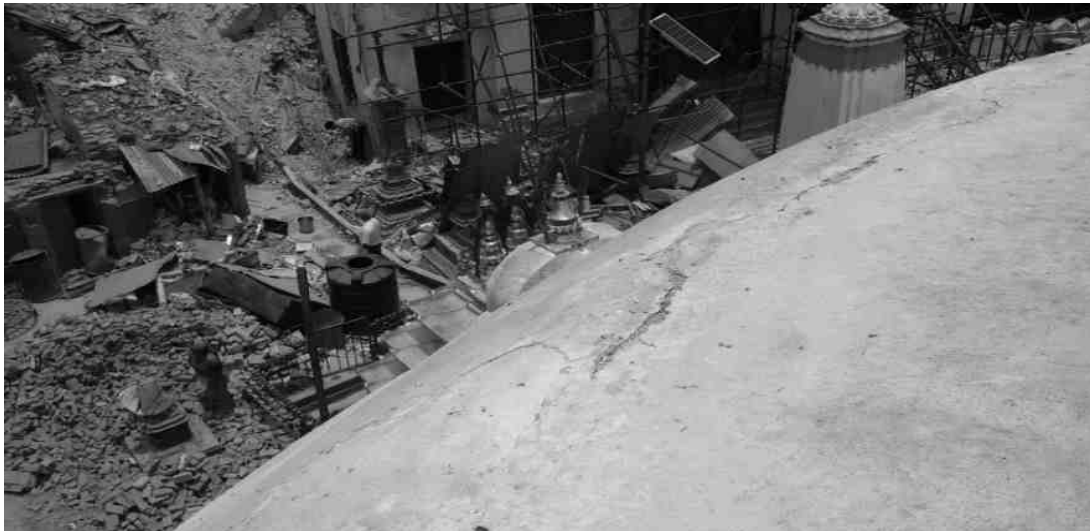
Base of Swayambhu Stupa had constructed with massive brick and mud structure. The shape of base is almost semi-spherical dome. It has minor damage in the main dome base. Minor circumferential and radial cracks are observed as shown in Figure13 and Figure14. Minor cracks were observed in the joint of dome and main structure as shown in Figure15.

Mass dome might be weakened due to age and water penetration. Minor cracks are observed due to massive shaking of huge mass of dome which might be less resisting capacity of dome mass in radial and circumferential direction.

Figure 13 Circumferential crack in Swayambhu temple of main base dome
(Photo source: author)

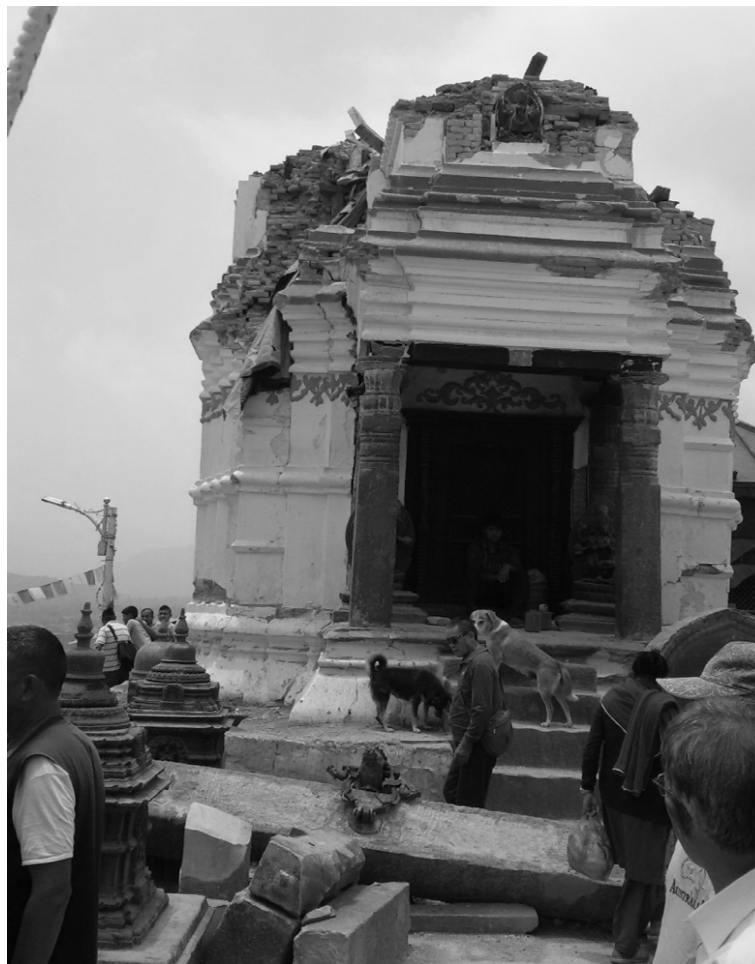
Anantapur and Pratappur temple of Swayambhu premises are almost in same plan dimension in both directions. It has big door opening in front side of temple. These temples were damaged in Gorkha earthquake, 2015. Anantapur temple was damaged severely as shown in Figure 16. Top part of temple was collapsed totally. Another temple Pratappur is slightly damaged in plinth level. Plinth level brick was damaged in compression crushing and shear. Both the temples were constructed with brick masonry in mud mortar. Both the temples are very slender with respect to base dimension.

Since both temples are slender there are more chances of failure of brick masonry structure in earthquake. Brick masonry was constructed without horizontal band and vertical connection. It is not seen that connection between external brickwork and internal core. Due to these causes, this beautiful structure failed in Gorkha earthquake.

Figure 16 : Collapse of Anantapur temple in Swayambhu premises, Kathmandu

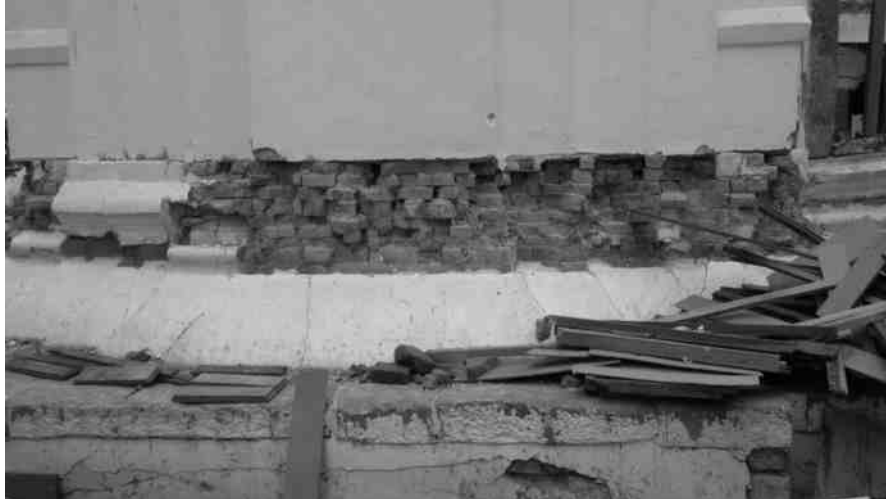
Figure 17: Collapse of Anantapur temple in Swayambhu premises, Kathmandu
(Photo source: author)

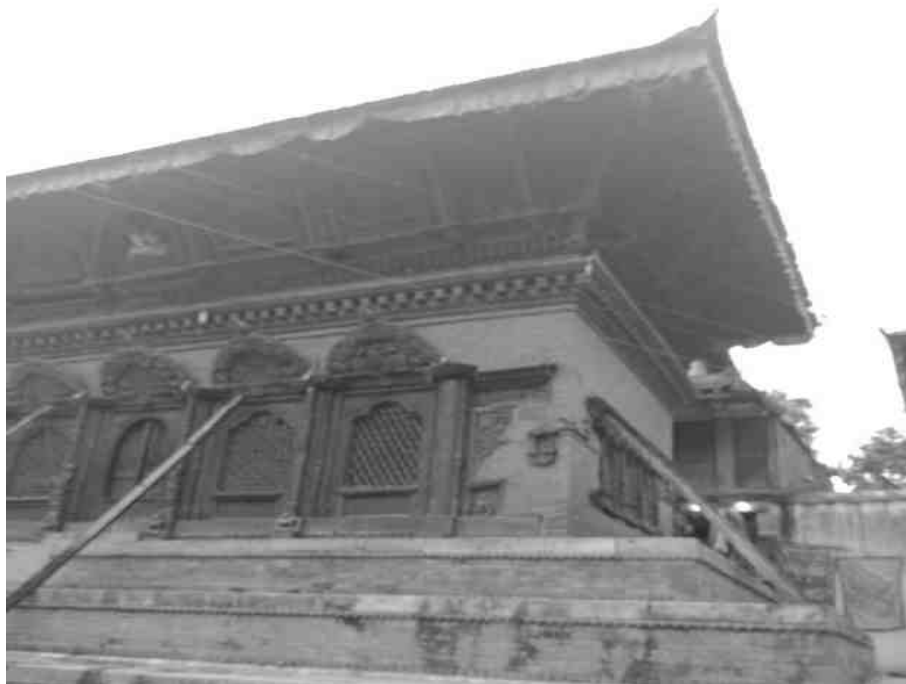
Shiva Parvati Temple is located in Basantapur Durbar Square, Kathmandu. Temple was constructed with brick masonry in mud mortar. Temple is rectangular in shape. Length is comparatively two times longer than breadth. Temple has heavy roof mass in the top. It has larger opening than brick masonry walls on ground floor. It can be seen that temple has diagonal crack failure in short direction. The temple and its crack patterns are given in Figure 18, Figure 19, and Figure 20.

Figure 18: Failure of masonry structure of Shiva Parvati temple

Due to the heavy load in roof and big openings on ground floor and less brick masonry structure part, masonry wall of temple is failed. Since the temple has one direction long and another direction short, cracks are observed in the shorter direction due to the less stiffness or shear capacity of masonry wall in earthquake load.

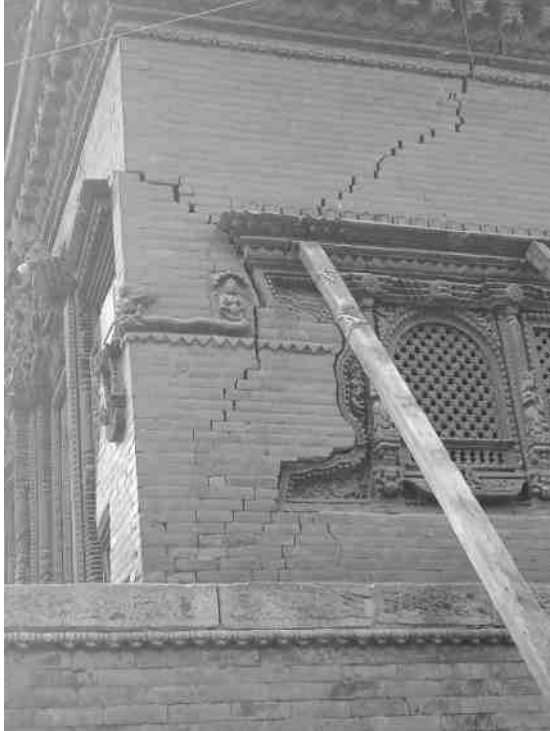
Figure 19: Diagonal shear crack in south east corner of short side elevation
(Photo source: author)

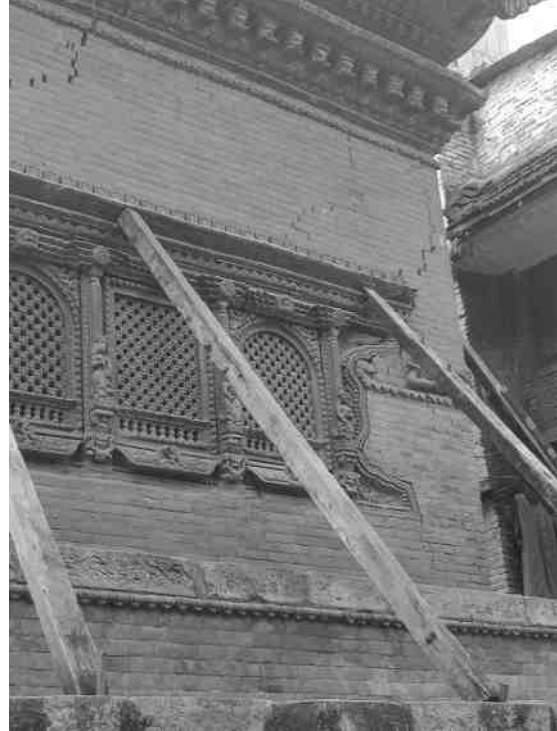
Figure 20: Diagonal shear crack in north east corner of short side elevation
(Photo source: author)

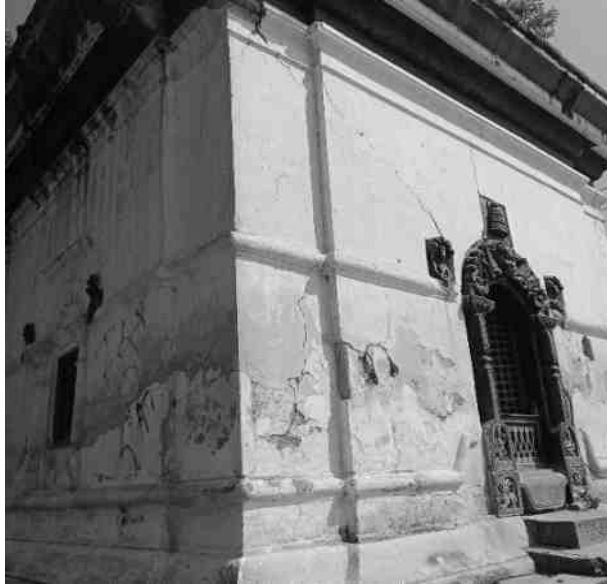
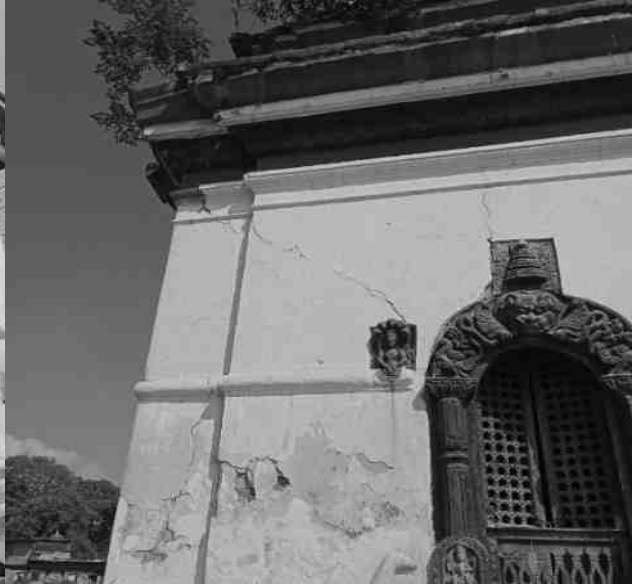
Narayan Temple in Kalmochan temple area, Thapathali, Kathmandu, was made of brick with surkhi+lime+sand mortar. Brick masonry with surkhi+lime+sand mortar seems delaminated due to water penetration in temple building. Temple has small opening in all sides with different sizes. It is one story temple. There is no horizontal timber and brick band in temple. The temple and its crack patterns after Gorkha earthquake, 2015 are shown in Figure 21, Figure 22, Figure 23, and Figure 24. In the premises, main structure of Satya Narayan temple was fully collapsed in the Gorkha earthquake, 2015.

Figure 21: Wall crack in Narayan temple of Kalmochan
(Photo source: author)

Figure 22: Wall crack in Narayan temple of Kalmochan
(Photo source: author)

Narayan temple of Kalmochan area damaged in masonry wall. Crack of brick masonry of temple seems due to delamination of masonry work. Continuous water penetration in brick masonry might weaken the strength of temple masonry and cracked it in Gorkha earthquake, 2015.

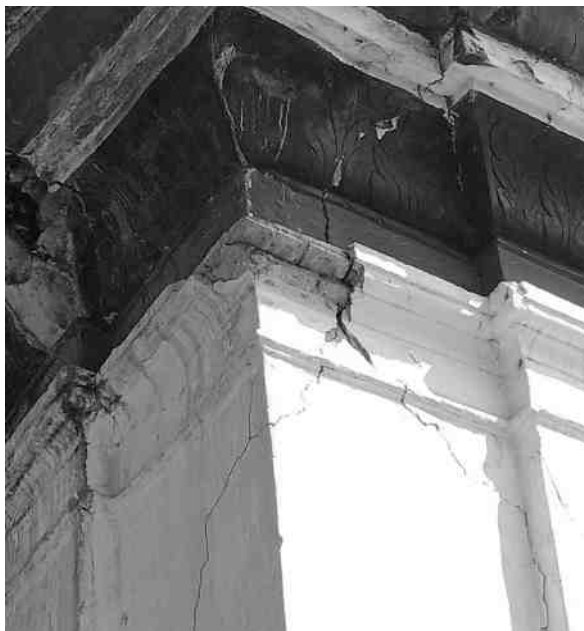
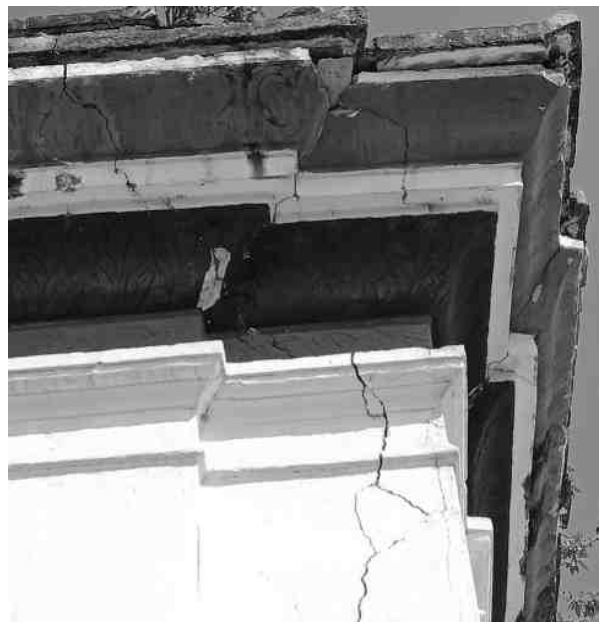
Figure 23: Crack near the roof of Narayan temple in Kalmochan
(Photo source: Author)

Figure 24: Crack near the roof of Narayan temple in Kalmochan
(Photo source: Author)

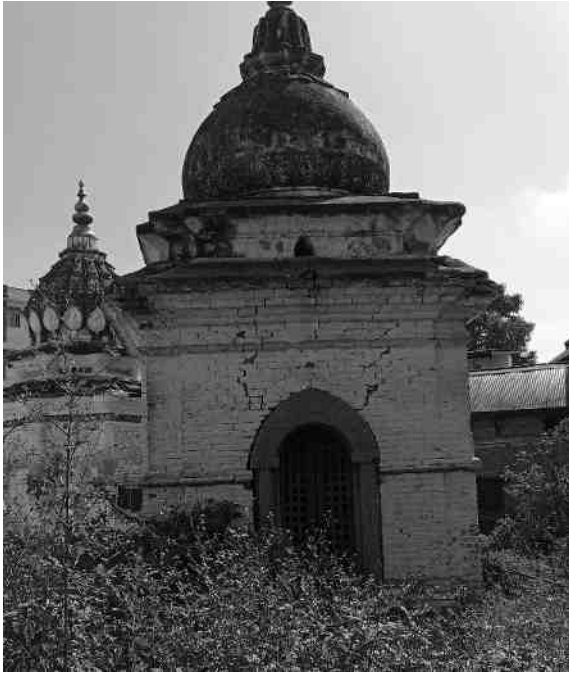
Figure 25: Crack over opening in brick masonry in Mahadev temple of Kalmochan premises

Mahadev Temple in premises of Kalmochan temple area at Thapathali in Kathmandu was made of brick with surkhi, lime sand mortar. The temple has almost square in plan with small door opening. Brick masonry with mud mortar seems delaminated condition. Bonding between brick with mortar seems already weak. It seems water penetration in brick masonry from roof which made brick masonry weak. Cracks are seen above two edges of opening almost in vertically. The temple and its crack patterns are shown in Figure 25 and Figure 26.

Mahadev temple of Kalmochan area damaged in masonry wall. Cracks on brick masonry of temple seems due to delamination of masonry work. Continuous water penetration in brick masonry weakens the strength of temple. Almost vertical crack above the edge of opening shows weakness of masonry wall due to old age of temple and weakened water penetration and cracked in Gorkha earthquake, 2015.

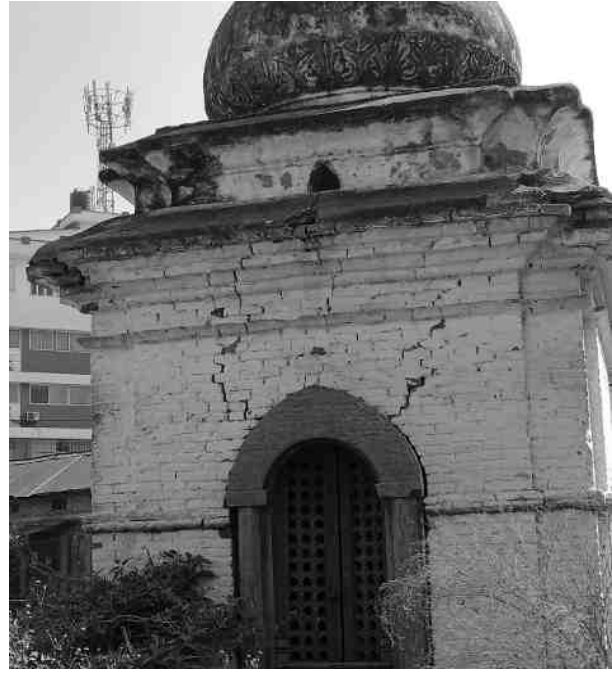
Figure 26: Close view of crack over opening in brick masonry in Mahadev temple of Kalmochan premises
