# Observed Behavior of Reinforced Concrete and Unreinforced Masonry Buildings in April 25, 2015 Nepal Earthquake

Yadin Shrestha

*Institute of Engineering, Tribhuvan University, Nepal*

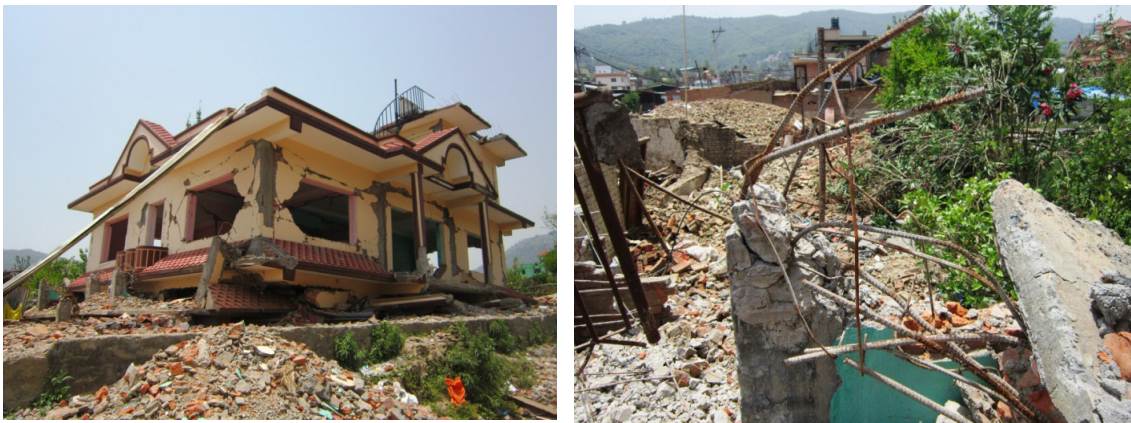
Figure 1. Collapsed RC frame building in Ramkot VDC, Kathmandu (left) and Close up view of its damaged exterior column (Right)

The figure 1 (left) is a recently constructed RC frame residential building at Ramkot village of Kathmandu. The building was constructed on the black cotton soil as observed in the nearby pits. This three storey building was collapsed by soft-first storey failure mechanism causing pancaking of first two stories. Structural layout of the buildings as shown in the figure 2 shows that total number of columns (size 9"x12") is 16, which are arranged symmetrically in plan area of 1162 sq.ft. The structural layout of the building seems good so far as multiple load path and regular plan is considered. But in the field it is observed that size of stirrups in columns is 6mm spaced at 150 mm c/c and reinforcement detailing was very poor (figure 1, right). Also, it is found that when a piece of broken concrete taken out from damaged column was pressed in the palm, it was crushed easily. So the compressive strength of concrete is expected not as much as per requirement. This indicates that presence of weak soil in the foundation, poor workmanship, and lack of ductile detailing are the major factors contributing to the collapse of this building. Similar type of failure mechanism was observed in Chamati, near Bishnumati river (Figure 3) and Gongabu area (Figure 4). These buildings had opening in the first floor and sizes of the columns were also inadequate. Addition of more stories on the same sized columns was done on both the buildings.

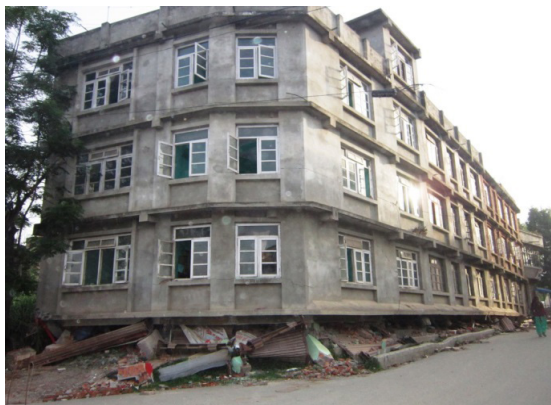
Figure 3. Soft-first storey failure of 4 storey building in Chamati, Kathmandu

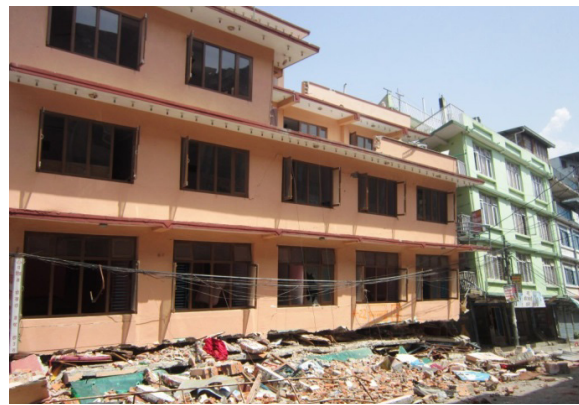
Figure 4. Soft storey failure of a guest house building in Gongabu, Kathmandu

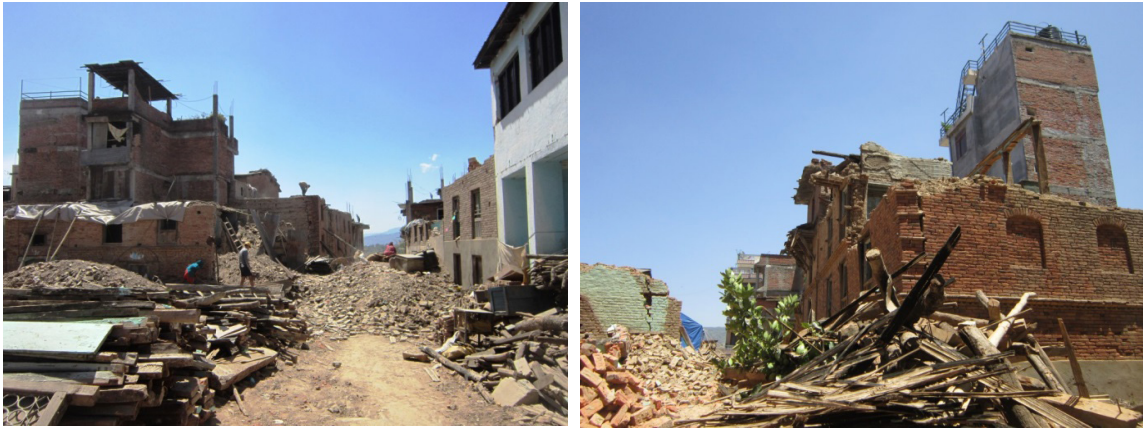
Nowadays, construction of brick masonry buildings with load bearing walls is decreasing except for some old heritage structures. In the recent earthquake, many brick masonry buildings and heritages structures had suffered heavy damages. The figure 5 below shows the collapse of many old brick masonry buildings and still standing recently constructed RC frame building in Sankhu, Kathmandu. As seen in the figure, mostly toppling of top storey walls, out of plane failure of load bearing wall, corner separation and in some cases in-plane failure mechanism were observed. Similarly, extensive damages were observed in the Kathmandu durbar square, Patan Durbar square, Bhaktapur durbar square, and other heritage sites.

Figure 5. Collapse of old brick masonry buildings and still standing RCC building in Sankhu, Kathmandu.

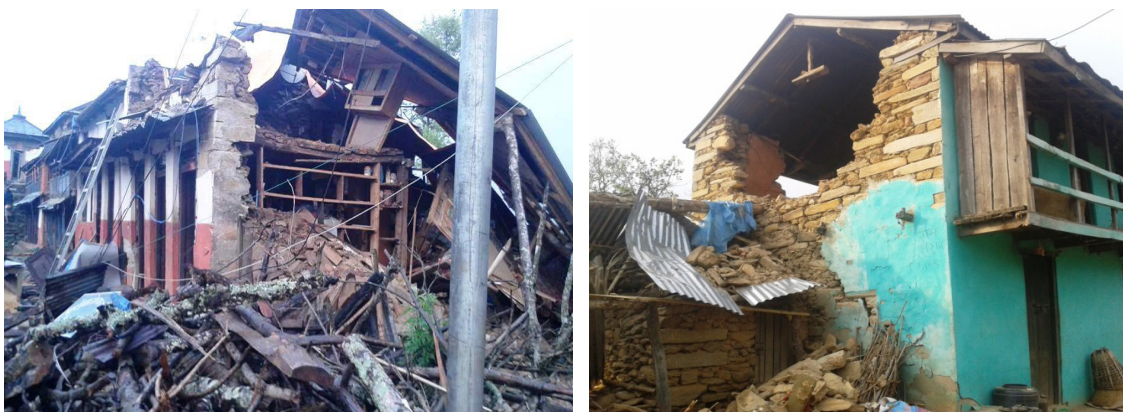
In rural areas, people cannot afford construction of reinforced concrete building. For economic reason, they use locally available materials such as stone, mud and wood for the construction of their houses. This traditional type of stone masonry buildings which are mostly found in the villages were heavily suffered in the recent Nepal earthquakes, and damages were distributed all across the region. In many villages, all the houses were destroyed making whole villagers homeless. Such type of unreinforced masonry buildings are weak in tension and hence cannot resist earthquake lateral forces. Majority of the failures are out-of-plane type. The out-of-plane failure of walls of right wall and back side wall are seen in figure 6. However, good arrangement (stacking) of long regular stones at corners alternatively at adjacent faces prevented the falling of roof on the ground. Use of wooden members in the face wall prevented this wall from collapse which explains the beneficial aspects of wood in such kinds of buildings.(Figure 6)

Figure 6. Collapse of stone masonry buildings with mud mortar Pipalhok village, Gorkha

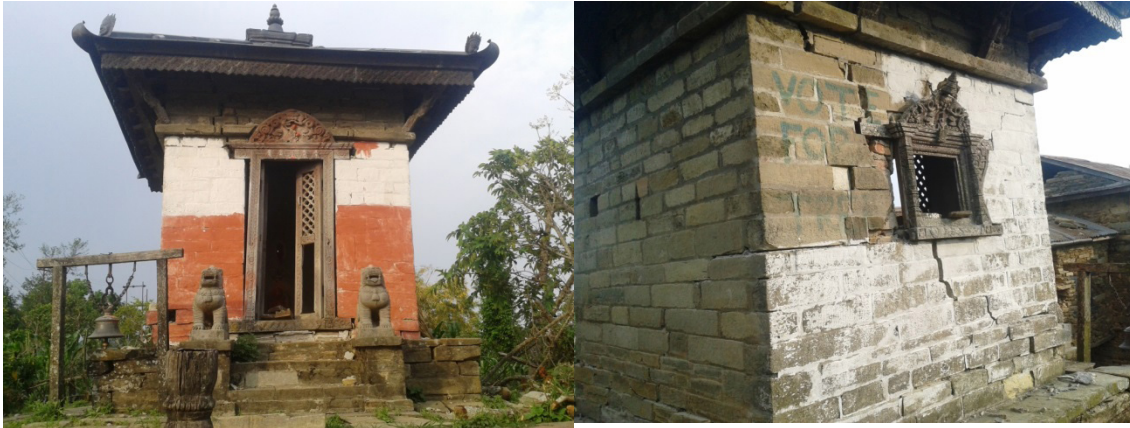
Figure 7 demonstrates the development of cracks in a temple of Phinam VDC, Gorkha, which was constructed using regular shaped stones and cement mud mortar. Cross diagonal cracks are visible in the side face of the temple and a prominent gap between wall and door frame is visible in the

front wall with door. Of course stones are very strong in compression than cement mortar and no breaking of stone is found. The stable failure mechanism called rocking can be expected during the ground shaking. However, it is also noteworthy that similar type of stone masonry houses and a temple at another village located just opposite face of the hills sustained only minor or no damages. This may be due to site effects and directivity nature of ground motion, but not confirmed yet.

Figure 7: Diagonal Shear cracks at two side faces of Vimsen Temple at Phinam-5, Gorkha
