Engineering geological and geotechnical investigations of dam of the Bunakha Hydroelectric Project (180 MW), Chukha Dzong, Bhutan Himalaya

A. K. Naithani^{1*}, P. C. Nawani², L. G. Singh¹ and D. S. Rawat¹

¹National Institute of Rock Mechanics, Kolar Gold Fields - 563 117, India

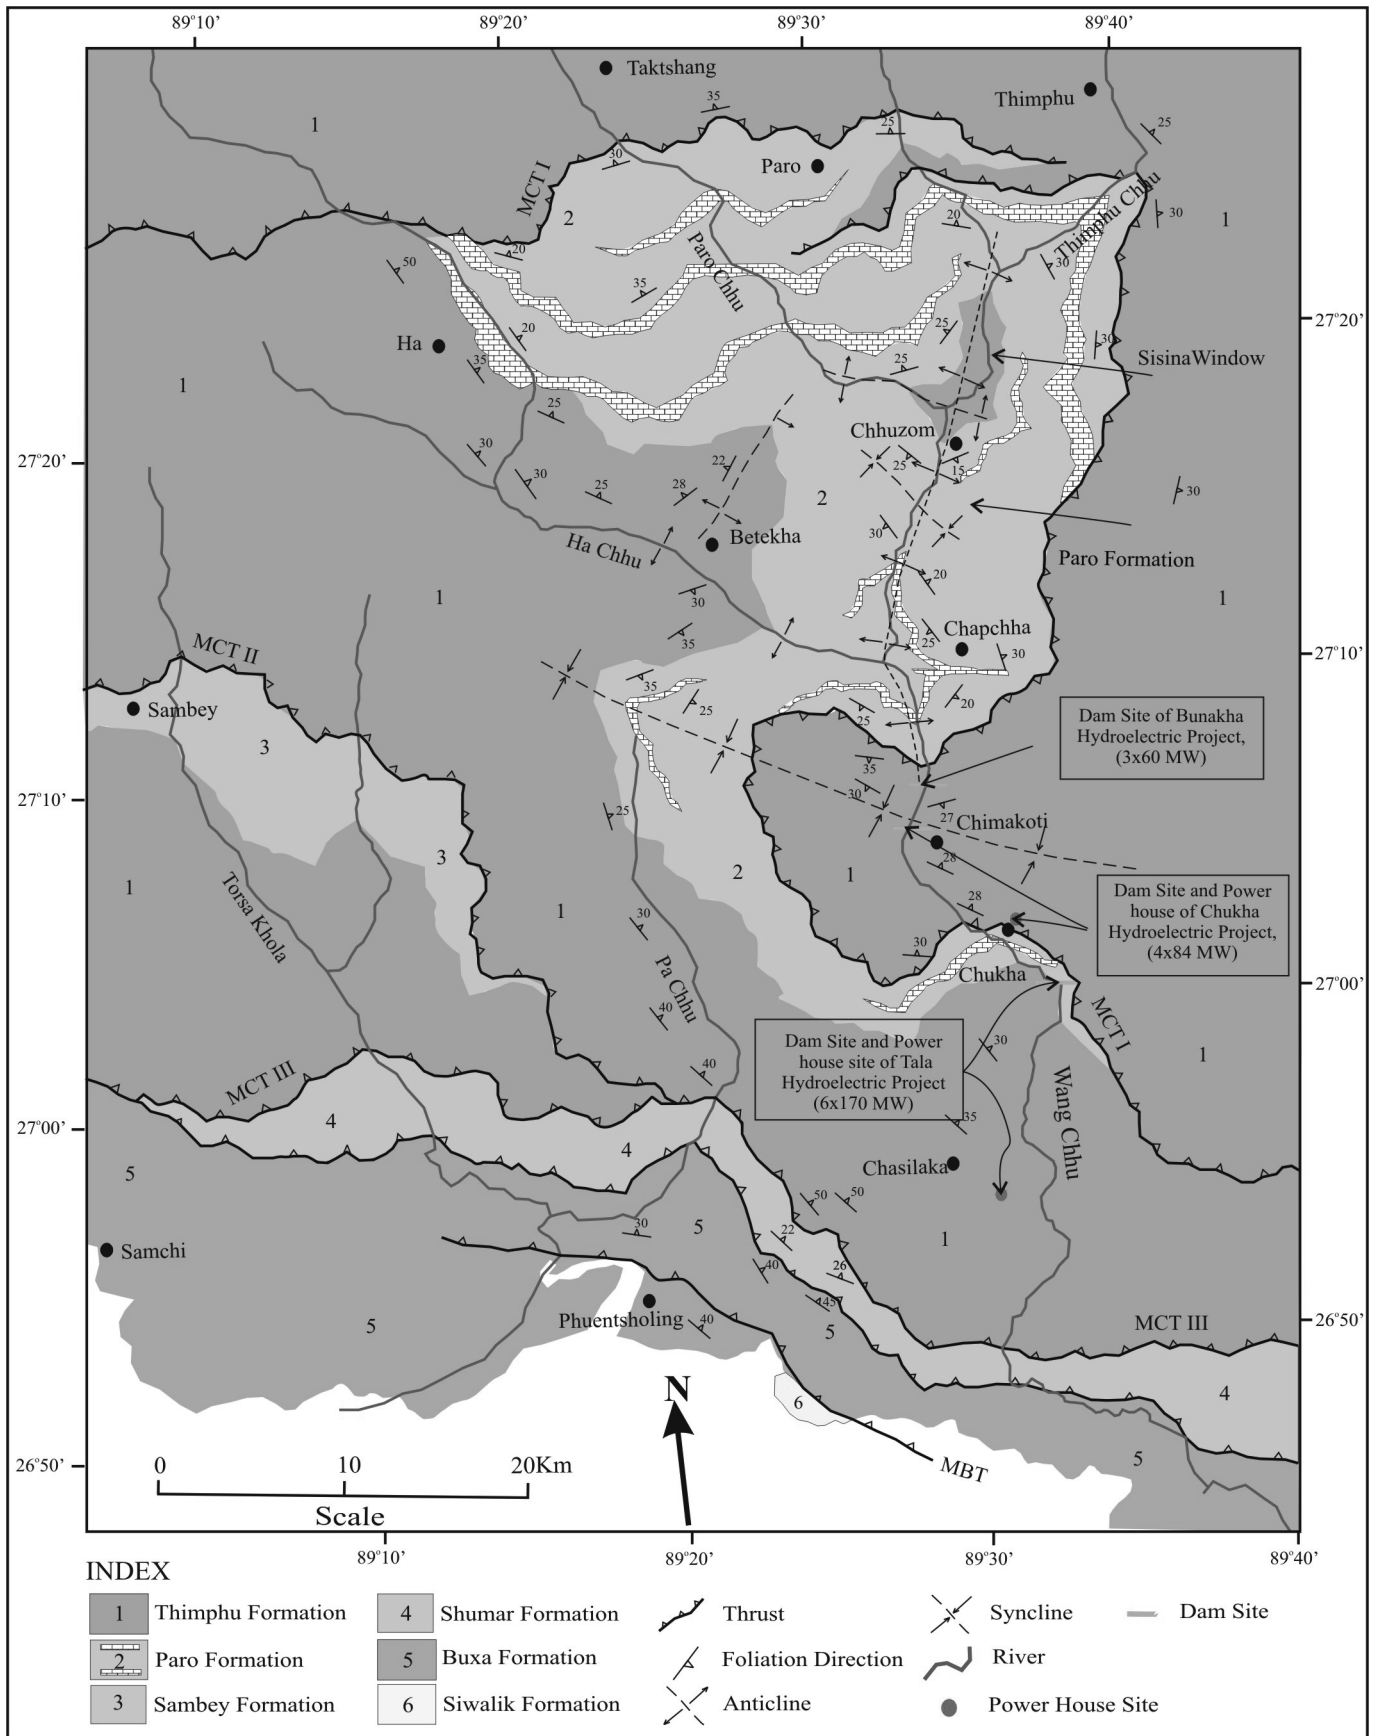
Fig. 2: Geology map of the Bunakha hydroelectric project and area around (After Geological Survey of India Map 1979-80; Bhargava 1995; Koike 2001, 2002).

amphibolite gneisses. On the surface, in and around of dam area, garnetiferous foliated gneisses and banded gneisses have been mapped while drilling at this site encountered a sequence of foliated gneisses, banded gneisses, amphibolite gneisses and calc-silicate gneisses at different depths. At about 1.6 km upstream from the dam, there is a thrust contact (MCT-I) between the rocks of Thimphu (Thimphu Gneissic Complex) and Paro Formations (Bhargava, 1995, Koike, 2001, 2002). In general, formations (bedding/foliation S-1) show low to moderate (10° to 35°) dip excepting in areas adjoining to fractures where local steep dips are noted. The rocks of Thimphu Formation at project site are folded into N-S trending antiform, dipping towards downstream side (20° - 30°) i.e. into the hill and plunging ($<19^{\circ}$) southerly in the downstream. Endemic to folding these litho-units are traversed by multiple set of discontinuities viz. (i) parallel to axial plane forming valley parallel longitudinal joints (ii) steeply dipping conjugate system of diagonal joints and (iii) low angle conjugate discontinuities. In addition to these discontinuities, foliation discontinuities and shear-zones parallel to foliation have also been recorded. Geological map of this area compiled from the Geological Survey of India Map (1979-80); Bhargava (1995) and Koike (2001, 2002) is given in Fig. 2.

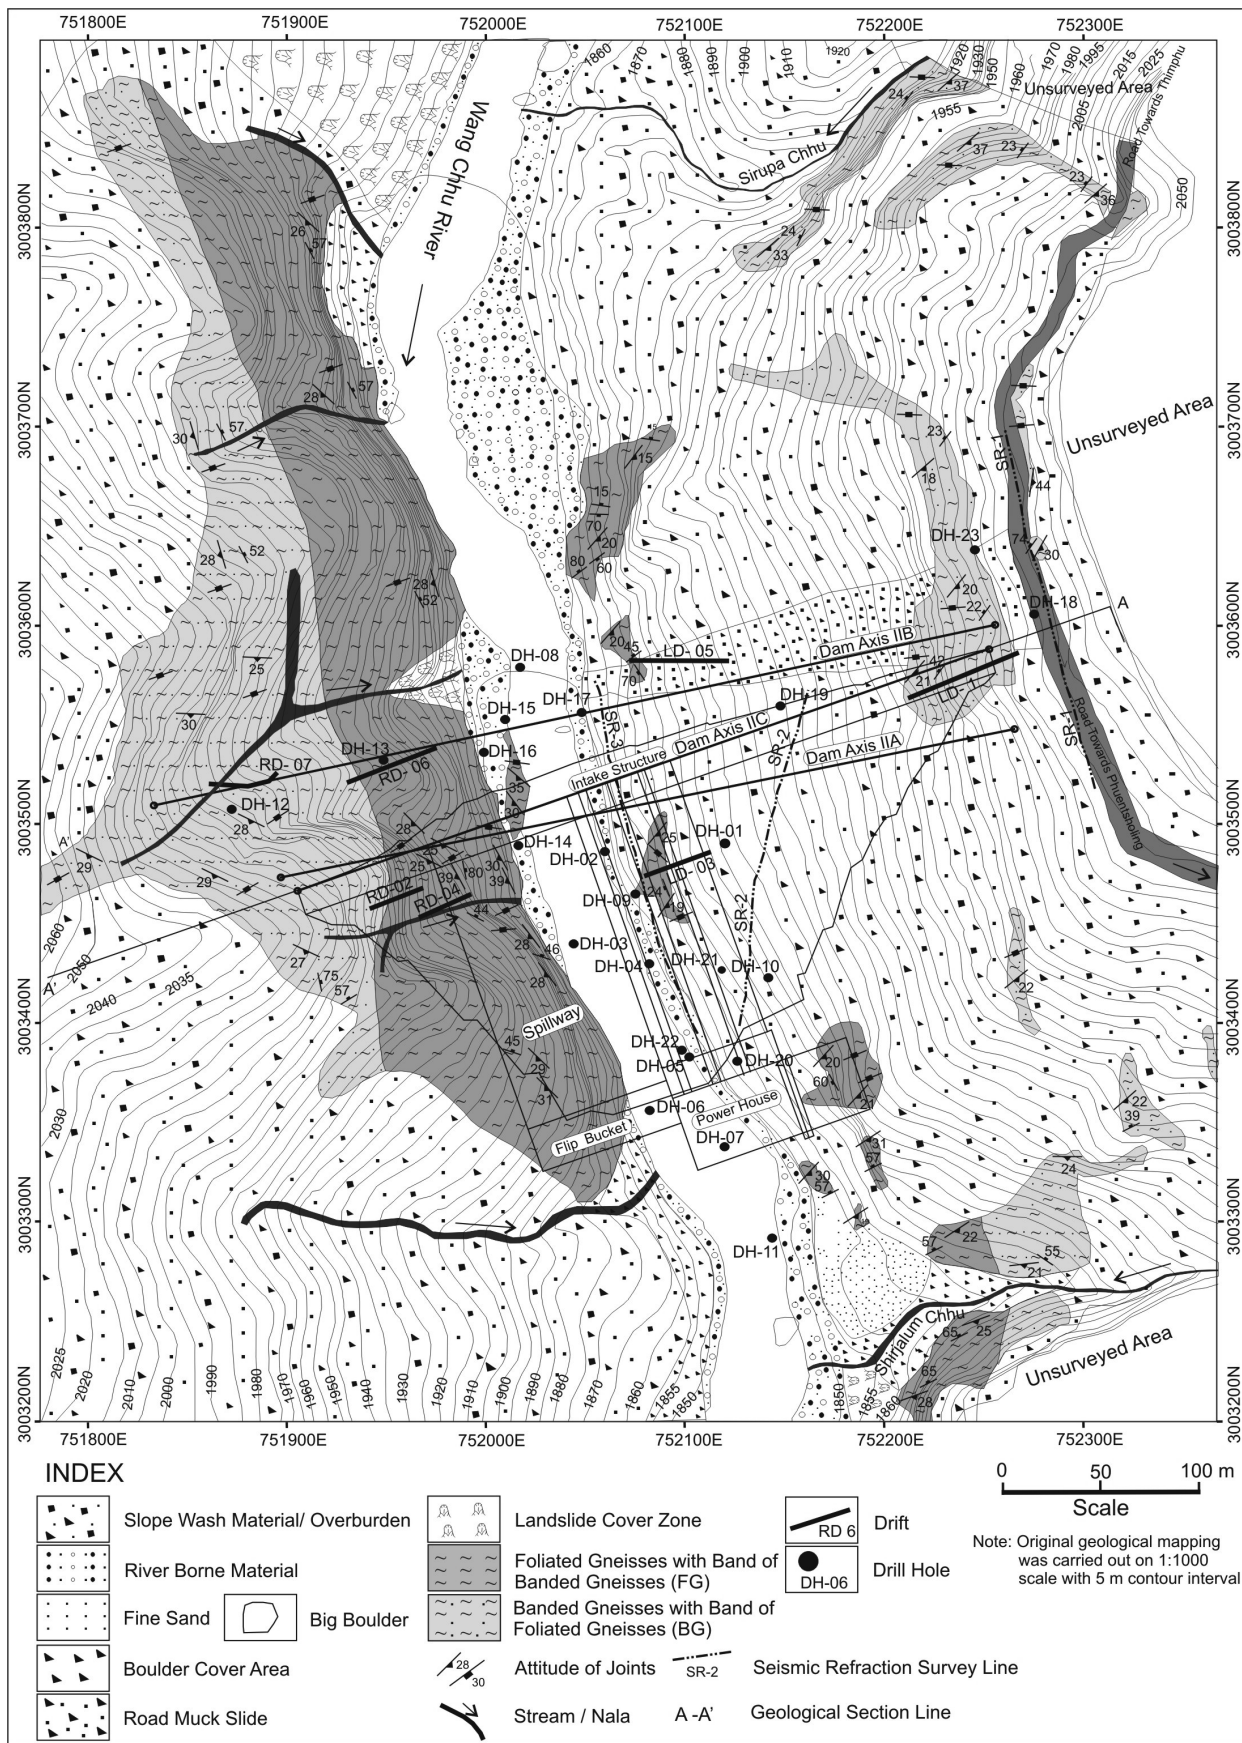
Fig. 3: Geological plan map of the dam area.

abutments, four and three sets respectively of discontinuities are mostly inclined to vertical in nature are prominent (Table 2). The geological details available from the geological plan at the dam site and on the basis of exploratory drill holes data, drift data and geophysical profiling, geological section was developed on the observed section along the dam axis is given in Figure 4. Probable lines defining weathering and distressed limits are indicated in the geological section.

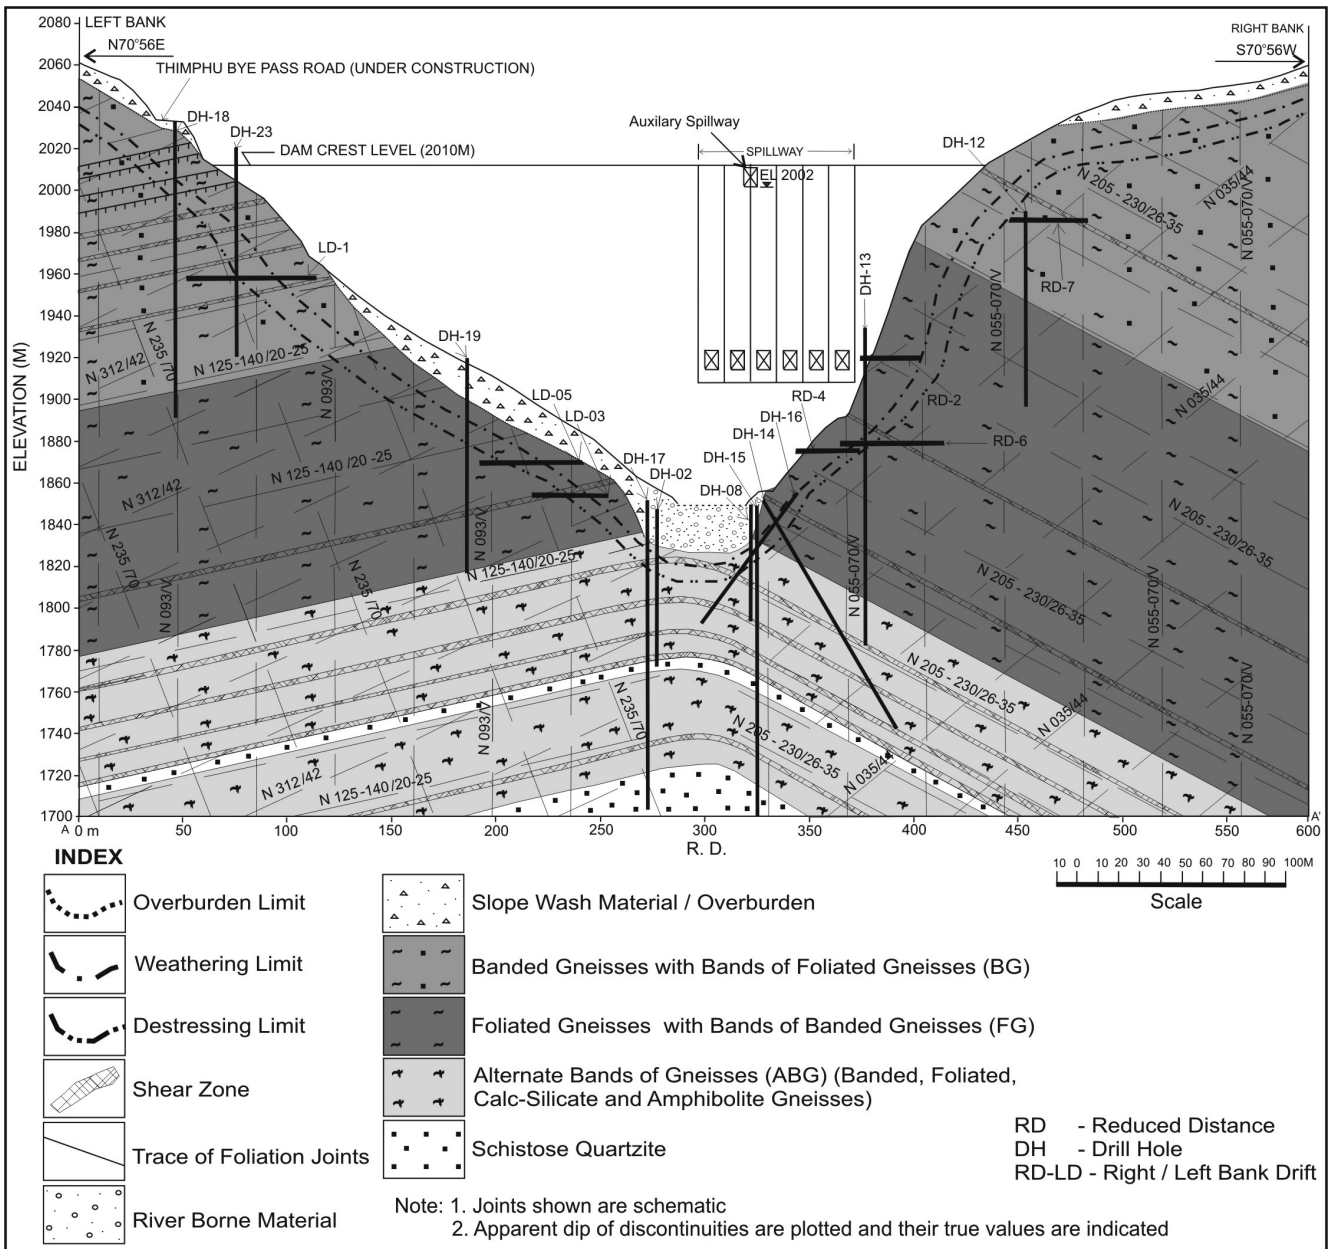
Fig. 4: Geological section along the dam axis.

*Depth/levels with respect to the geological section along the dam axis
