Impact of July 2004 high-intensity rain on Hilepani–Jayaramghat–Diktel Environment-Friendly Road in East Nepal

Megh Raj Dhital

*Central Department of Geology, Tribhuvan University,
Kathmandu, Nepal*

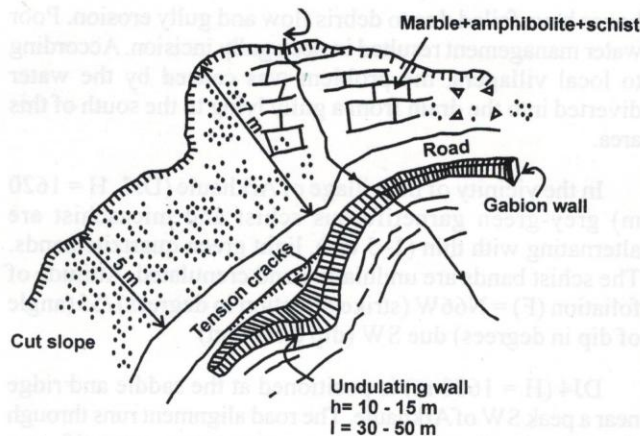
There is an unstable ground with an undulating gabion wall founded on loose soil (Fig. 3) where the bedrock is made up of 20 cm to 1.5 m thick, white to cream coloured marble bands alternating with dark green to blue-green amphibolite, green schist, and grey schist. At places karsts and caverns are developed in the marble zone. The failure is partly attributable to the open (10 to 20 cm wide) joints in the karstified marble. The road also suffers from water management problems.

Fig. 3: Sketch of landslide and undulating retaining wall south of Nagi

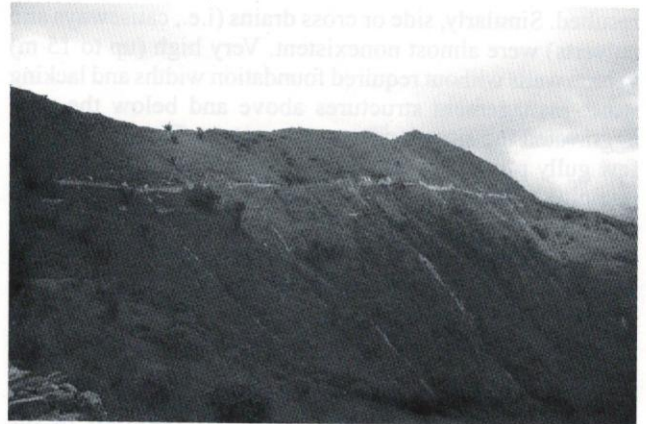
A zone of plane rockslide begins at DJ9 (H = 1700 m) where thick- to very thick-banded, grey, blue-grey marble (B = F= N90E/48S) has grey schist partings (thickness = 10 to 20 cm). The failure zone (Fig. 4) is about 250 m long and extends beyond DJ10 (H = 1700 m) up to the second bend. Large blocks (1–1.5 m long) of marble (derived from the rockslide) are resting on the road. There are three sets of clean joints in the marble. Plane rock failure and debris flow problems (Figs. 4 and 5) continue to further northwest up to the bend.

Fig. 4: Panoramic view of plane rockslides west of Nagi. View to SE. Photo by Cris Grant.

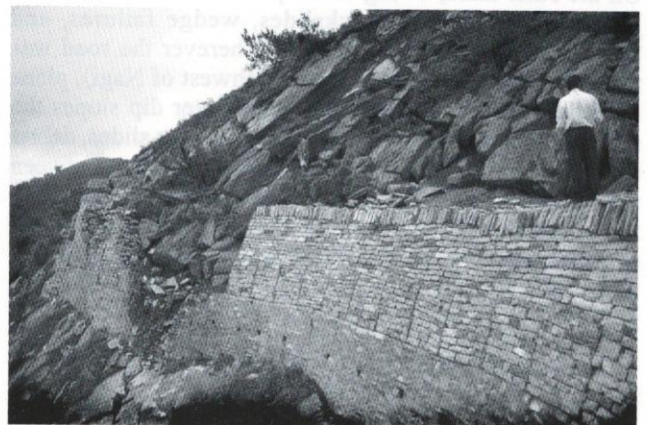
Fig. 5: Walls (below the road) damaged by debris flow in a gully west of Nagi. View to N. Photo by Cris Grant.

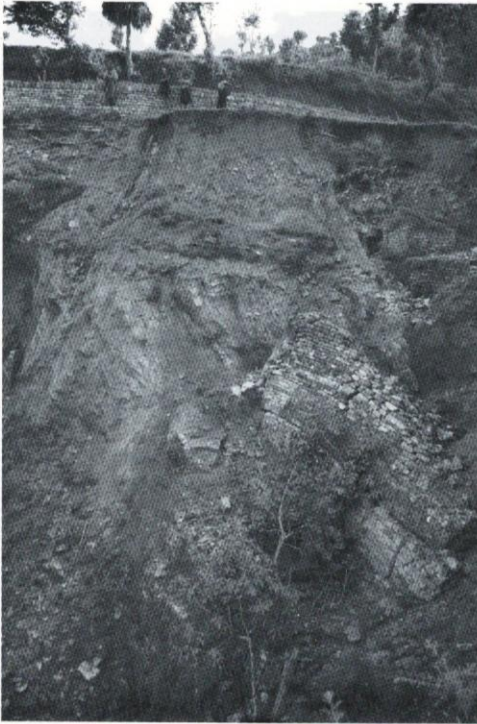
Fig. 6: Damaged road and failed gabion walls in the Narsinge Khola northeast of Halesi. View to NE. Photo by Cris Grant.

At the Narsinge Khola, extensive gully erosion and bank cutting is observed (Fig. 6). About 100 m long, 20 to 30 m wide, and 10 to 15 m deep erosive gully has developed on highly weathered grey to grey-green schist and quartzite covered by red soil. The problem is related to a high discharge in the gully due to flooding and debris flow. The water partly followed the road (as no cross drains were provided) and damaged the gabion walls (Fig. 6). There is also a zone of thin-banded light yellow quartzite (F = N88W/74SW) and garnetiferous (1–3 mm) schist.

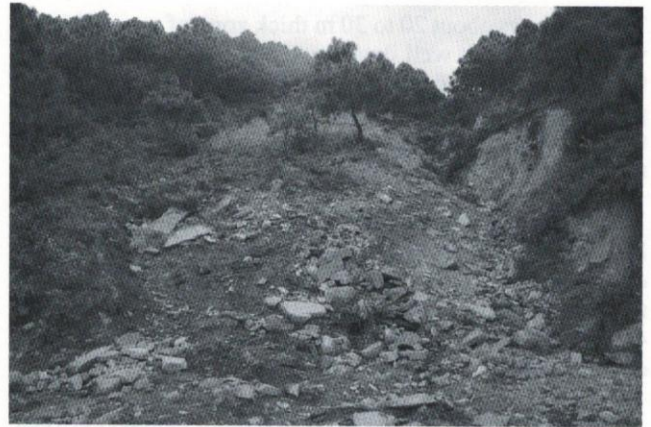
Fig. 7: A large slide obstructing the gully at DJ22. View to N. Photo by Cris Grant.

There is a critical gully passing through the loops in the vicinity of DJ22 (Km 27+000 m, H = 1440 m) and it is obstructed by a large (about 75 m long, 30 m wide, and 7 m deep) circular failure (Fig. 7).

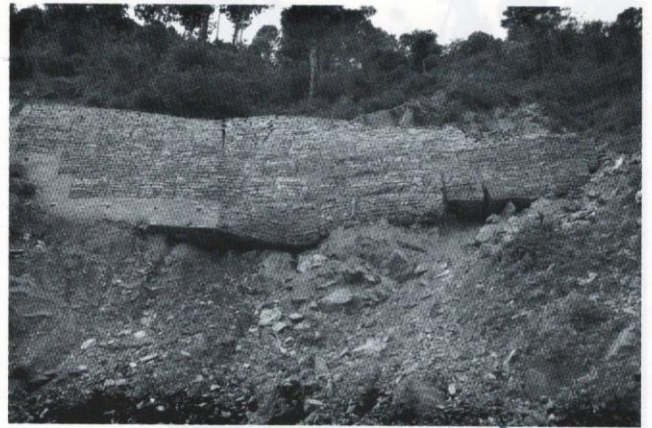
In the next gully (about 100 m north of DJ31), there is a damaged wall with undulating gabions (Fig. 8). The wall is 5 to 7 m high, about 10 m long, and was constructed on an unstable soil foundation. Big boulders (diameter = 0.5 to 1.5 m) are resting on the road.

Fig. 8: Partly damaged gabion wall and overhanging stone masonry wall at DJ31. View to W. Photo by Cris Grant.

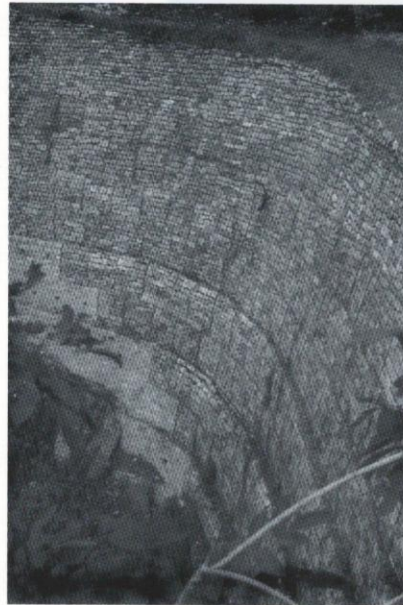
The area north of Sorchum (DJ32, H = 1240 m) is represented by a grey dolomite cliff (the Gauri Bhir). About 15 m high composite wall (gabion, dry stone, and stone masonry) is bulging at its base (Fig. 9).

Fig. 9: The gabion wall is bulging near its base at DJ32. View to SW. Photo by Cris Grant.

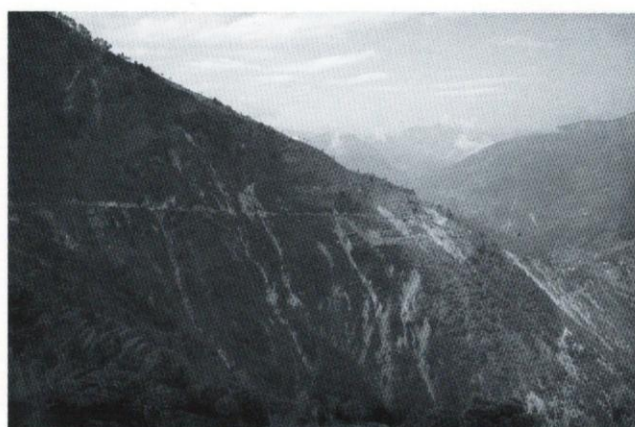
At Km 10+800 m (DJ39, H = 1130 m), the road above Maitung is severely damaged by gully erosion and debris flows. All the three gullies above Maitung have made wide (5 to 7 m) and deep (2 to 3 m) valley bottoms. They also suffered from side failures on the colluvium (Fig. 11). Extensive erosion and debris flow also took place in a large gully at DJ40 (H = 1120).

Fig. 11: Active gullies in the vicinity of Maitung. View to SW. Photo by Cris Grant.

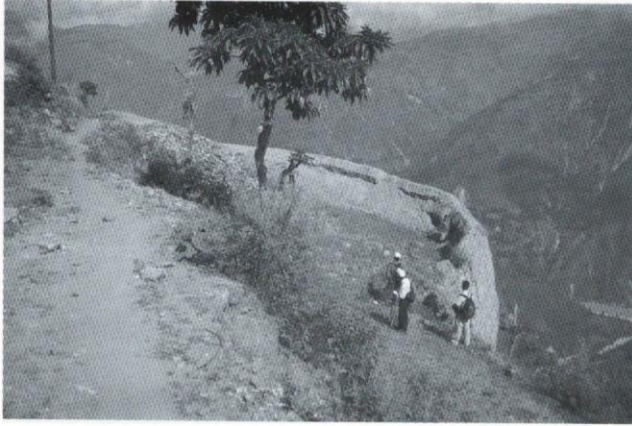
About 7 m high Loop No. 7 is intact, but the entire road alignment just below Loop No. 8 is destroyed. A debris flow from a gully and a colluvial slide have damaged the road.

Fig. 12: Scene of Loop No. 8 from above. A sag pond is seen behind the wall. View to W. Photo by Cris Grant.

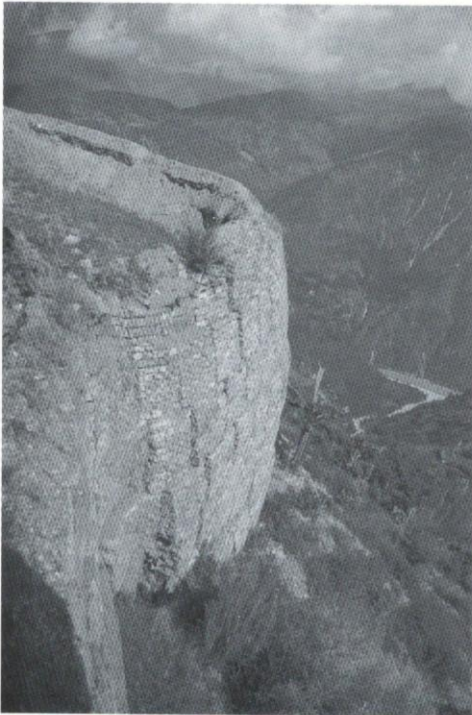
Fig. 13: Very high and bulging wall of Loop No. 8 as seen from the side. View to W. Photo by Cris Grant.

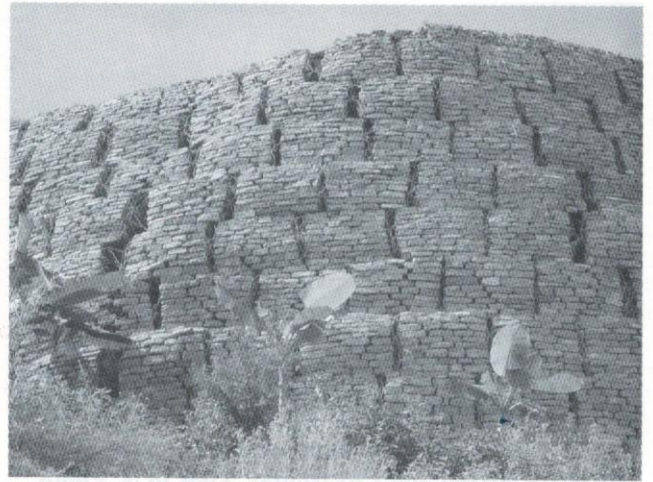
Fig. 14: Open joints between the gabion boxes of Loop No. 8. View to SW. Photo by M R Dhital.

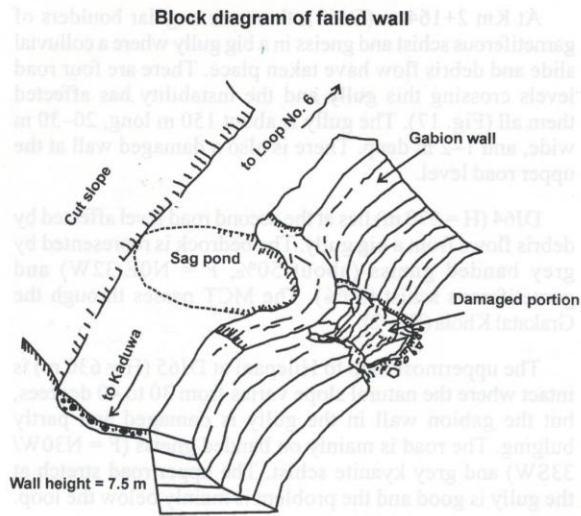
The road between Loop Nos. 6 and 7 is covered by cut slope failures and debris flows. About 11 m high Loop No. 6 is mostly intact (as it is on a rocky spur), but its southeast end is partly damaged. About 50 m east and ahead (while descending) of Loop No. 6, there is a gabion wall which is partly damaged due to liquefaction and foundation failure (Figs. 15 and 16).

Fig. 15: Block diagram and sketch sections of the bulging wall between Loop No. 6 and Loop No. 5.

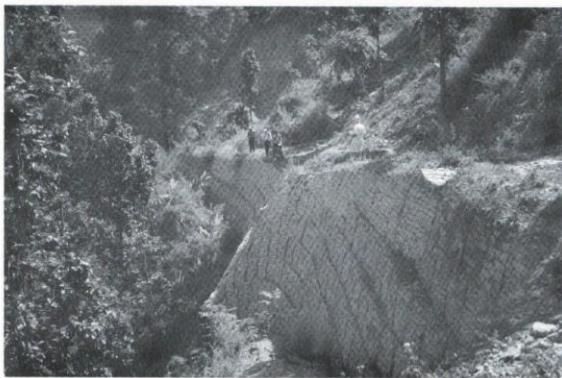
Fig. 16: Partly damaged and bulging wall east of Loop No. 6. View to NE. Photo by Cris Grant.

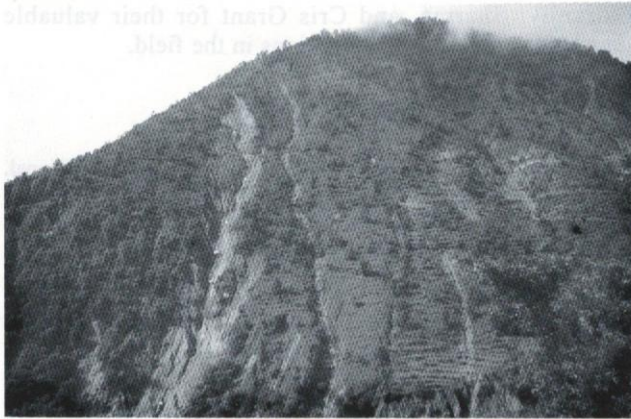
At Km 2+164 m (DJ63), there are angular boulders of garnetiferous schist and gneiss in a big gully where a colluvial slide and debris flow have taken place. There are four road levels crossing this gully and the instability has affected them all (Fig. 17). The gully is about 150 m long, 20–30 m wide, and 1–2 m deep. There is also a damaged wall at the upper road level.

Fig. 17: A large erosive gully affecting four road levels. View to SW. Photo by Cris Grant.

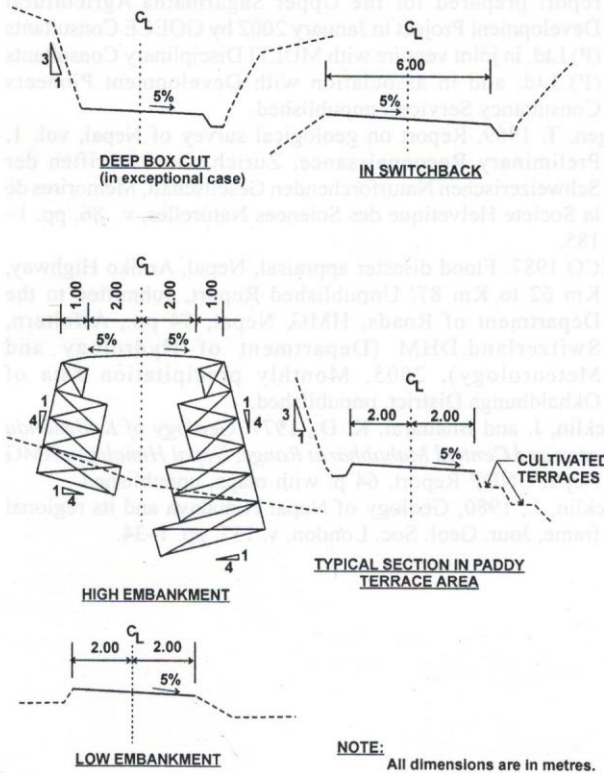
Field observations showed that most of the cut slopes in soil were almost vertical without proper protection measures. In GEOCE et al. (2002), there are typical cross-sections for the design of cut slopes and box cuts (Figs. 18 and 19). In these cross-sections, the proposed cut slope angle in soil is 3:1 (i.e. about 72 degrees), which is significantly steeper than the friction angle of soils in that area (which is generally less than 35 degrees). Such steep cut slopes were designed and constructed without due considerations to appropriate protection measures (such as retaining or breast walls).

Fig. 18: Typical cross-sections for JDEFR (GEOCE et al. 2002). Note missing walls on soil slopes of box cut.

depth of a few centimetres, and they are not suitable for stabilising possible deeper failures, if used alone. For this propose a combination of inert structures (e.g. walls, check dams) and live structures is required. However, the bio-engineering measures (i.e. in Table 8.1 on p. 8-2 of GEOCE et al. 2002) were some simple vegetative systems alone.

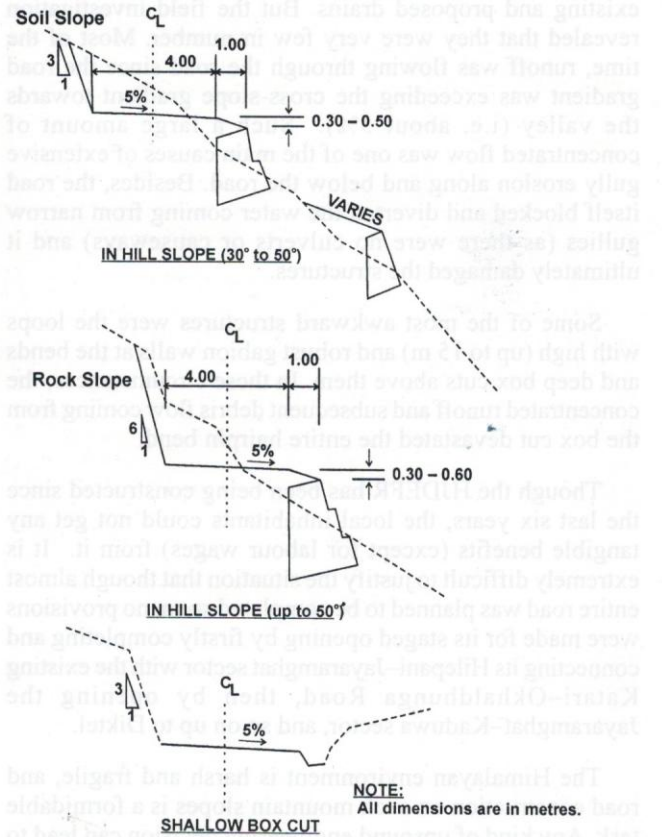
Fig. 19: Typical cross-sections for JDEFR (GEOCE et al. 2002). Note missing walls on soil cut slopes.
