Problems of river degradation in the Kathmandu Valley

R. P. Pradhananga

ABSTRACT

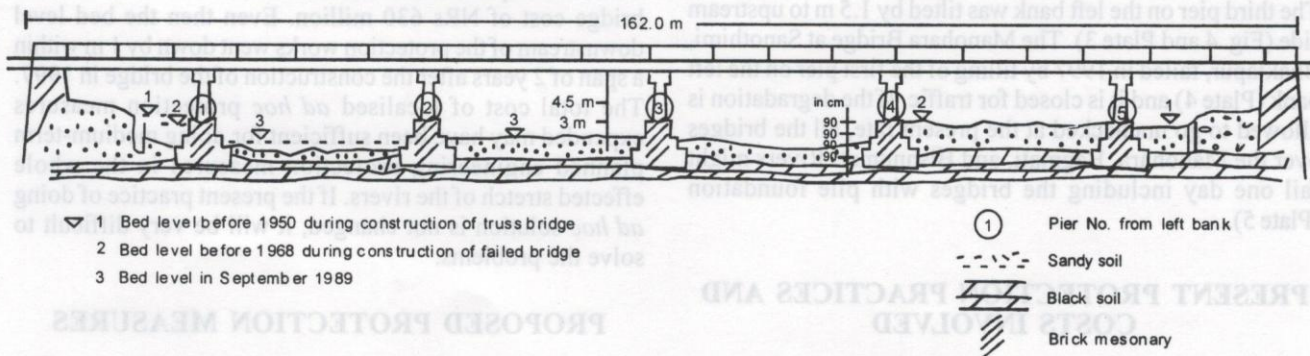
The extent of river degradation in the Kathmandu Valley varies spatially as well as temporally. During the last 2,500–3,000 years, the degradation of the Bagmati River was about 20 m at Thapathali (Pradhananga 1991). The rate of downcutting by rivers depends on the erosion of bed level at the Chobhar Gorge to some extent. Before 1950, the degradation rate was not so high, but it increased rapidly after intensive sand extraction from the Bagmati River and its tributaries at various places in the valley. The degradation was about 1 m at the Hanumante Bridge in Bhaktapur during 1970–1990 before the sand extraction. The alarming rate of degradation started from 1990 with the exposure of black clay bed by over-extraction of sand. The bed level at the Thapathali Bridge went down by 1.7 m between 1950 and 1989 (Fig. 4) (Table 1). During the process of downcutting in the black clay, at first

Fig. 4: Section with riverbed in September 1989 (Bagmati Bridge, Thapathali)

The degradation of rivers has led to the failure of bridges in the Kathmandu Valley. The Thapathali Bridge over the Bagmati River failed on 16 September 1991 after the scour of the foundation by 2.5 m in the 3-m deep open foundation. The third pier on the left bank was tilted by 1.5 m to upstream side (Fig. 4 and Plate 3). The Manohara Bridge at Sanothimi, Bhaktapur, failed in 1997 by tilting of the first pier on the left bank (Plate 4) and it is closed for traffic. If the degradation is allowed to go unchecked at the present rate, all the bridges over the Manohara, Bagmati, and Bishnumati Rivers might fail one day including the bridges with pile foundation (Plate 5).

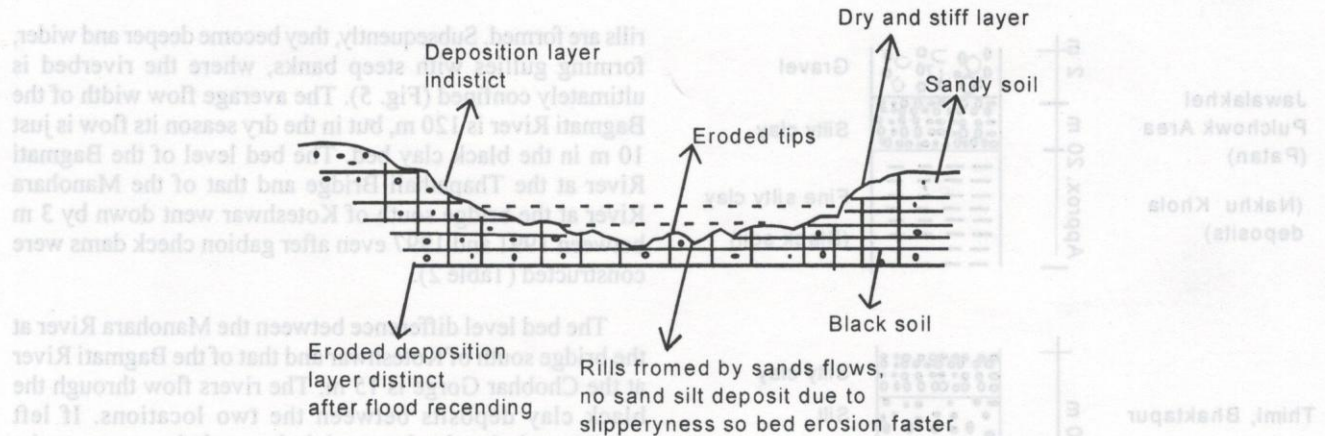
rills are formed. Subsequently, they become deeper and wider, forming gullies with steep banks, where the riverbed is ultimately confined (Fig. 5). The average flow width of the Bagmati River is 120 m, but in the dry season its flow is just 10 m in the black clay bed. The bed level of the Bagmati River at the Thapathali Bridge and that of the Manohara River at the bridge south of Koteshwar went down by 3 m between 1991 and 1997 even after gabion check dams were constructed (Table 2).

Fig. 5: Erosion process in black soil bed in Manohara River

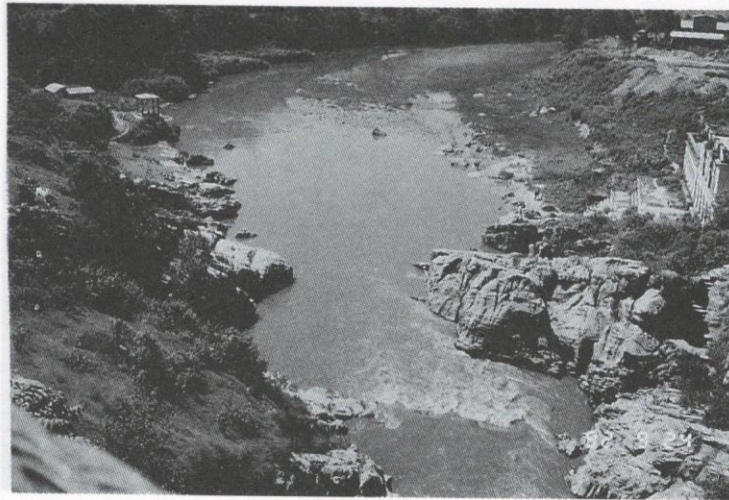
The bed level difference between the Manohara River at the bridge south of Koteshwar and that of the Bagmati River at the Chobhar Gorge is 15 m. The rivers flow through the black clay deposits between the two locations. If left unprotected, the clay layer might be eroded away up to the depth of 14.5 m between the two locations in the long run. The river degradation in the south beyond the Chobhar Gorge also will be greater in future, as the river flows there also in the black clay bed (Plate 1).

Plate 1: River degradation beyond Chobhar Gorge in the Bagmati River

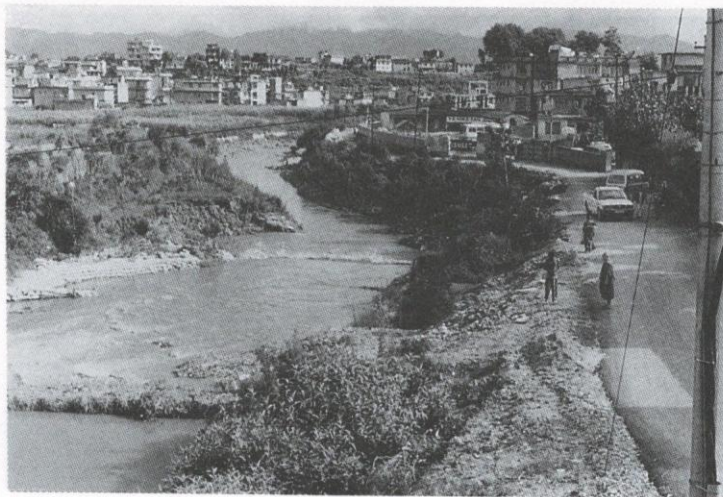
Plate 2: River degradation, narrowing and encroachment along the Bagmati River

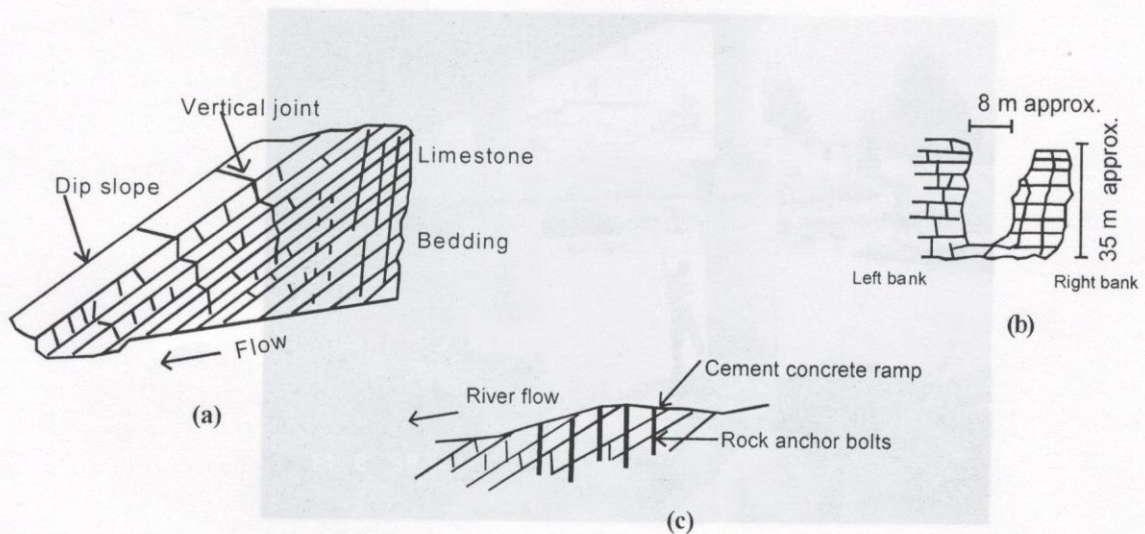
The main cause of recent river degradation in the Kathmandu Valley is the excessive sand extraction from the riverbed for construction activities. The sand demand for construction of houses in the three major cities of the Kathmandu Valley in 1997 was 270,000 m³ (Pradhananga 1991). Similarly, population explosion in the Kathmandu Valley and settlement of people in low-lying areas encroaching riverbanks have helped directly or indirectly in narrowing and degrading the rivers (Plate 2). The construction of guide bunds and riverbank protection works without proper planning has also contributed to the degradation. Erosion of the limestone (bed rock) at the Chobhar Gorge due to rapid weathering as well as reaction with acidic effluents has also added to the speedy river degradation north of it (Fig. 6a and 6b).

Fig. 6: (a) Rock structure, (b) cross section, and (c) probable stabilisation method for river gorge at Chobhar

The medium-term solution is based on an integrated approach consisting of construction of check dams with apron, natural covering of black clay bed by sand, and stabilisation works at the Chobhar Gorge. It is proposed to construct a series of check dams along the affected stretches at a regular interval to prevent failure of existing check dams and stabilise black clay bed, and they should be slightly higher than the present black clay bed height. After covering the black clay bed by sand, again the height of these check dams needs to be raised by adding more gabion boxes above them. Gabion mattress aprons are provided both upstream and downstream of the check dams to prevent scouring (Fig. 7). Formation of cascade should be avoided as far as possible to prevent scouring by water jet effect. It is proposed to stabilise the Chobhar Gorge with rock dowel bars and cement concrete to bond and cover the fractures favourable for bed erosion (Fig. 6c).

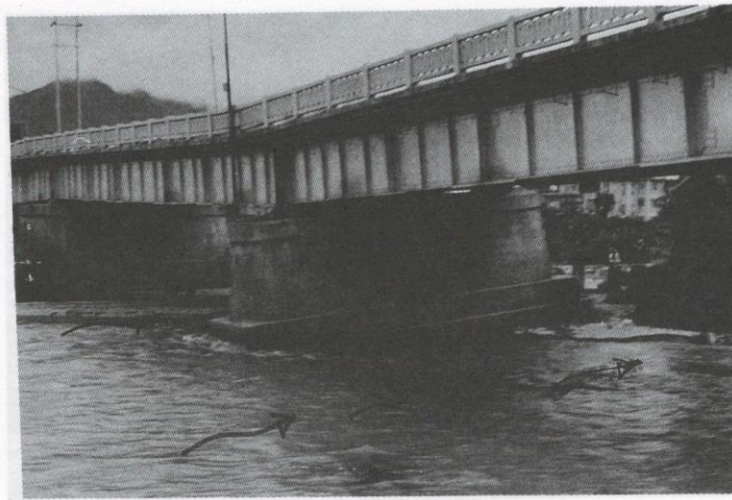
Plate 3: Failure of Pier No. 3, Bagmati Bridge Thapathali on 16 September 1991

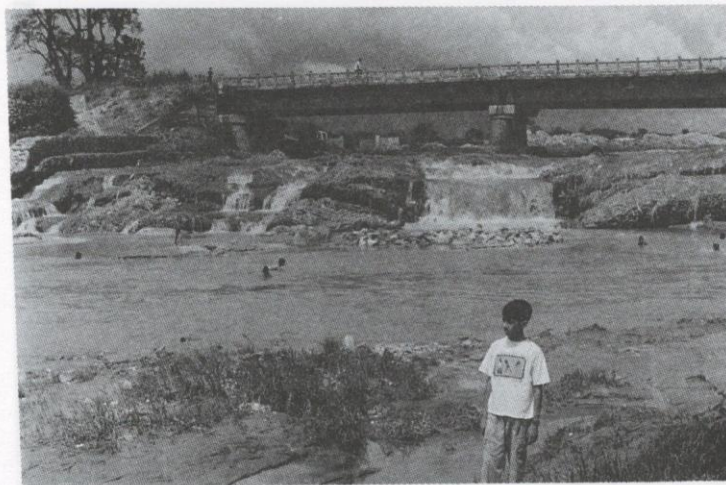
After the failure of the Thapathali Bridge in 1991, heavy gabion check dams but without proper apron (Plate 4) were constructed at huge costs at most of the bridge locations where foundations were exposed. The protection works were

done in an *ad hoc* basis without proper design, plan, or long-term perspective. Consequently, most of those check dams became useless or failed after one or two years of construction. They were again and again maintained or replaced at huge costs. The failed old Thapathali Bridge was maintained immediately, at the cost of NRs 10 million. The Manohara Bridge maintenance may cost more than NRs 20 million, and if a new bridge is constructed, it might cost NRs 40 million. Even during the construction of the new Thapathali Bridge under Japanese Government grant, the existing bridge protection work cost NRs 4.6 million and the protection work against the lowering of the riverbed cost NRs 38 million with the total cost coming to be NRs 42.6 million. The protection cost comes out to be 7% of the total bridge cost of NRs 630 million. Even then the bed level downstream of the protection works went down by 1 m within a span of 2 years after the construction of the bridge in 1997. The total cost of localised *ad hoc* protection measures expended may have been sufficient for doing medium-term planned engineering protection measures in the whole effected stretch of the rivers. If the present practice of doing *ad hoc* solution is not changed, it will be very difficult to solve the problems.

Plate 4: Failure of protection work and bridge, Manohara Bridge, Sanothimi in 1997

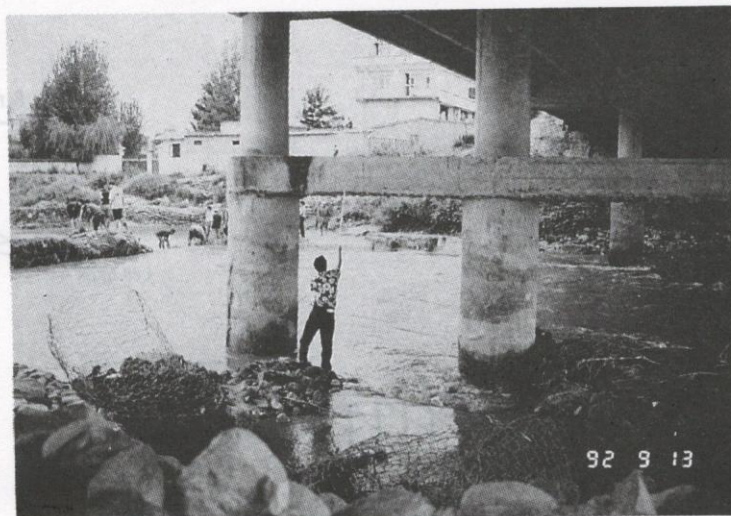
Plate 5: Exposure of Pile Foundation, Bagmati Bridge, Subidhanagar in 1992
