The 1998 Tatopani Landslide in the Kali Gandaki Valley of Western Nepal: cause and relation to mass rock creep

Hellmut R. Völk

ABSTRACT

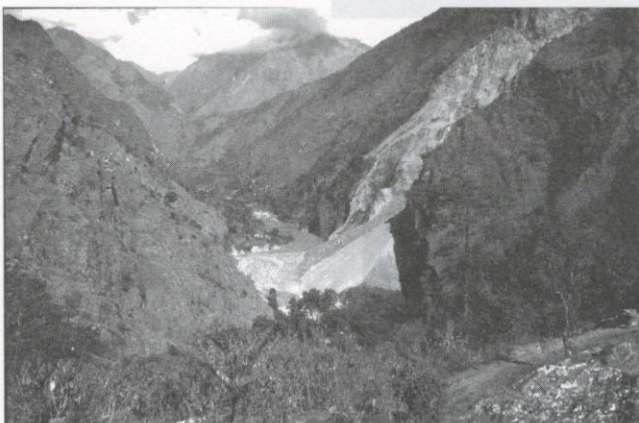
The monoclinical structure of the rocks in the surrounding of Tatopani is determined by a pronounced foliation (s1) or bedding (s0) with a dip of 25° NE, i.e. the dip is inclined upstream and oblique to the course of the Kali Gandaki Valley, which runs NNE. In such a situation, one would suppose that this bank would be endangered by failures along the foliation planes which might act as slip interfaces oblique to the thalweg, especially along the incompetent weak phyllitic members. However, there is in fact no dangerous slope movement, and therefore the village of Tatopani does not experience a special threat for the time being. Still, there exist very slow and continuous mass movements of gigantic dimensions, persisting over thousands of years, owing to a process which belongs to the category of mass rock creep, and is also responsible for the narrow course of the Kali Gandaki River there in correspondence to a counteracting slope movement from the opposite bank. It should be mentioned that a set of steep joints dissects the thick quartzite member (Plates 1 and 2) and eventually will cause toppling here and there near the river.

Plate 1: View of the village of Tatopani in the Kali Gandaki Valley upstream of the recent landslide, which has dammed the river to form a small lake along the village in the middle part of the picture. Note the steep joints in the quartzite member exposed in the left (western) foreground, and the relict failure scar on the right (eastern) front.

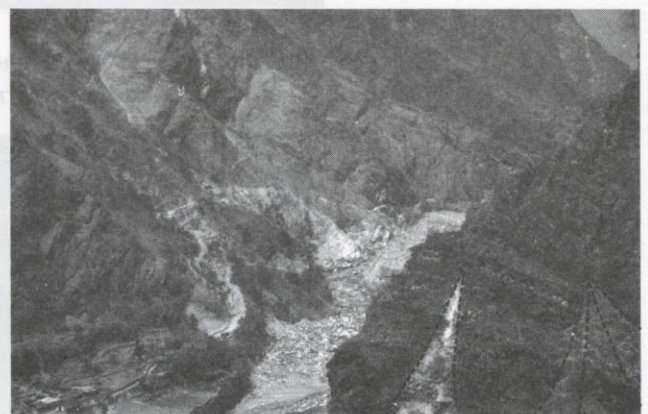
Plate 2: Upstream view of the Kali Gandaki River and its steep banks; on the left-hand (western) side can be seen mainly coarse, bedded quartzites in light grey colours showing steep joints crosscutting the bedding planes, which dip towards the thalweg, and are overlain by darker phyllites in the lower background. Note the white streak, a tiny debris flow (typically) marking a shear plane of the quartzite-phyllite interlayering in the right foreground.

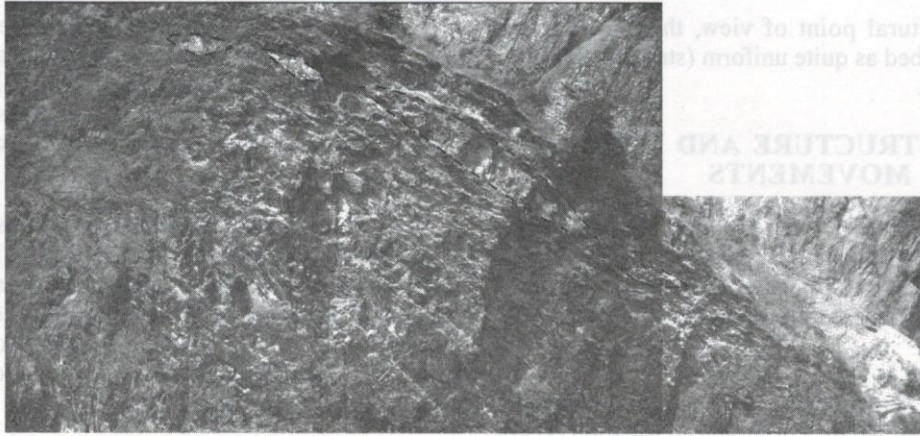
This mass rock creep is acting parallel to the foliation, quite unlike to the kinematics of the left (eastern) bank. Two kinds of geotechnical reaction are visible: shear pods (German: phacoids) in the ductile phyllites, and along small quartzite intercalations inside thick phyllitic members (Plates 3 and 4).

Plate 3: Phyllite members with quartzite intercalations (detail of Plate 6), which are deformed into lenticular shear pods (marked by dotted lines) on the right or western bank, indicating tensile shearing movements along the foliation of these metasedimentary rocks. There are also some steep joints, which are crossing the foliation planes, and thus increasing the appearance of strained disordered rock.

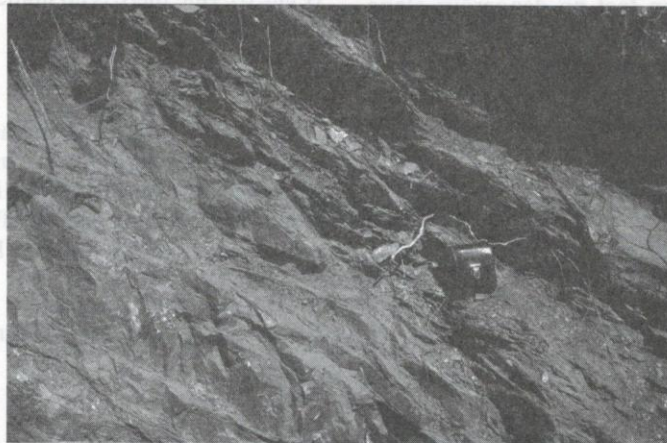
Plate 4: Phyllite, containing lenticular shear pods, indicates extensional movements along the foliation. Outcrop on the western bank near Tatopani

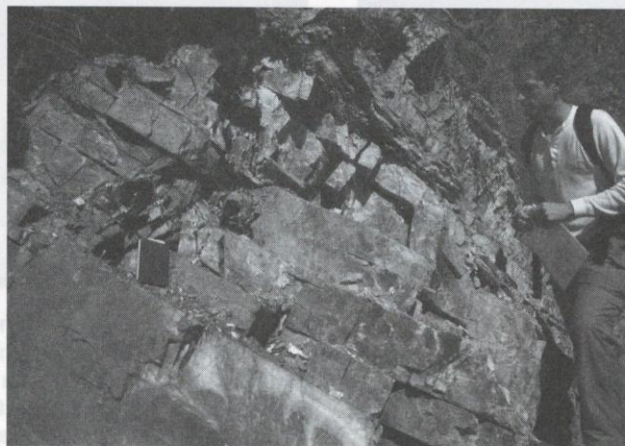
Shear pods—lenticular shaped bodies—are considered typical phenomena of extensional gliding zones in heterogeneous lithology, e.g. brittle quartzite in ductile phyllites (Fry 1984; Eisbacher 1991). The brittle quartzite members, on the other hand, respond quite differently, namely by showing numerous fractures and openings across the bedding plane (Plate 5).

Plate 5: Bedded quartzite on the western bank near Tatopani, exhibiting extensional features marked by shearing along the bedding as well as cracks and openings across it

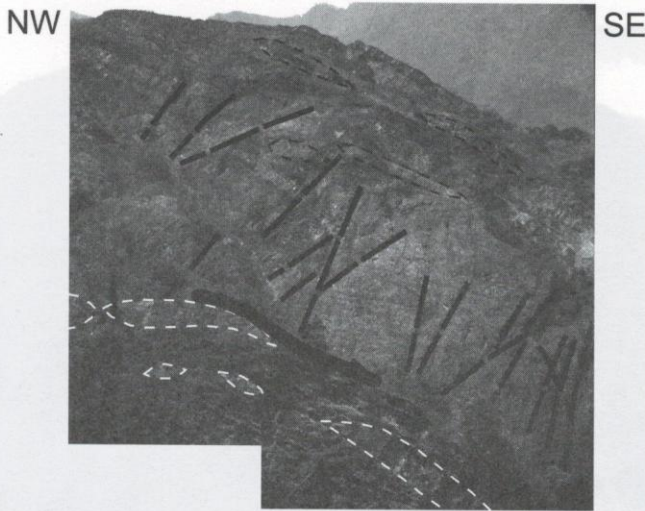
From both of these clear signs of tensile strain, we can conclude for the western bank that the whole series of metasedimentary rocks is internally sheared, stretched, and dismembered into various slices. These slices are gravitationally drifting towards the thalweg, with thick quartzitic sequences gliding down on phyllitic ones (Plate 6). But, there is no immediate danger of large rockfall at the moment.

Plate 6: View of the western bank near Tatopani showing the metasedimentary rocks of the Lesser Himalaya in some disorder and gravitational deformation due to deep-seated creep (drift) along the foliation, especially inside the phyllites and along the interface between quartzite and phyllite members, directed towards the thalweg of the Kali Gandaki River to the right, outside the photograph. Ductile phyllites (dark rocks) serve as gliding zones between thick quartzite members consisting of light grey, bedded rocks. Thick quartzite sequences are slowly gliding down on phyllitic ones (indicated here by a half-arrow symbol). Quartzite shear pods (phacoids) in the phyllites (thinly dotted lentils at lower left; cf. Plate 3), wedging of quartzite members (thinly dotted lentils at upper right), and disruption of thick quartzite members by steep joints (thickly dotted lines in middle part) testify to the extensional movements towards the thalweg.

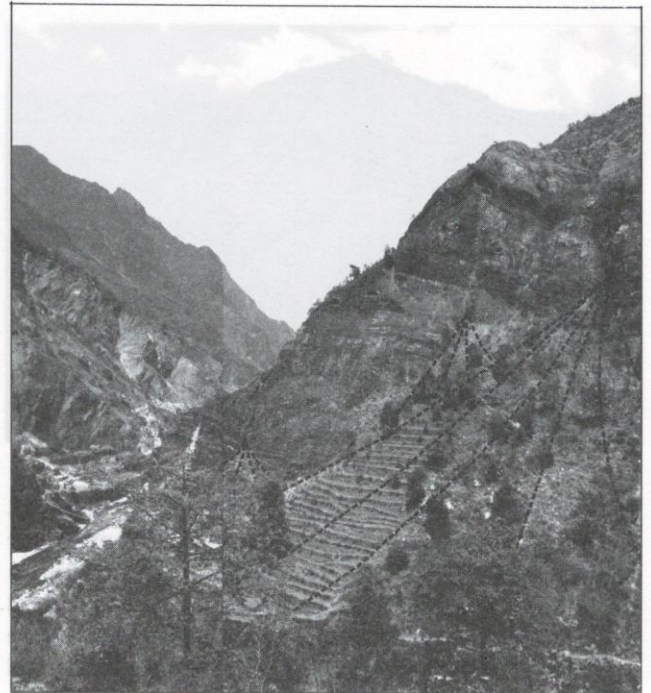
This valley side is in fact the threatening one and produced the landslide discussed in this paper. This has happened despite the dip of foliation oblique to the mountain slope, and therefore supposedly the foliation plays a minor role in potential rock failures (Plate 7).

Plate 7: To the right we recognise the steep eastern bank along the dismembered spur-ridge between the Gar Khola tributary and Kali Gandaki Valley looking upstream i.e. northwards. The steeply inclined shear ("fault") planes are visible either by a whitish streak of a tiny debris flow seeping out of the slope, by an open fissure (left of middle part in the picture) connected with a tiny cone of scree, or with larger cones of scree adjoining the more important bigger shear planes, e.g. a terraced scree cone below a steep scar or scarp, i.e. a relict shear feature on the upper right of the picture.

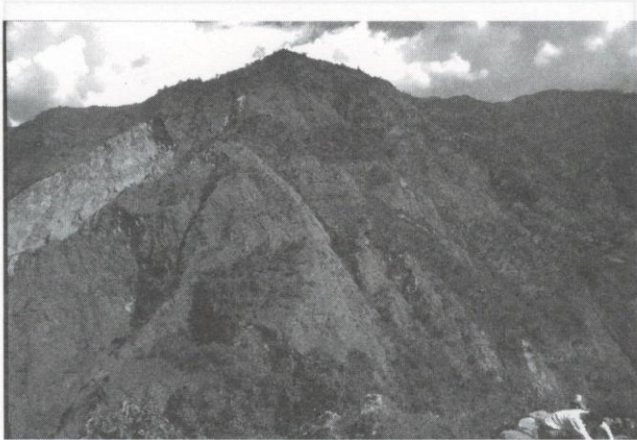
were made possible by four different sets of steep joint (Plate 8): j1 (NNW-SSE), j2 (NE-SW), j3 (ENE-WSW), and j4 (WNW-ESE).

Plate 8: Similar to Plate 9, but taken from a greater distance, it exhibits the morpho-tectonic dissection of the spur-ridge between the Gar Khola (right) and Kali Gandaki Valley (in the front). Note the relict failure scars on the frontal mountain pyramid and also to the right of the recent failure as well as the step-like rise of the ridge crest from the frontal part to the top in the background.

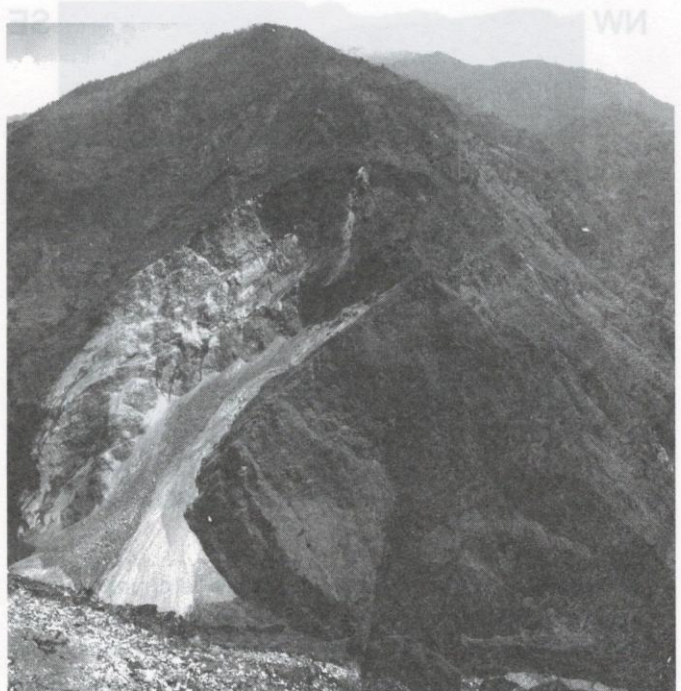
The landslide can be described as a wedge failure producing a major rock fall of 400,000 m³. Its failure planes make a triangle confined by the two main joints, j1 and j2, in combination with the general foliation s1. Clearly dominant is the long j1-joint on the vertical backside of the detachment-

niche, a rock wall, which is crossed on the narrow side by a j2-joint. The bottom of the triangle, finally, is formed by the foliation s1, which represents the top of a phyllite member.

Plate 9: View across the Kali Gandaki Valley, looking onto the asymmetric wedge failure of the 1998 Tatopani Landslide (rockfall and avalanche), located near the front of the spur-ridge, on the eastern bank of the Kali Gandaki River. The light coloured upper section of the failure scar along joint j1 is made up of quartzite, while the smaller lower section is phyllitic and exhibits dark spots of cleft-water seeping out of the quartzite beds over the underlying impermeable phyllite member.

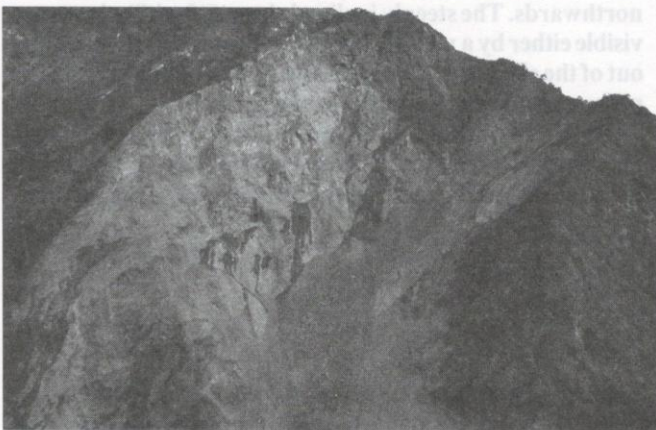
Searching for the triggers of this rockfall, we have to look at the uppermost part of the phyllite member below the failure scar where dark wet patches are observed on light grey phyllitic rocks (Plate 10). The patches are apparently derived from cleft-water, which seeps through the permeable quartzite member over the impermeable grey phyllites below and stains it with dark spots. Therefore, it was probably cleft-water overpressure at the interface of quartzite and phyllite, which brought about the failure. The rockfall occurred in two stages: the first stage was related to the short joint wall (j2) on the right-hand side and happened on 7 September 1998, some hours after a period of tremendous monsoon rainstorms during the weeks of August and September; and the second stage was initiated by the spontaneous opening of a large vertical fissure along the

Plate 10: This picture shows some features of Plates 8 and 9 in more detail, especially the potential failure sites adjacent to the recent one. Also note the faulted left part of the frontal mountain pyramid with its precipice, namely a relict failure scar at the Kali Gandaki Valley slope in the foreground.

long joint wall (j1) on 10 September 1998, which was reported by farmers. Only 16 days later, i.e. on 26 September 1998, the larger rock fall occurred and produced the coarse-grained (mainly quartzitic) rock avalanche down to the river.

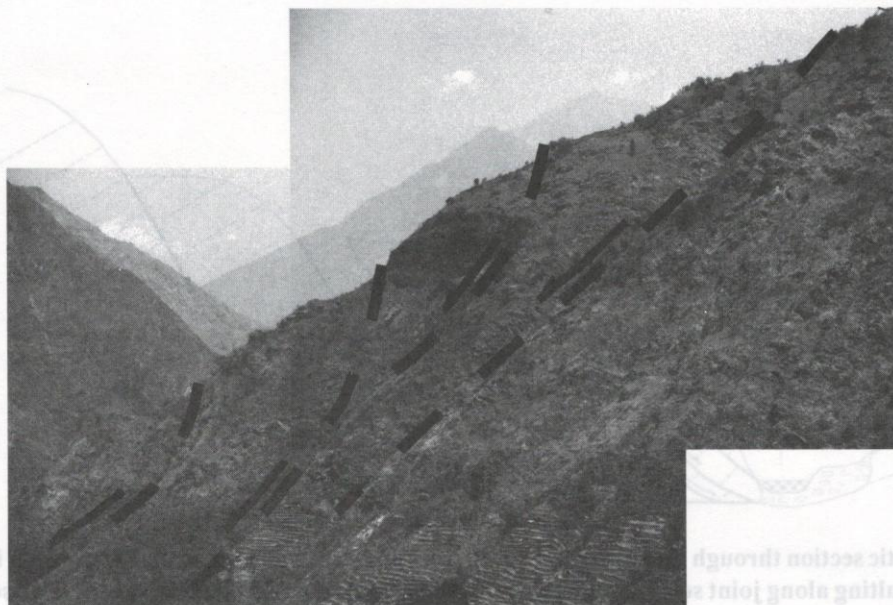
structures on a somewhat wider scale, including the whole mountain spur-ridge separating the Kali Gandaki River and Gar Khola. The spur-ridge is structurally divided into a regular set of "fault-planes" (j1) all parallel to the Kali Gandaki River (Plates 11 and 12; Fig. 3). It must be stressed that these "faults" are not strictly tectonic ones (Hoppe 1998), but a combination of tectonically induced discontinuities and gravitationally imposed cracking and faulting, by which a series of rock slabs had slid down by shearing along each other very slowly. This structural rock creep has also created quite typical slope morphology by creating a step-like shape with morphological breaks of benches and scarps, especially on the crest of the spur-ridge. Quite a similar process has been studied by the author on slopes in the Indus Valley along the Karakoram Highway, northern Pakistan (Völk *in press*).

Looking against the spur-ridge in a section along the northern bank of the Gar Khola tributary, we clearly recognise the above-mentioned set of deep reaching "fault" planes, which are morphologically manifested by steeply inclined "fault" scarps with inclinations of 75–45° dissecting the bank (Plates 11 and 12; Fig. 3).

Plate 11: Cross-section of the spur-ridge (W-E) south of the landslide site of 1998 along the Gar Khola bank. It demonstrates the morpho-tectonic shape of the faulted spur-ridge firstly by furrows, which are inclined from the right to the left towards the trunk valley of the Kali Gandaki River, and secondly by flatter and steeper crest morphology or even uphill-dipping forms at the left margin.

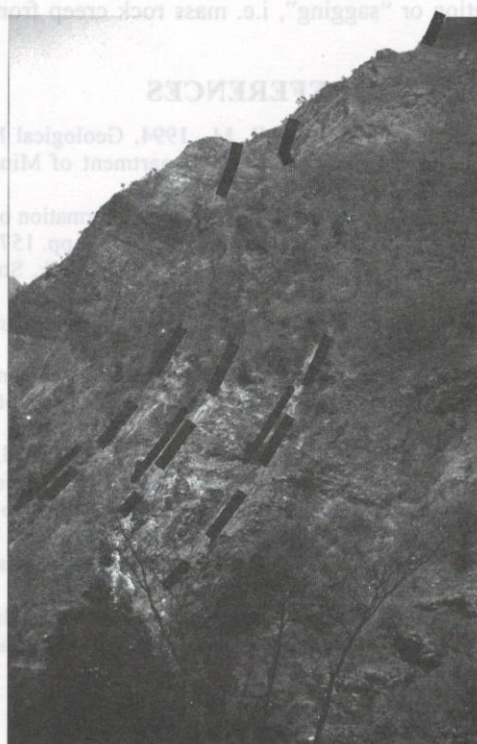
Plate 12: This view is similar to Plate 11, and was photographed after a heavy rainstorm, through which the steep shear (“fault”) planes were marked with tiny debris flows of cleft-water rich in fine suspension out of the slope. Steep slope sections on the ridge crest correspond to shear planes.

Moreover, – and this is a strong indication for shearing movements inside the slope – almost every outcropping “fault” plane is visibly marked by a streak of light-coloured tiny mudflow and/or debris cone, apparently produced by local suspension-rich water out of the mountain slope during rainstorms. These tiny “mudflows” contain quartzitic and sericitic rock powder, which is the product of shearing of the sliding rock slabs (Plates 2, 7, and 12).

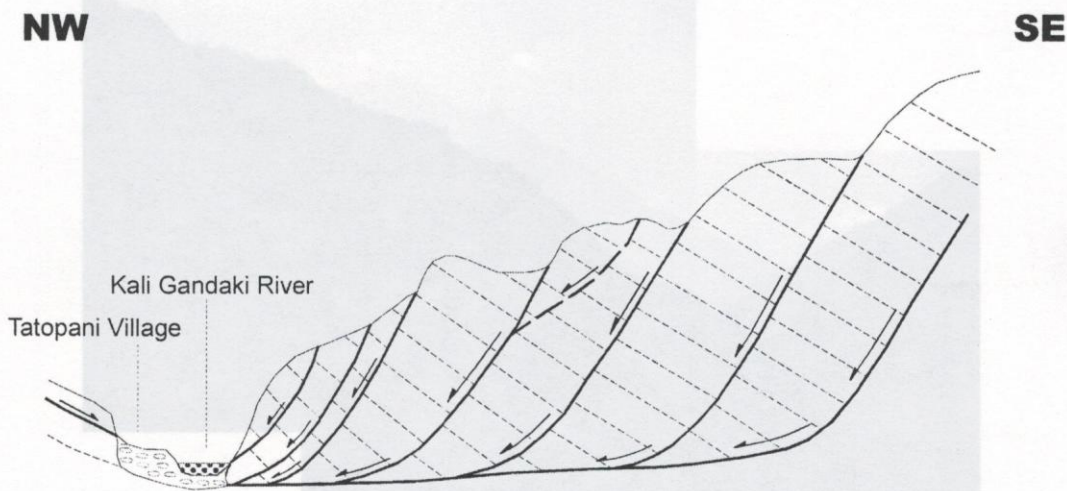
Such stepped mountain slopes are formed by extremely slow mass movements, namely deep-seated rock creep, which appears to be possible along well-defined shear planes (Chigira 1992). These shear planes thus separate large, steeply inclined rock slabs to form rock cliffs (scars) and/or steep slope surfaces on the crest of the spur-ridge. Each shear (“fault”-) plane is almost vertical (75°) at the ridge crest whereas the lower part seems to be bent into a listric shape.

If we search for a causal connection between the mass rock creep on the spur-ridge of the eastern bank near Tatopani and the actual rock failure, there we arrive at the conclusion that the landslide depended on deep-seated rock creep. The logical linking is strongly indicated by the identification of fissures, “faults”, and shear planes with the wedge failure. It appears to be a matter of cause and effect not only for the current rock failure but for more than half a dozen older ones, which are manifested by relict failure scars in the vicinity of the fresh failure (Plates 8, 9, and 10). The climate-

Fig. 3: Diagrammatic section through the spur-ridge south of Tatopani, eastern valley flank, showing inferred “sagging” by gravitational faulting along joint set (j1) which runs parallel to the Kali Gandaki River ca. 1 km south of the village. Sketch not to the scale. Note: main failure plane of landslide (rockfall) just behind the section coincides with joint (j1) system.
