## Recumbent fold and deformed cut slope in the landslide-prone region of the Niigata Prefecture, Central Japan

Tamotsu Nozaki<sup>1</sup>, Katsumi Ookubo<sup>2</sup>, and Toshio Yamamoto<sup>3</sup>

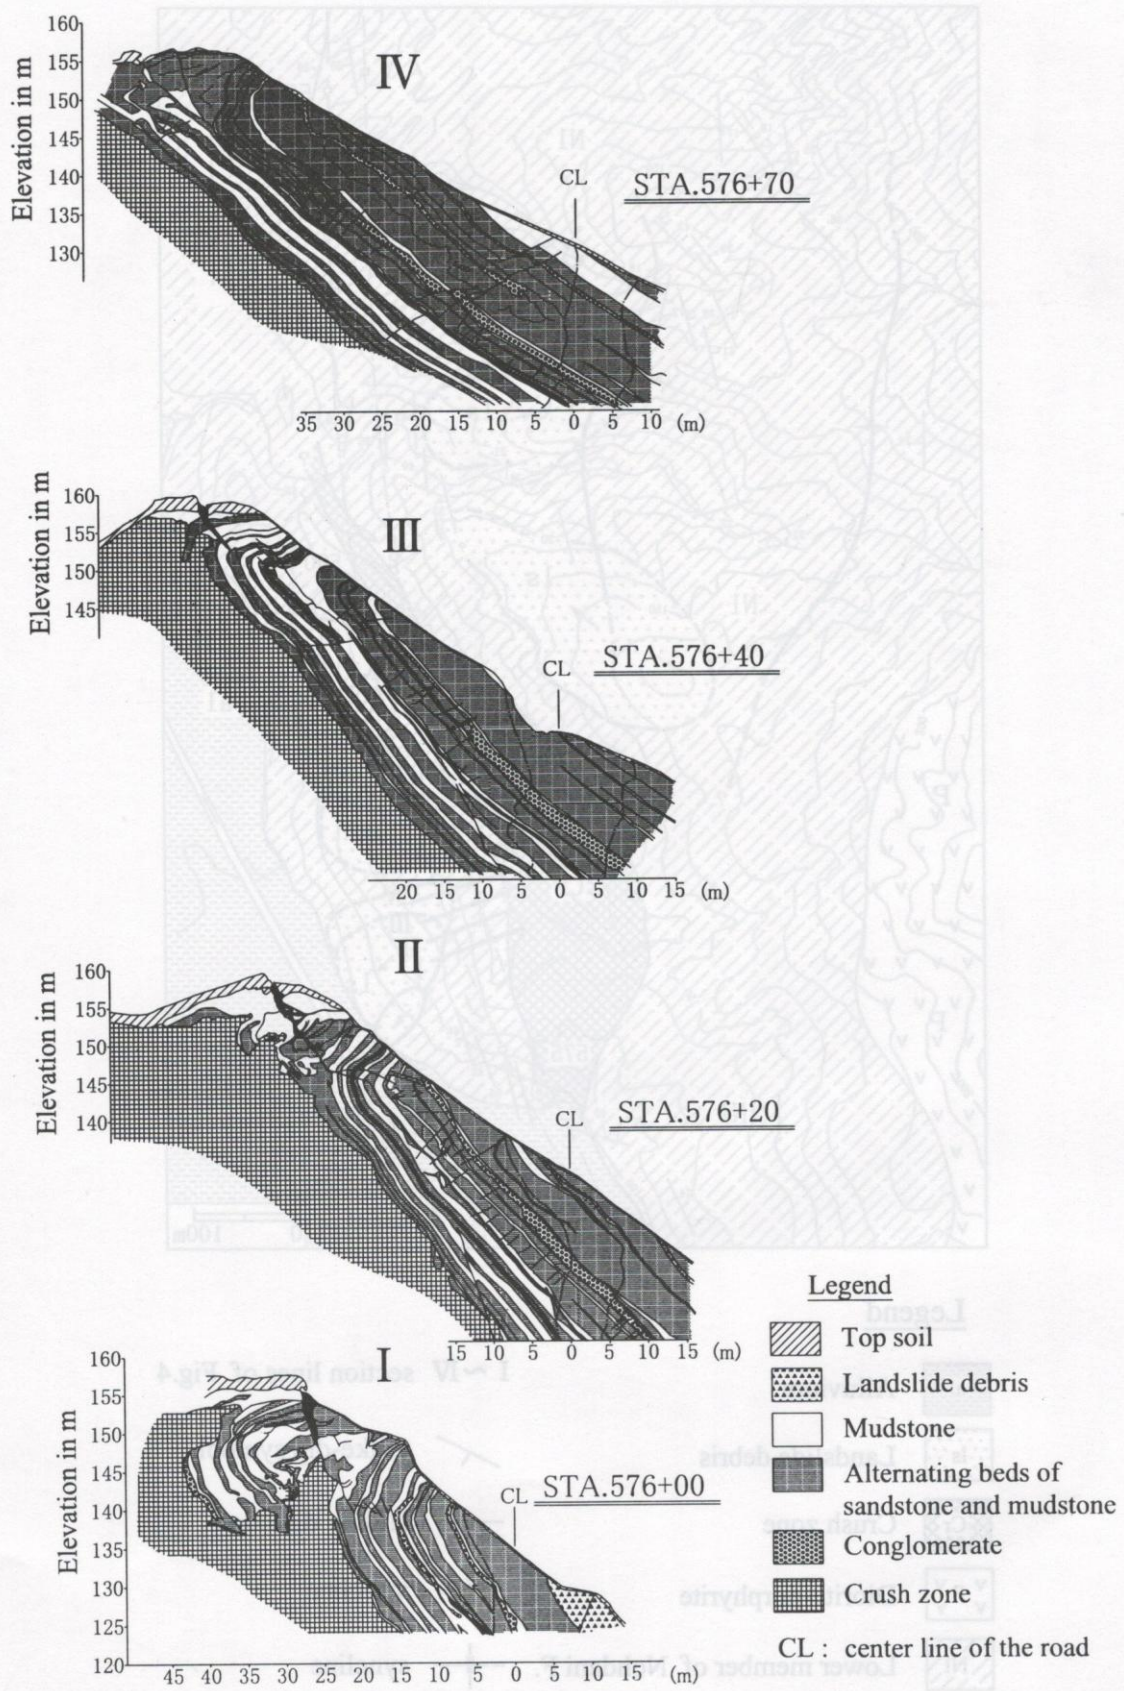
Fig. 4: Geological cross-sections showing the detail structures of the recumbent fold

- (2) Generally, typical rockslides are not crush or deformed in a chaotic manner as found in this case, and usually retain the original sedimentary structure except along the edges of the slides (Nozaki and Fukumoto 1992).
- (3) The crush zone appears to be tight and fresh, where the overlying beds are friable and oxidised in places, and does not include any foreign materials such as soils and fragments of diorite porphyry, which are found on the upper slopes.
- (4) Although there are many slip surfaces (slickensides) parallel to the bedding plane in the sandstone and mudstone, they never cut through the structure of the recumbent fold. As shown in Fig. 4, the stratification and the morphology of the fold are well preserved.

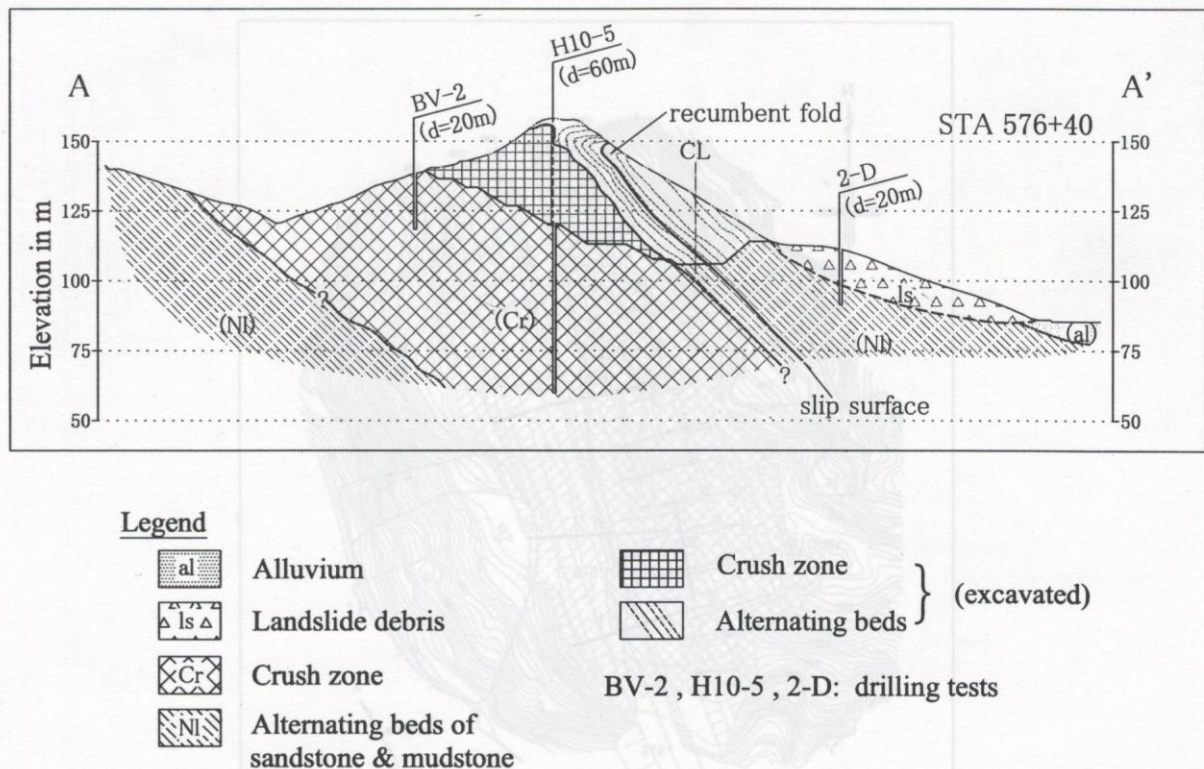
Fig. 5: Schematic section showing the geological structure of the study area

The crush zone underlies the interbedded sequence of sandstone and mudstone (Fig. 5). One of the boreholes (H10-5) was drilled to about 20 m below the alluvial plain. However, it did not reach the bottom of the crush zone. The examination of cores revealed that the entire section was intensely shattered and sheared. Although the materials were the same as the overlying sandstone and mudstone, the original sedimentary structures were obliterated. The thickness of the crush zone is at least 70 m, and it is neither oxidised nor weathered except for the top 2–3 m.

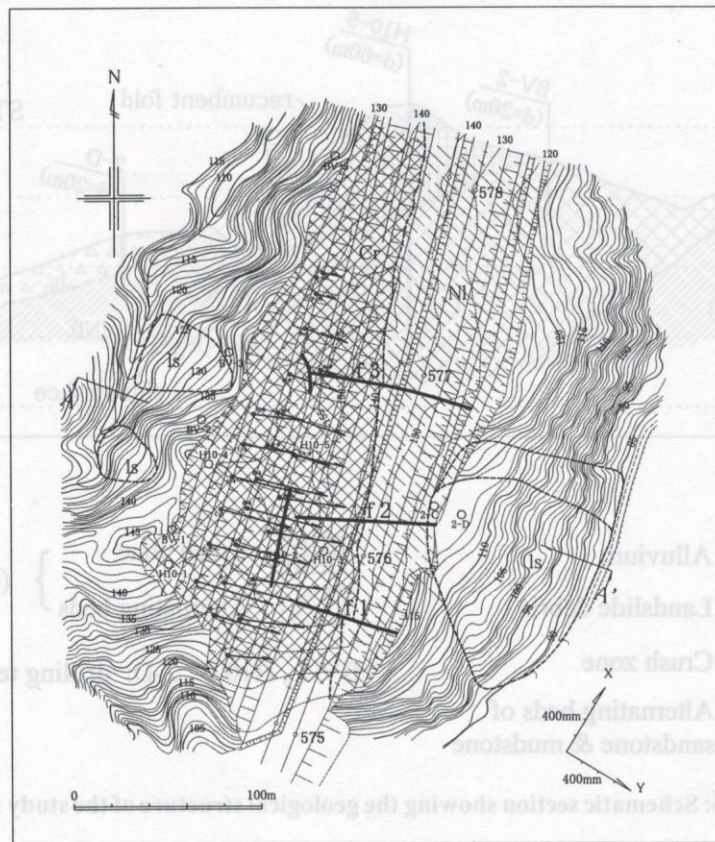
**Fig. 6: Geological structure and horizontal displacement of the cut slope**

cut slope started to deform. Some small displacements developed along the pre-existing minor faults, which are oriented in N-S direction, and the lower portions of the cut slopes started to bulge (two of them are shown in Fig. 6).

The horizontal displacement of control points (vector in terms of X- and Y-axes) for the period of one year between May 1998 and June 1999 is shown in Fig. 6. The map shows the displacement occurred towards the downhill direction with the maximum displacement measuring up to 400 mm in a year. The horizontal displacement (Y-axis) and the vertical displacement (Z-axis) measured in the three-month period between July and October 1998 are shown in Fig. 7 and Fig. 8, respectively. Fig. 7 shows that the longer the cut slope, the larger the lateral deformation. Fig. 8 shows that the most subsided area is located beyond the upper edge of the slope, and the lower part of the slope is uplifted. It appears that the central portion of the uplifted area coincides with the former summit of the isolated hill. The mode of deformation of the cut slope clearly demonstrates that the deformation is caused by the stress release induced by unloading and subsequent gravitational displacement, and hence not by a landslide.
