GEOLOGICAL EFFECTS AND INTENSITY DISTRIBUTION OF THE UDAYAPUR (NEPAL) EARTHQUAKE OF AUGUST 20, 1988.

A. M. Dikshit

Department of Mines and Geology, Kathmandu

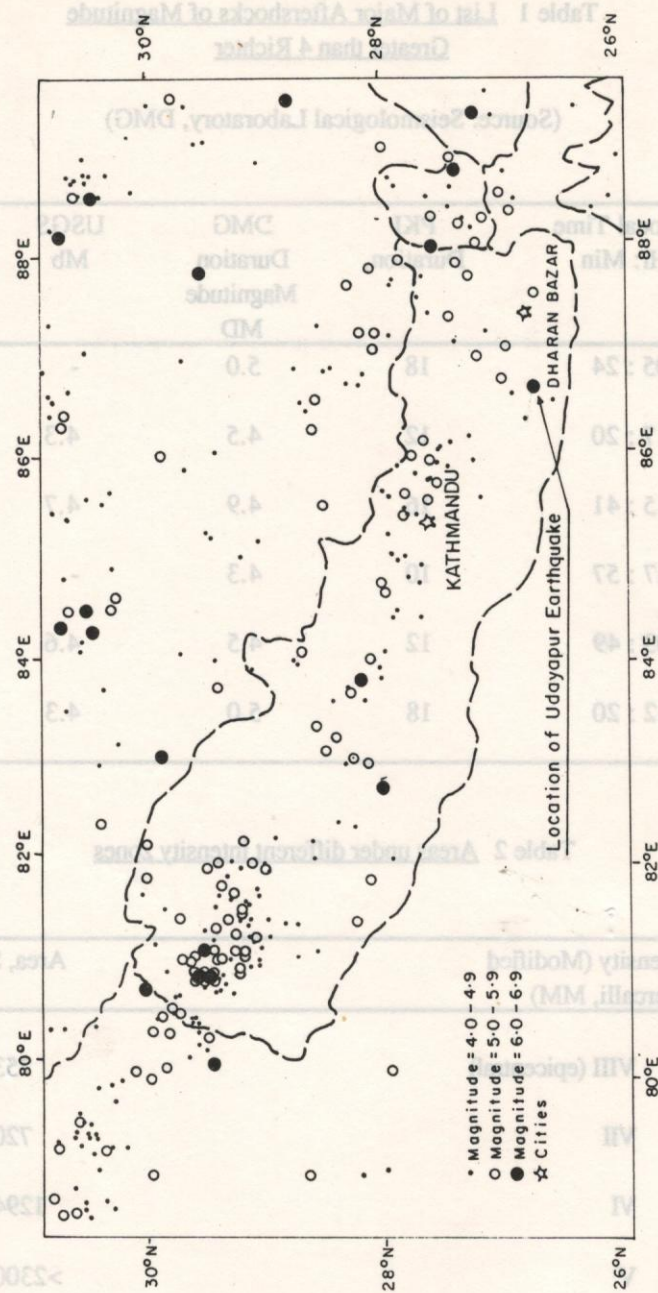
Fig. 1 Seismicity of NEPAL and Surrounding Areas (1897-1988)
Magnitude 4.0 and Greater

Fig. 1 shows the seismicity of the country and the situation of the main shock. As seen from it, the epicentre lies in the Udayapur District to the south of the Churia Range in the northern part of the Terai plain. Fig. 2 is the focal mechanism solution for the earthquake.

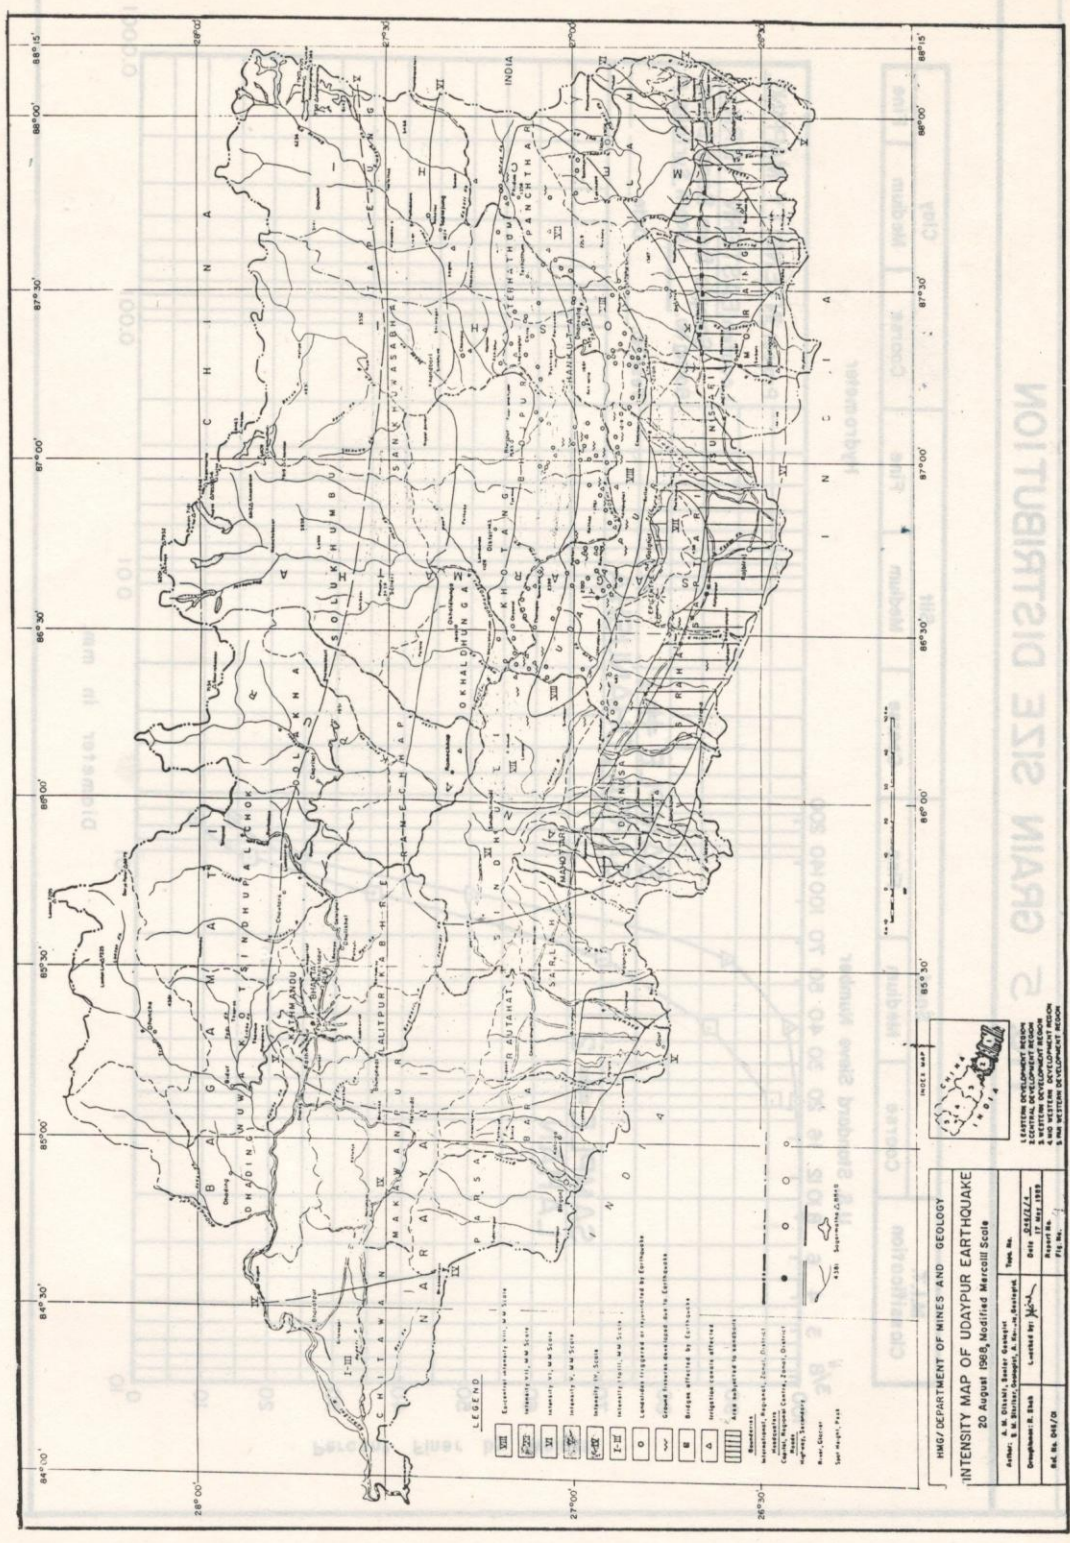
MINISTRY OF MINES AND GEOLOGY
INTENSITY MAP OF UDAYPUR EARTHQUAKE
 20 August 1968, Modified Mercalli Scale

Fig. 4 shows the distribution of earthquake intensities in Modified Mercalli (MM) scale. The epicentral intensity was in the upper range of VII MM. Isoseismals of V to VIII MM were mapped rigorously in the affected area. An east-west trend of the isoseismal with conspicuous northward bend in the eastern as well as western parts of the affected area is obvious. The epicentre itself falls in the intensity VII area which is due to the fact that the fault rupture plane is dipping steeply towards south (Fig. 2). The epicentral intensity extends more towards east than towards west of the epicentre.

Attenuation in north-south direction is about three times faster than in the east-west direction (Fig. 4). Table 2 shows the areas of territories lying in various intensity zones.
