## GEOLOGY AND FOUNDATION TREATMENT OF KULEKHANI DAM, CENTRAL NEPAL

D.B. Thapa  
Electricity Department  
Kathmandu.

### ABSTRACT

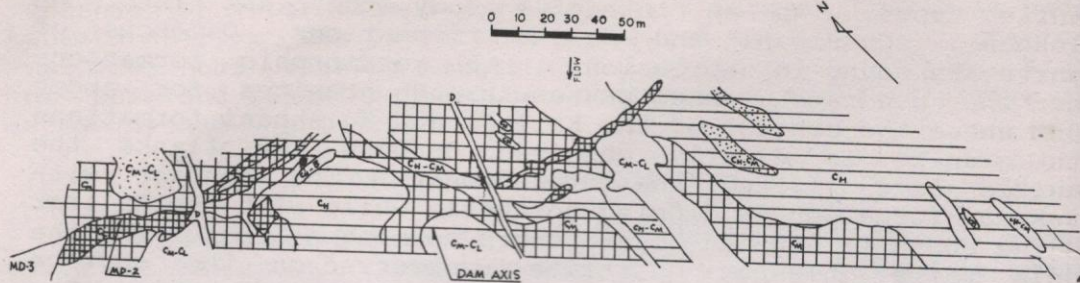
Fig. 3

From the rock classification map of dam foundation, (Fig. 3) it is seen that rocks on the left bank are of better quality than on the river bed and right bank. CH class which represent the hard rock with very little weathering (Standards recommended by JNCD for Geological investigation of dam foundation) are distributed mainly on the left bank and in portions of right abutment and river bed. The weakest rock condition class-D are found along the faults F-1 and F-2. Moderately hard and weathered rocks (class CM and CL) constitute the river bed portion and right bank of the dam foundation.

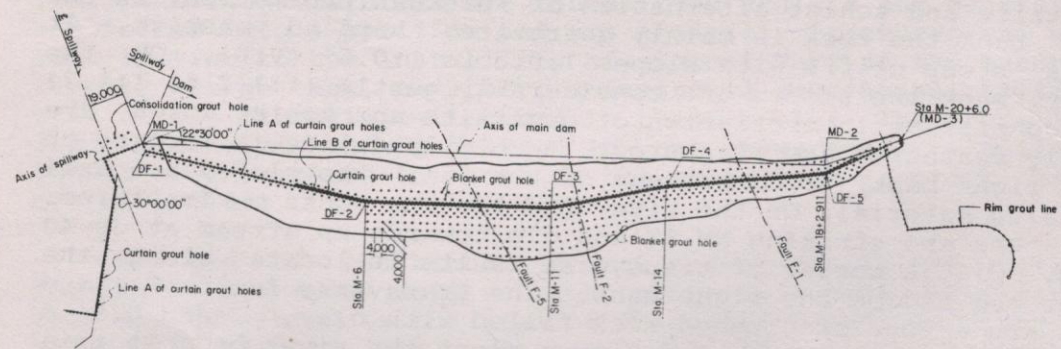
Fig. 4 Arrangement Plan of Grouting Holes in Damsite

The subsurface treatment of foundation was carried out according to an elaborate grouting plan (Fig. 4) which covered the entire foundation under core zone and extended to the spillway on the left bank and about 100m upstream on the right bank. The main purpose of grouting was to fill up cracks in the bedrocks in order to minimize the seepage of water from the reservoir through the foundation rocks into the downstream part of the river. Three types of grouting were carried out:

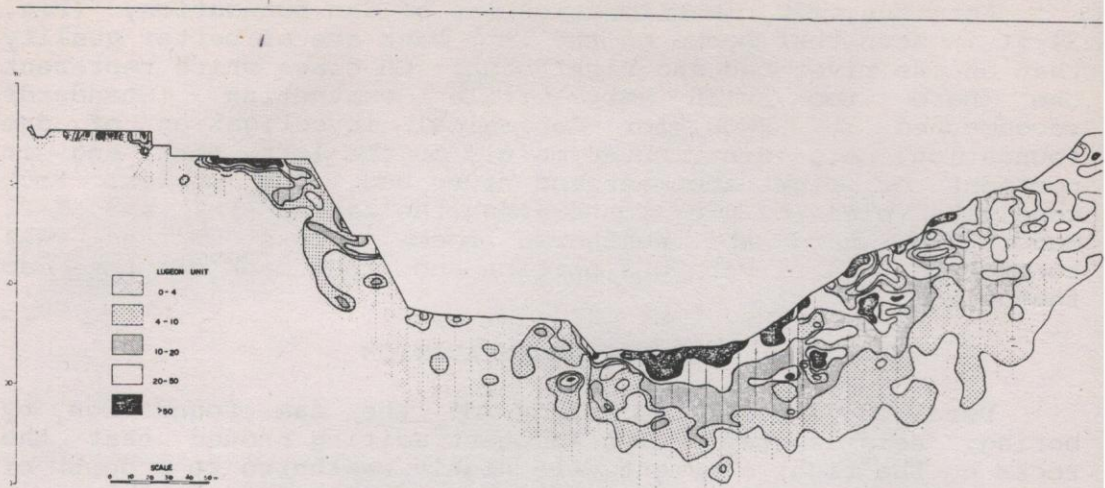
Fig 5a Permeability Profile of Main Dam Curtain Grouting, Primary Holes

The permeability of the rocks was determined by carrying out water pressure test in each grouting stage under the same pressure as for grouting. The water pressure test is a basis to determine the cement water ratio of the grout. Upon completion of curtain grouting check holes were drilled at selected points to see the effect of grouting. In case when the final permeability of the rocks was more than 4 Lugeon units additional grouting were done. Figures 5 and 6 show the permeability profiles of primary, secondary, tertiary and quarternary holes. It is seen that a gradual decrease in permeability after each grouting was well achieved.
