## EVALUATION OF CORROSION CONDITION OF SOME STEEL-REINFORCED CONCRETE INFRASTRUCTURES AVAILABLE IN POKHARA VALLEY OF NEPAL

### ABSTRACT

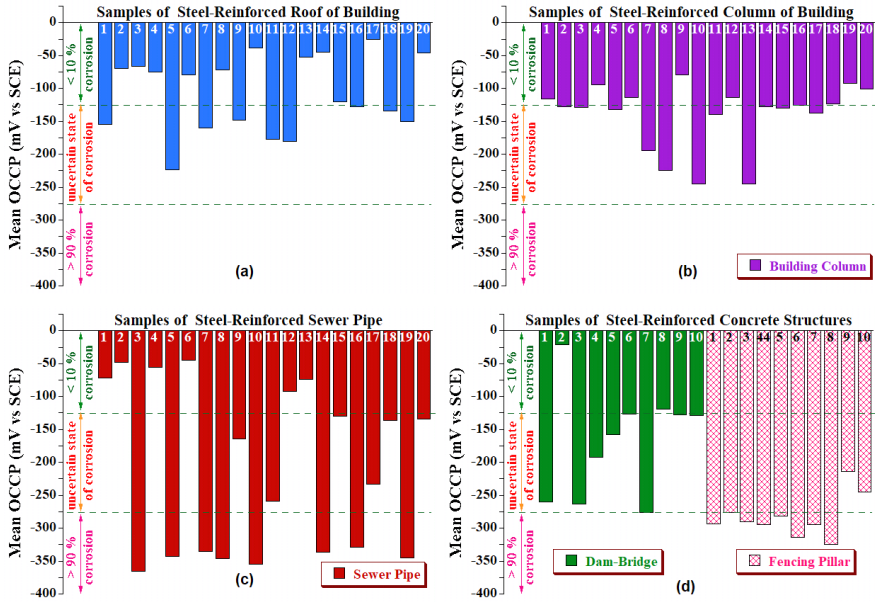
More details about the qualitative assessments of these three corrosion levels of the SRC infrastructures were ascertained from the recorded  $\phi_{\text{corr}}$  for each sampled specimen of all categories of infrastructures, as depicted in Figure 2. Twenty SRC roofs of twenty buildings from different localities of the Pokhara Valley were randomly chosen to study their condition using the HCP method. Four points of each concrete roof specimen were monitored for their  $\phi_{\text{corr}}$  values using a voltmeter, and the  $\phi_{\text{corr}}$  values of the four attempts for all twenty specimens [Figure 2(a)], and the mean and standard deviation values are summarized in Table 2.

The  $\phi_{\text{corr}}$  values were observed between  $-23$  and  $-230$  mV vs SCE, which are belonging to only two corrosion groups (i.e., LeC and MiC), not of HiC corrosion group based on the ASTM C876-15 standard (2015) which is presented diagrammatically, as depicted in Figure 3(a). Among twenty SRC roofs of the building, 55% (11 sample specimens) are considered to be LoC (i.e., a probability of less than 10 % corrosion occurs), while the remaining 45% (9 specimens) roofs are considered to be MiC with the mean  $\phi_{\text{corr}}$  values within  $-128$  and  $-224$  mV, as shown in Figure 3(a) and also in Table 2. Furthermore, the  $\phi_{\text{corr}}$  values of four points of each twenty concrete roof specimens are within the standard deviation potential value of less than 10 mV. The results pointed out that the measured  $\phi_{\text{corr}}$  values of four points of a single sample specimen represent the real and more precise corrosion conditions of the SRC roof of all twenty buildings of the study areas. Also, such homogeneous  $\phi_{\text{corr}}$  values of all four measurement points within the wide areas of the concrete infrastructure do not demonstrate the occurrence of localized types of corrosion, for example, the pitting, inter-granular or galvanic corrosion so on (Ebell *et al.* 2018).

**Figure 2:** Mean  $\phi_{corr}$  values showing three corrosion conditions of the SRC infrastructures of (a) building roof, (a) building column, (c) sewer pipe, and (d) dam-bridge and fencing pillar

the building columns (i.e., 8 sample specimens) have less than 10% chance of the corrosion risk (LeC) having the average  $\phi_{corr}$  value more positive values than  $-126$  mV, while the remaining 60% (12 sample specimens) building columns with the average  $\phi_{corr}$  values between  $-126$  mV and  $-245$  mV are considered as the corrosion condition at uncertain based on the classification of the ASTM C876-15 standard (2015), which is plainly shown in Figure 3.

On the Other hand, among 20 sampled SRC sewer pipes used in different localities of the Pokhara Valley, nearly 30% (6 samples) were in good condition showing less than 10% chance of the corrosion risk with showing the mean  $\phi_{\text{corr}}$  value in noble than  $-126$  mV, as depicted in Figures 2(c) and 3(c), and also summarized the data in Table 4. Also, the figure distinctly showed that six sewer pipes (i.e., 30%) were to be in the mild corrosion condition with the average  $\phi_{\text{corr}}$  values in the range of  $-126$  mV to  $-276$  mV, while remaining 40% of pipes (4 samples) could be categorized as high corrosion condition, i.e., showing more than 90% probability of the corrosion damage having the average  $\phi_{\text{corr}}$  value in less noble than  $-276$  mV.

Figure 2(d) shows the average  $\phi_{\text{corr}}$  values of 10 sampling sites of dam-bridge and 10 samples of fencing pillar used around the Pokhara Valley which are present in Table 5 also. All the recorded  $\phi_{\text{corr}}$  values of these ten dam-bridge concrete infrastructures are in between  $-21$  mV to  $-119$  mV, and only two (10%) dam-bridges are considered as LeC expecting  $< 10\%$  corrosion damage risk, while only one (10%) dam-bridge of Pokhara Valley could be grouped to the highly corroded level (HiC) with  $> 90\%$  corrosion damage, as shown in Figure 3(d). The rest of seven (70%) samples among the ten dam-bridge samples could be considered as the uncertain corroded state based on the ASTM C876-15 standard (2015). These results revealed that most of the dam-bridges of Pokhara Valley are high prone state due to corrosion damages. Moreover, the  $\phi_{\text{corr}}$  values of 10 fencing pillars were recorded between  $-214$  mV and  $-325$  mV, as tabulated in Table 5.

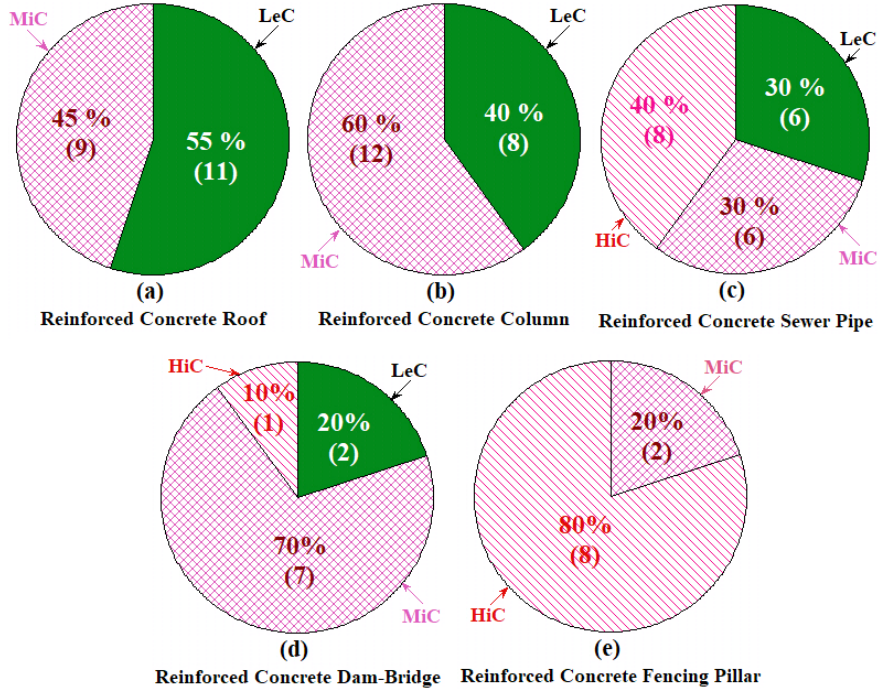
**Figure 3:** Pie charts showing three corrosion conditions of the SRC infrastructures of (a) building roof, (a) building column, (c) sewer pipe, and (d) dam-bridge and fencing pillar

The resultant  $\phi_{\text{corr}}$  values of all samples of fencing pillars are shown in Figures 2(d) and 3(e) which indicated that 80% of samples among the ten fencing pillars have  $> 90\%$  corrosion risk of the SRC, while the remaining two pillars; FcP-9 and FcP-10 [Fig. 3(e)] specimens are considered to be mildly corroded with the average  $\phi_{\text{corr}}$  values of  $-214$  mV and  $-245$  mV, respectively, as depicted in Figure 2(d) and Table 5 also. These results indicated that most of the entire fencing pillars do not function for a long time without the repairs.

The corrosion condition of 80 reinforced steel in different five categories of the concrete infrastructures of the Pokhara Valley (Nepal) was investigated using the HCPM method following the ASTM Standards. The results indicate that fencing pillars, old sewer pipes, and dam bridges are at high corrosion risk in moist conditions. Besides, the SRC infrastructures with porous/rough surfaces are at high corrosion risk. Present research concluded that the HCPM provides precious information on the likelihood of corrosion, and helps for the quality assurance of the SRC repair and rehabilitation. Depending on the measured  $\phi_{\text{corr}}$  values, the probability of active corrosion damages of the SRC infrastructures even in large areas could be successfully assessed regularly in a short time without investigating huge amounts of money.
