The Jajarkot Earthquake: Revealed the Vulnerability of Load Bearing Structures in Western Nepal

Hemanta Raj Poudel and Hemchandra Chaulagain*

School of Engineering, Faculty of Science and Technology, Pokhara University, Nepal

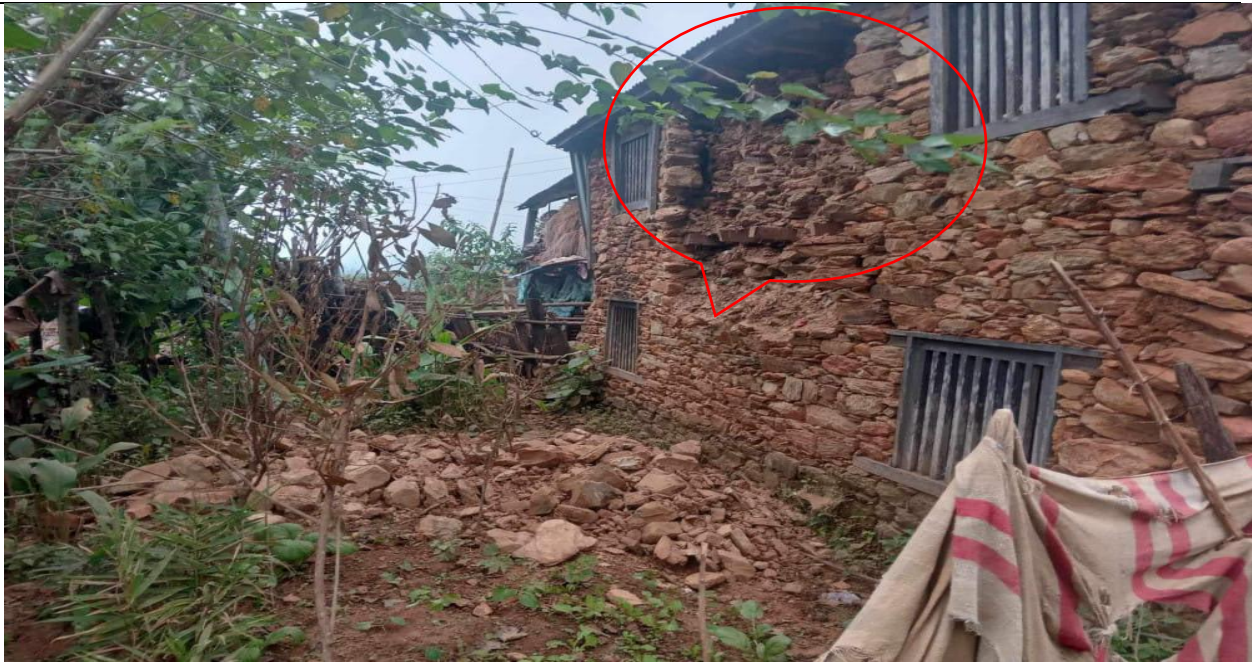
Delamination of exterior walls as shown in 8 refers to the separation or peeling off of layers in the masonry due to inadequate bonding between bricks or stones. This weakening of the wall structure of the buildings in the affected area were resulted from factors such as poor-quality mortar, insufficient curing, irregular bonding system, stone block formation, use of incompatible materials, exposure to freeze-thaw cycles, chemical reactions, aging, and seismic activity.

Figure 8: Delamination of the exterior walls

To correct this problem, it is imperative to implement proper masonry techniques and bonding systems during construction. This includes ensuring a consistent and even distribution of masonry units and mortar to enhance structural integrity. Additionally, providing training and education for local builders and masons on correct masonry practices will help improve the quality of construction. Regular inspections and oversight during the construction process can also help identify and rectify any irregularities. Finally, using high-quality, durable materials that are suitable for load-bearing applications will contribute to the long-term stability and resilience of the exterior walls.

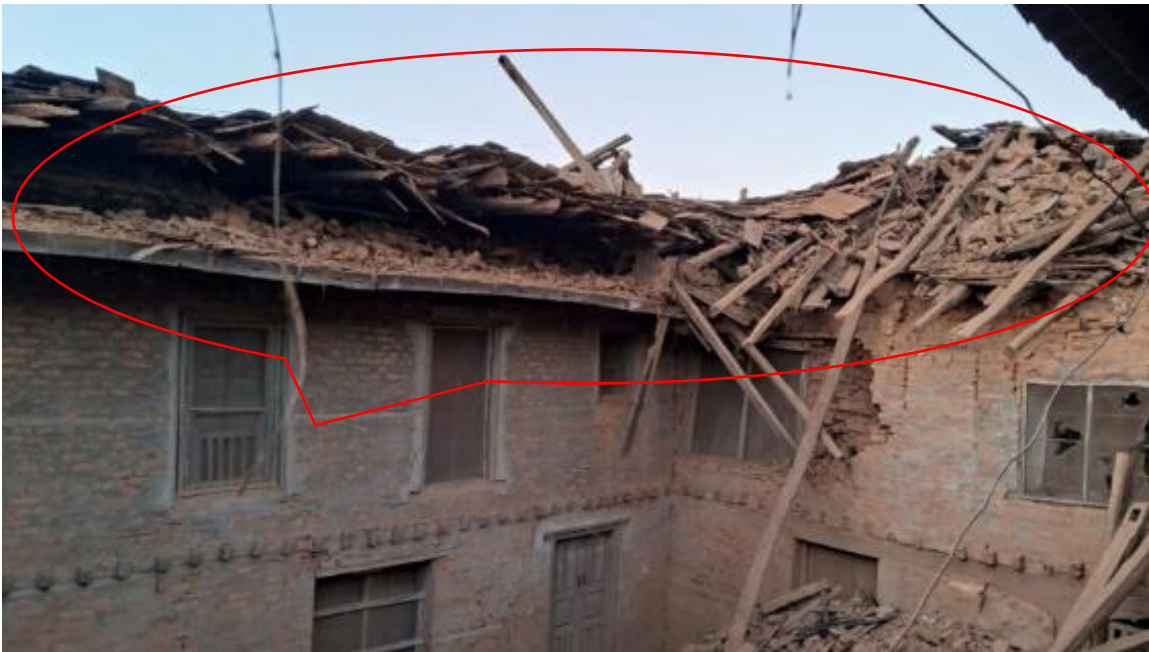
In the case of a Complete collapse of the roof and gable wall (*Fig 5.2*), it indicated a catastrophic failure where the entire roof structure, along with the gable wall, has given way. This type of failure was seen in the affected region due to inadequate bracing and improper construction techniques. It was also seen the use of slate stone, which is generally a heavier option for the roofing purpose, could be a reason of complete collapse of roof and gable wall.

Figure 9: Complete Collapse of Roof and Gable wall

To address this issue, implementing tie beams at both the floor and roof levels of load-bearing walls is crucial. These horizontal supports distribute the weight more effectively, providing essential reinforcement. Additionally, ensuring that roofing and flooring materials are appropriately selected and constructed to match the load-bearing capacity of the structural unit will help prevent overloading and subsequent deterioration. This approach ensures a balanced and resilient structural system.

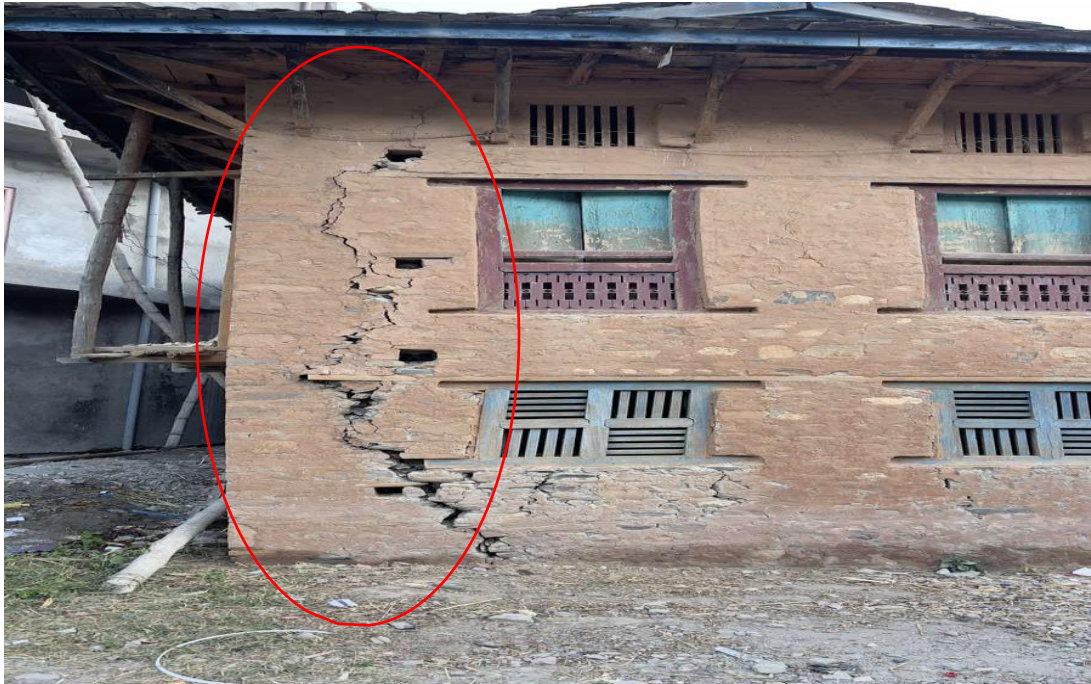
Fig. 10, illustrates severe cracking, primarily caused by the absence of inadequacy of a lintel beam. A lintel beam provides crucial horizontal support above openings in load-bearing walls and divides the wall into smaller parts having more moment of inertia. In the figure it is clearly seen that the lintel was insufficient and just over the opening because of which the concentrated load from the wall above lead to extensive cracking at the corners of the building, weakening the overall structural integrity.

Figure 10: Severe Cracking due to Inadequate Lintel Beam.

The Solution is to install sufficient lintel beams above openings to evenly distribute loads and prevent excessive cracking.

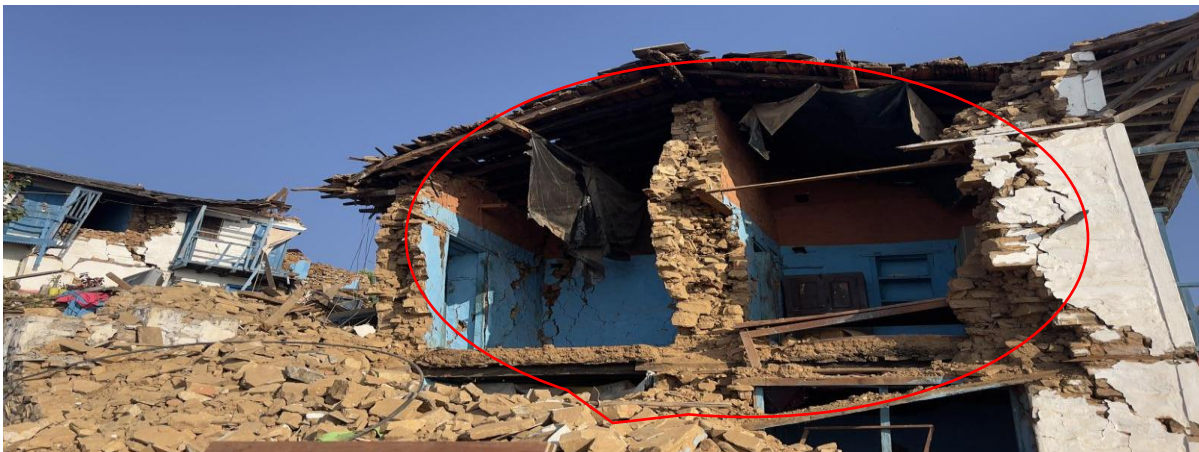
Out of plane collapse as shown in figure 11, occurs when exterior walls fail in an outward direction, away from the building's center. The major causes for this type of failure in the building can be taken as lack of tensile reinforced resulting into weak structural integrity, deficient bond at corners continuous vertical joints and flexible floor diaphragm.

Figure 11: Out of plane failure of exterior walls

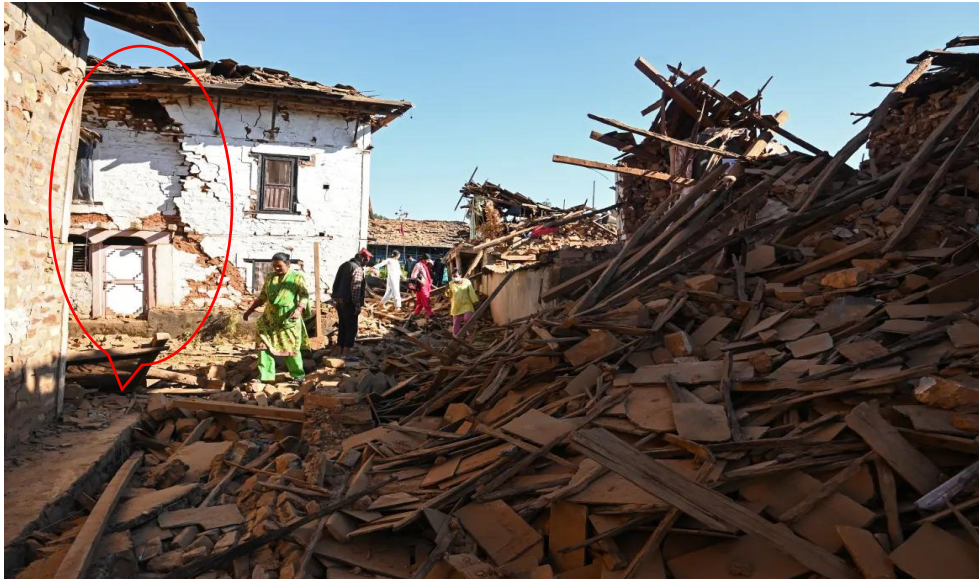
Fig.12 shows in-plane diagonal cracks, which form within the plane of the exterior walls as the lateral force acts parallel to the plane cause excessive shear forming diagonal cracks. These cracks indicated significant internal stress and deformation within the masonry. They resulted from the unequal distribution of seismic forces or inadequate reinforcement.

Figure 12: In-plane Failure of Exterior Walls

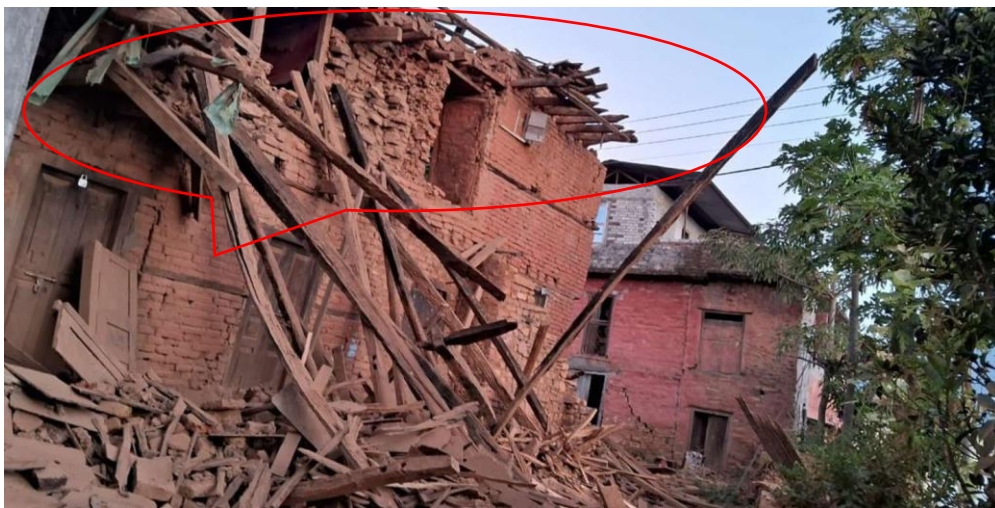
Diaphragm failure as shown in fig.13 involves the inability of the horizontal diaphragm elements (such as floors or roofs) to effectively transfer loads to the vertical elements (walls and columns). It was seen in the building due to deficiency in tension anchoring, creating a cantilever effect at the base of the wall. This is caused by the diaphragm exerting pressure against the wall, resulting in a non-bending action.

Figure 13: Diaphragm failure

It is necessary to strengthen tension anchoring and ensure effective load transfer mechanisms between horizontal and vertical elements.

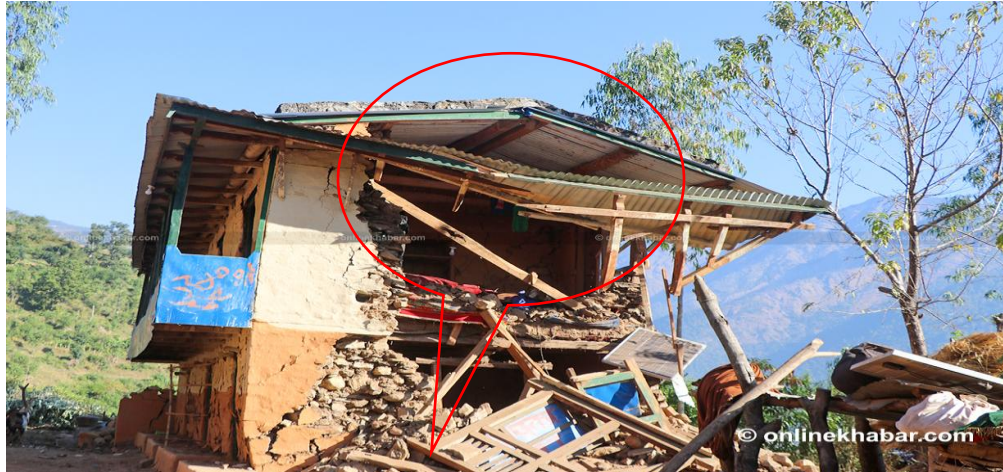
Torsional partial collapse as shown in fig. 14, occurs when torsional forces, which involve a twisting motion, lead to a partial failure of the structure. Torsional stresses were induced in the building due to irregularities in the building's layout or improper distribution of loads, use of different material with in the same structure which showed different stiffness properties to the component of the building.

Figure 14: Torsional Failure.

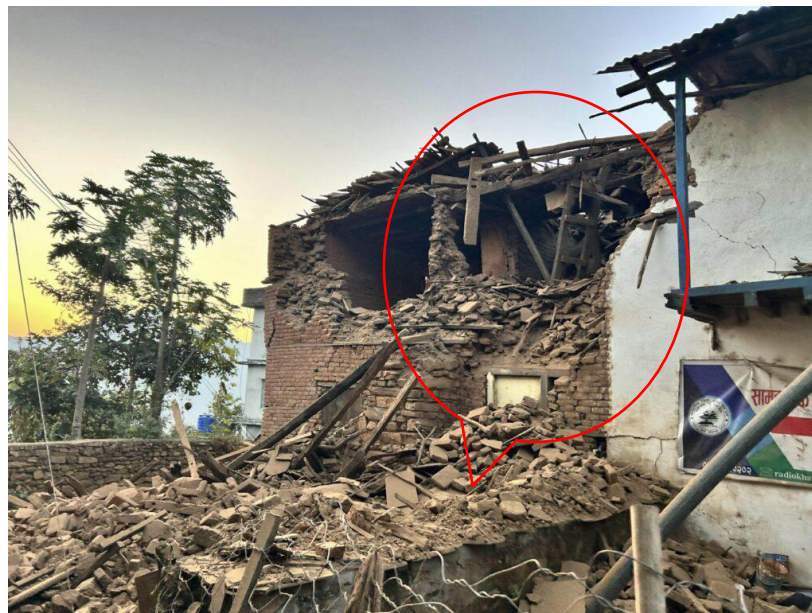
Pounding effects as shown in fig.15 occur when adjacent structures collide during seismic events due to relative movement. As shown in figure it leads to additional damage and exacerbate the overall structural failure. Being situated in the one of the commercial area of that region, they attached two building without proper spacing and reinforcement which lead to the pounding effect and damaged the side gable wall of adjacent building.

Figure 15: Pounding Effect

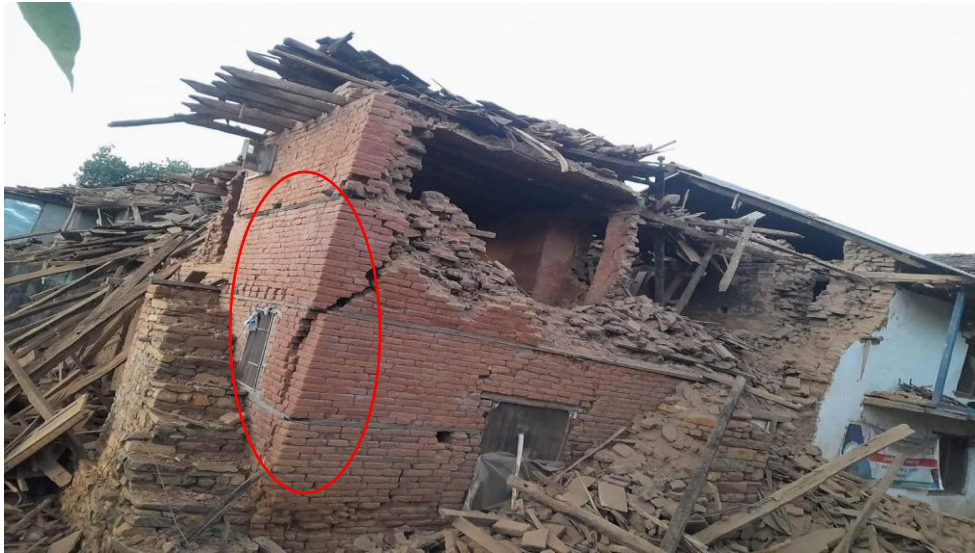
Connectivity failure as shown in fig.16, occurs when there is a breakdown in the connection between cross walls, which are essential for providing lateral stability to the structure. This type of failure was seen in the building because the use of longer tie stone was not provided in the connection and there was no use of any dowels, hooks or reinforcement to withstand concentrated loading at the corner.

Figure 16: Connection Failure

We should provide proper connections between cross walls, use suitable tie stones, and reinforce connections to withstand concentrated loads.

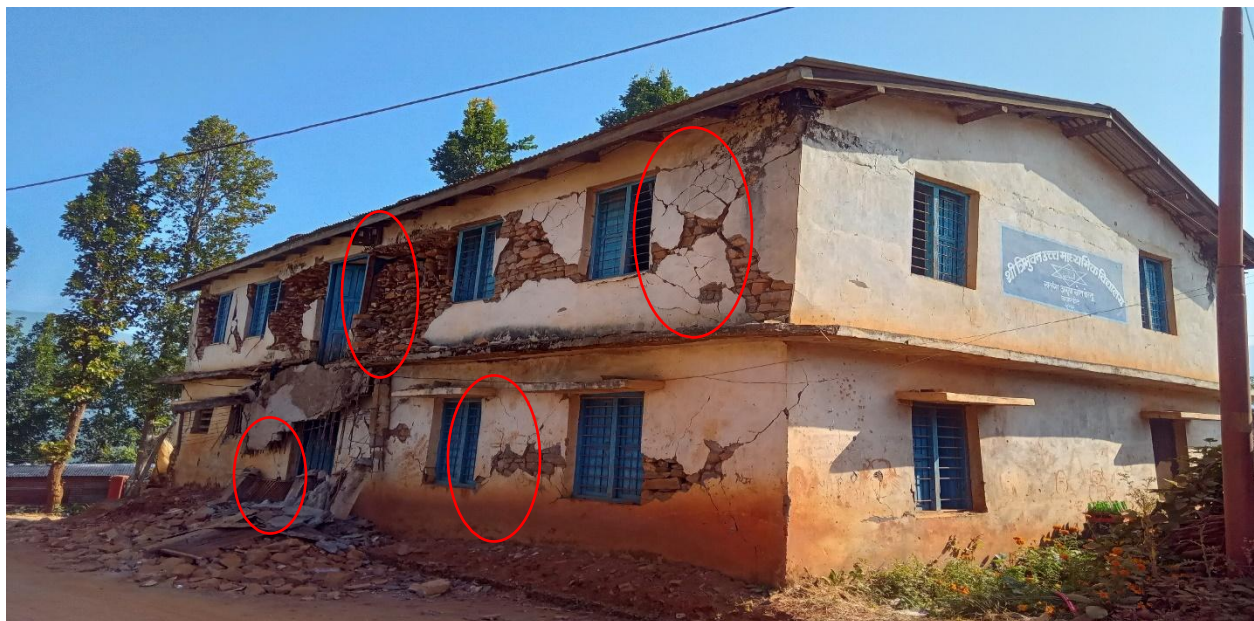
Fig 17 demonstrates the failure of openings in exterior walls, which occurred due to inadequate reinforcement around openings or poor construction practices. As seen in the figure the number of opening and their dimensions were not suitable as per the length of the exterior walls.

Figure 17: Failure due to excessive number of openings

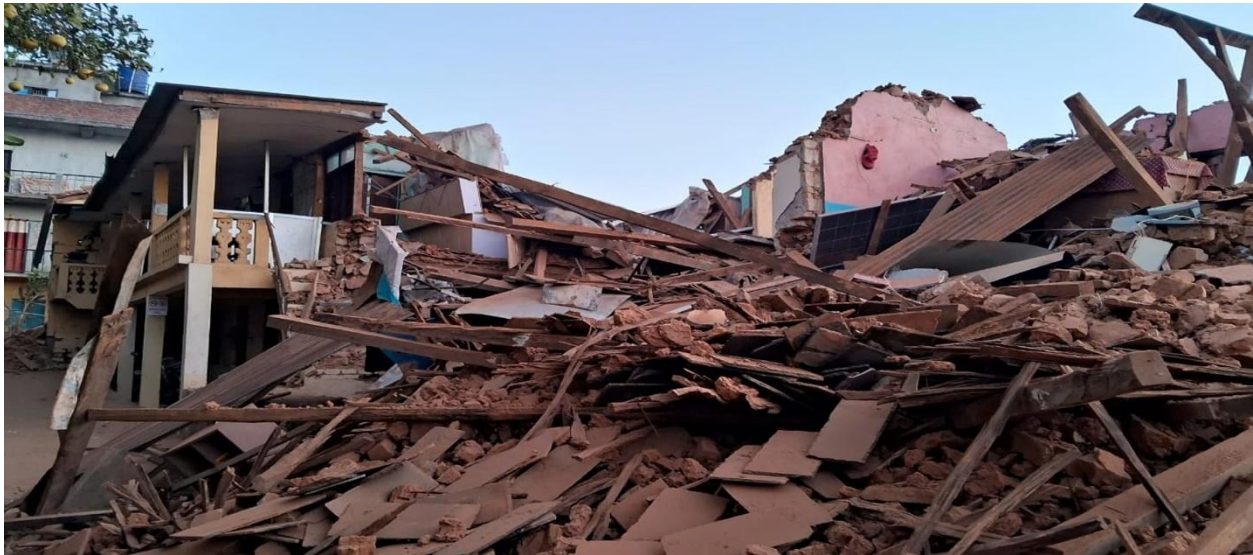
Mixed collapse as shown in fig.18, involves various structural elements exhibiting different forms of failure within the same structure. It was seen in the building due to inconsistency of mason during the construction of building, weaker connection in different places of the structure, irregular block pattern and haphazard placement of opening without proper planning can be the reason for the mix collapse in such areas.

Figure 18: Mixed Collapse

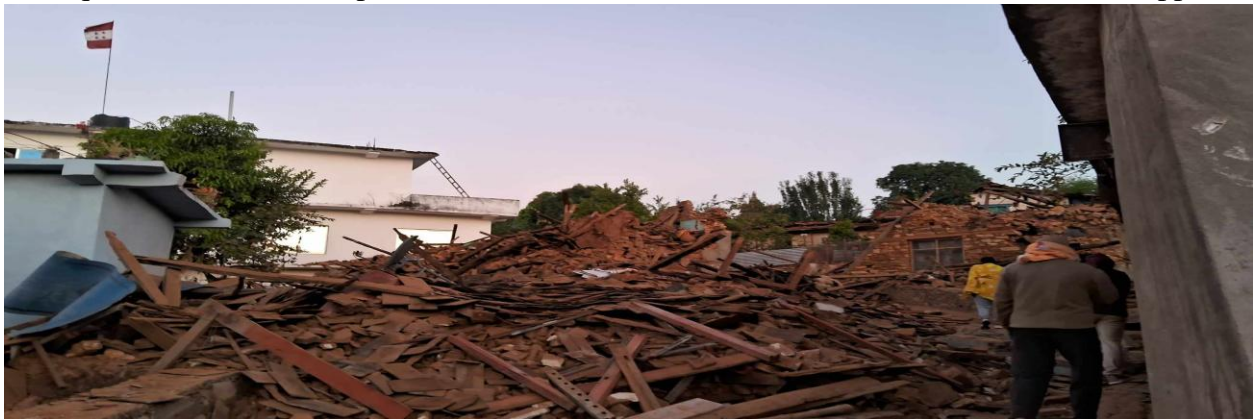
Complete collapse as shown in fig. 19, signified a catastrophic failure where the entire structure had given way, resulting in a total loss of structural integrity. This type of failure was a result of inadequate construction practices, weak materials, or insufficient structural support.

Figure 19: Complete Collapse
