Analysis of Highway Slope Failure by Using Stereographic Projection Method

Bharat Prasad Bhandari¹ and Tark Raj Joshi²

¹ Department of Civil Engineering, Thapathali Engineering College, Tribhuvan University, Kathmandu

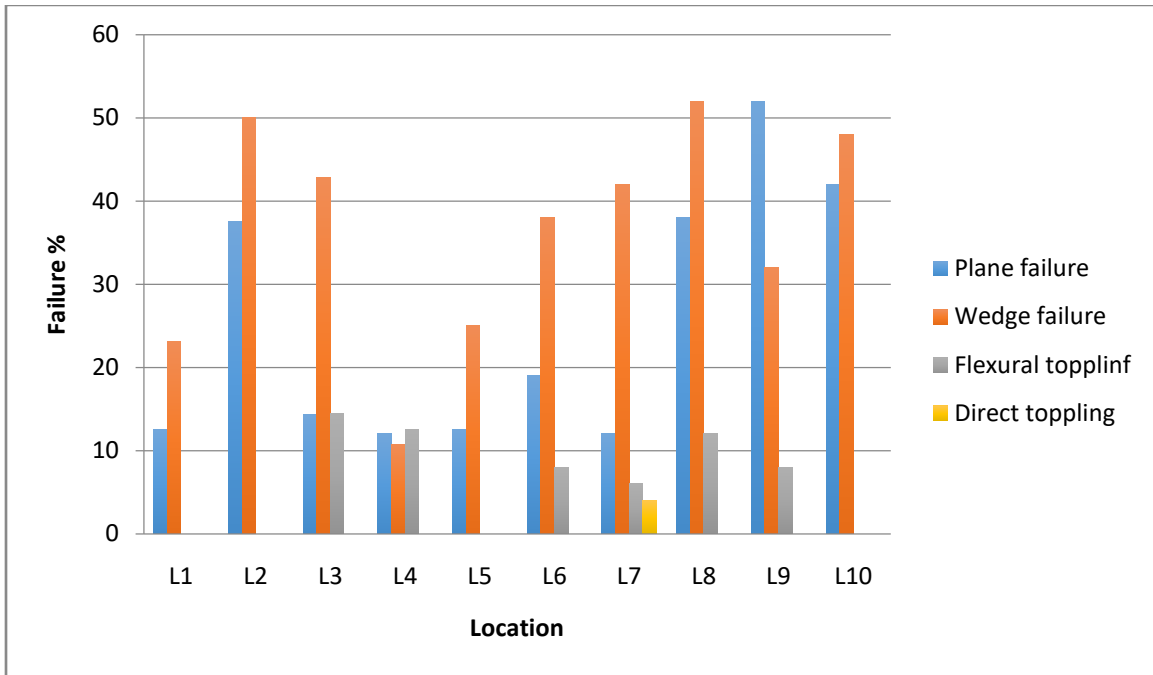
Figure 3: Different types of failure percentage in location 1 to 10.

Three different types of failure are obtained namely plane failure, wedge failure and toppling failure. We observed 100% plane failure and wedge failure in location 14 and 39 respectively. The percentage of each type of failure in each location is given in figure 3, 4, 5 and 6. Mostly, the probable wedge failure is found potential at the study area. Among the 40 locations, 23 locations have wedge failure possibility greater than 30% and in 17 locations, possibility of plane failure is greater than 30% (Fig.7). The major joints present in the bed rocks are, bedding joints, oblique joints and dip joints. The major cause of wedge failure in the study area is found dip and oblique joints present on bed rock.

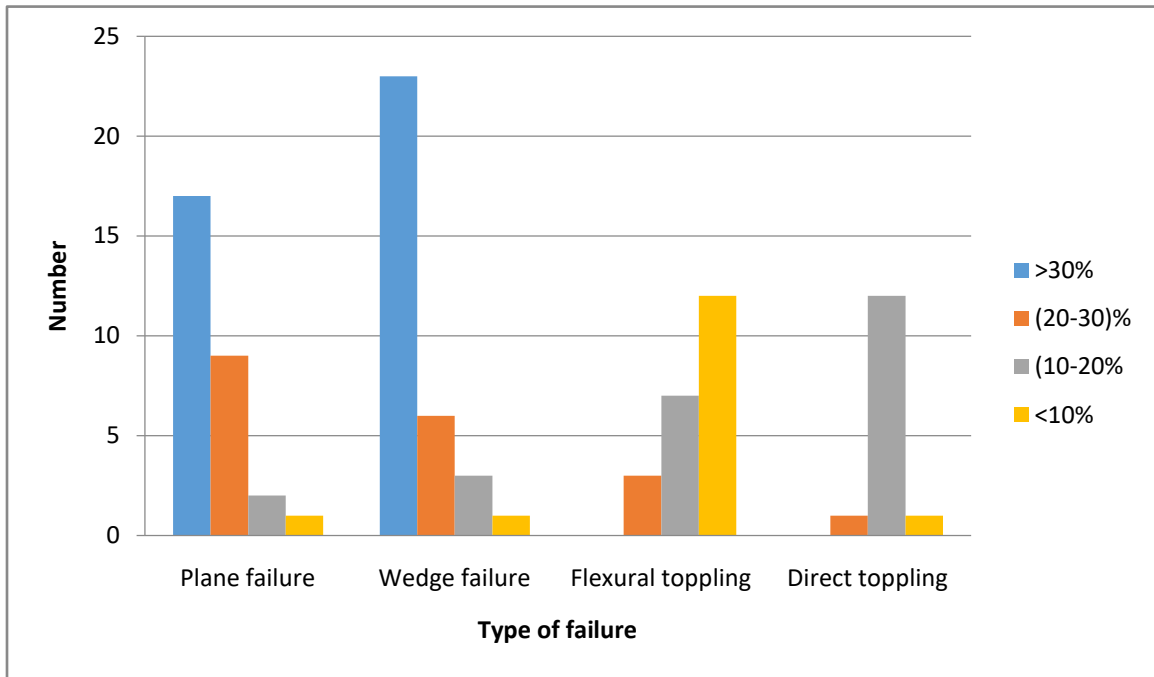
Figure 7: Failure percentage in different locations

The result shows that toppling failure is rare in the study area (Fig. 7). Most of the failure are either plane or wedge failure. The plane failure is controlled by hill slope and rock orientation. The hill slope is steep and the dip direction of hill slope and bed rock is within 20° . So, the plane failure is probable in this area. The pole concentration of joints indicates that the area is potential for wedge and plane failure (Fig.8).

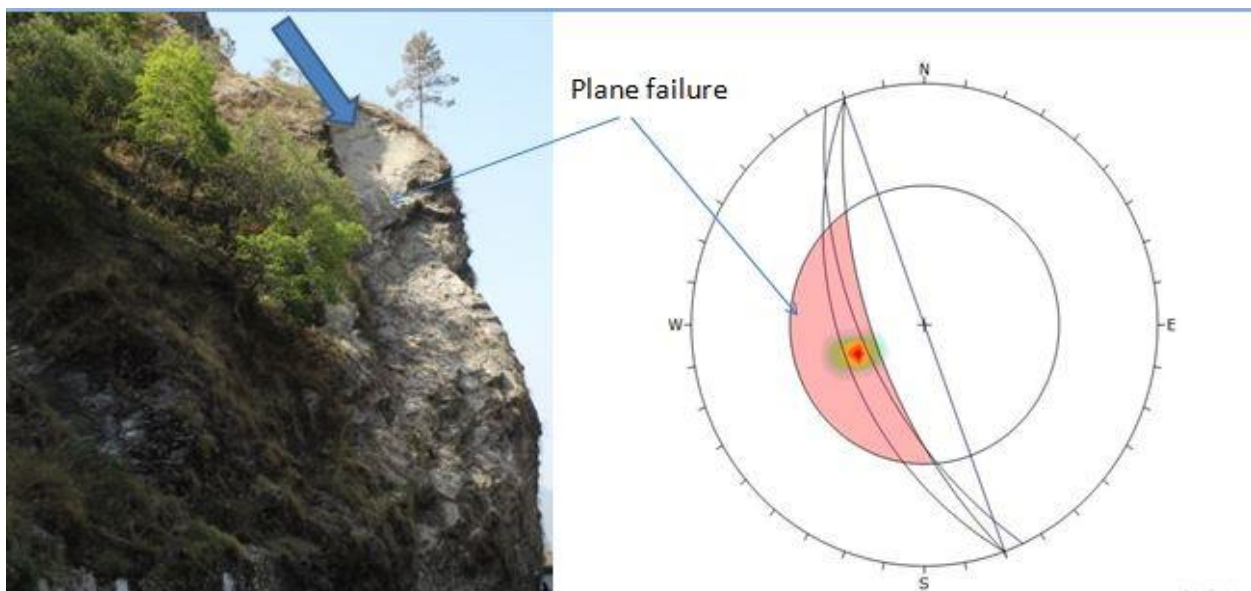
Figure 9: Typical plain failure of the study area

Figure 9 & 10 shows the typical plane and wedge failure of study area. In figure 9, the dip direction of hill and bed rock is in same direction. The rock type is sandstone. The hill slope is greater than 55° but the dip amount of bedding is less than 45° . In lower hemispheric projection of figure 9, the joint has deliighted the hill slope. Similarly, in figure 10, stereographic projection shows that the intersecting point between two joints lies between hill slope and friction angle.
