Bank erosion process and bank material loss potential in Manahara River, Kathmandu, Nepal

*Pramila Shrestha and Naresh Kazi Tamrakar

Central Department of Geology, Tribhuvan University, Kirtipur, Kathmandu, Nepal

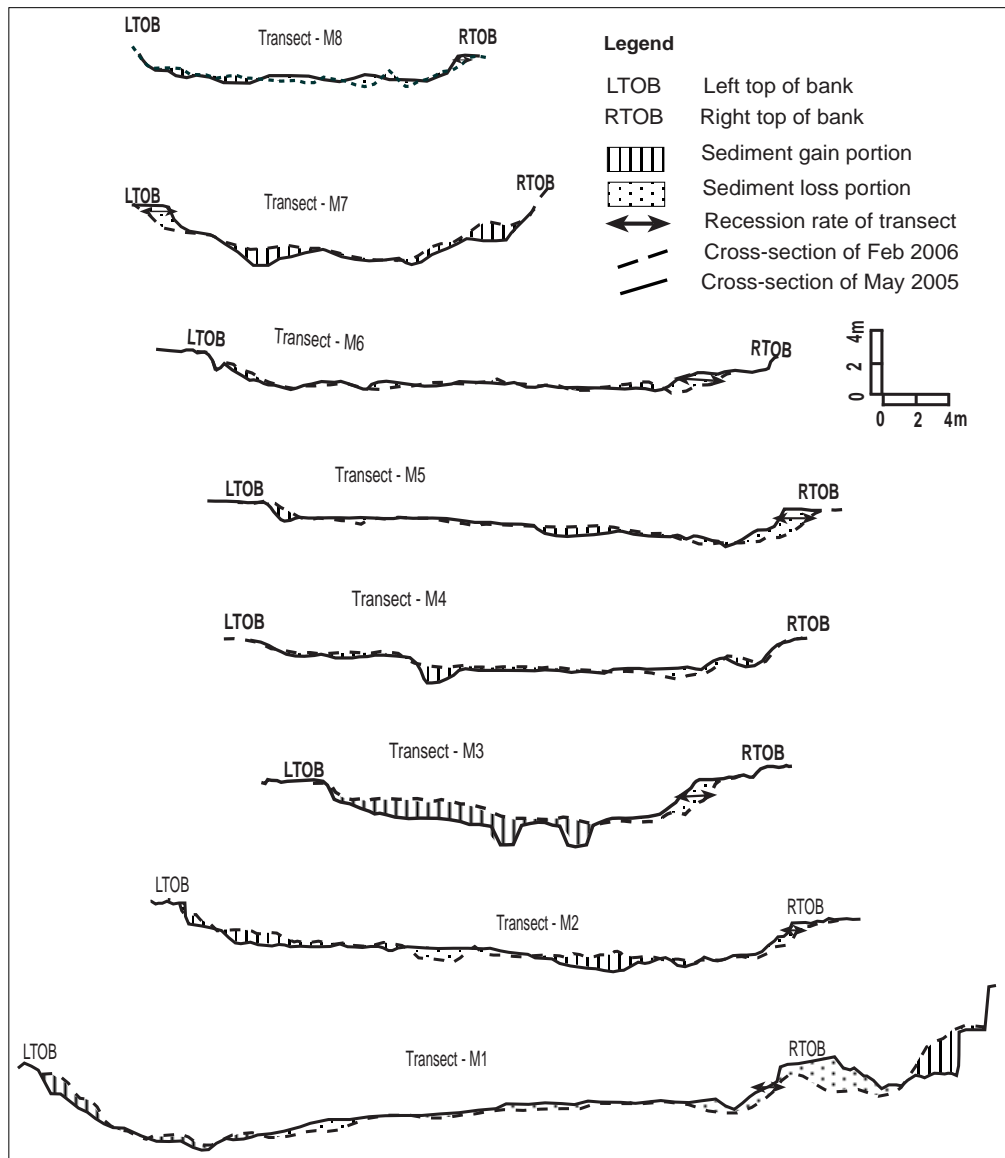
Fig. 4 Cross-sections of the Manahara River recorded in May 2005 and Feb 2006

The results of profile survey are shown in Table 2. In totality, Sankhu, Mulpani and Sano Thimi segments gain cross-sections while Kurthali segment loses it. But considering the streambanks only, M4 (Mulpani segment) and M6 (Kurthali segment) indicate greater proportion of bank material loss out of total cross-section. Therefore, in both Kurthali and Mulpani segments, bank loss potential seems to be higher compared to other segments.

Regarding average width of bank loss per year, the transect M6 (Kurthali segment) had the highest width of bank loss (2.2 m/yr) and transect M4 (Mulpani segment) had the lowest width of bank loss (0.4 m/yr). But, according to field observation bank

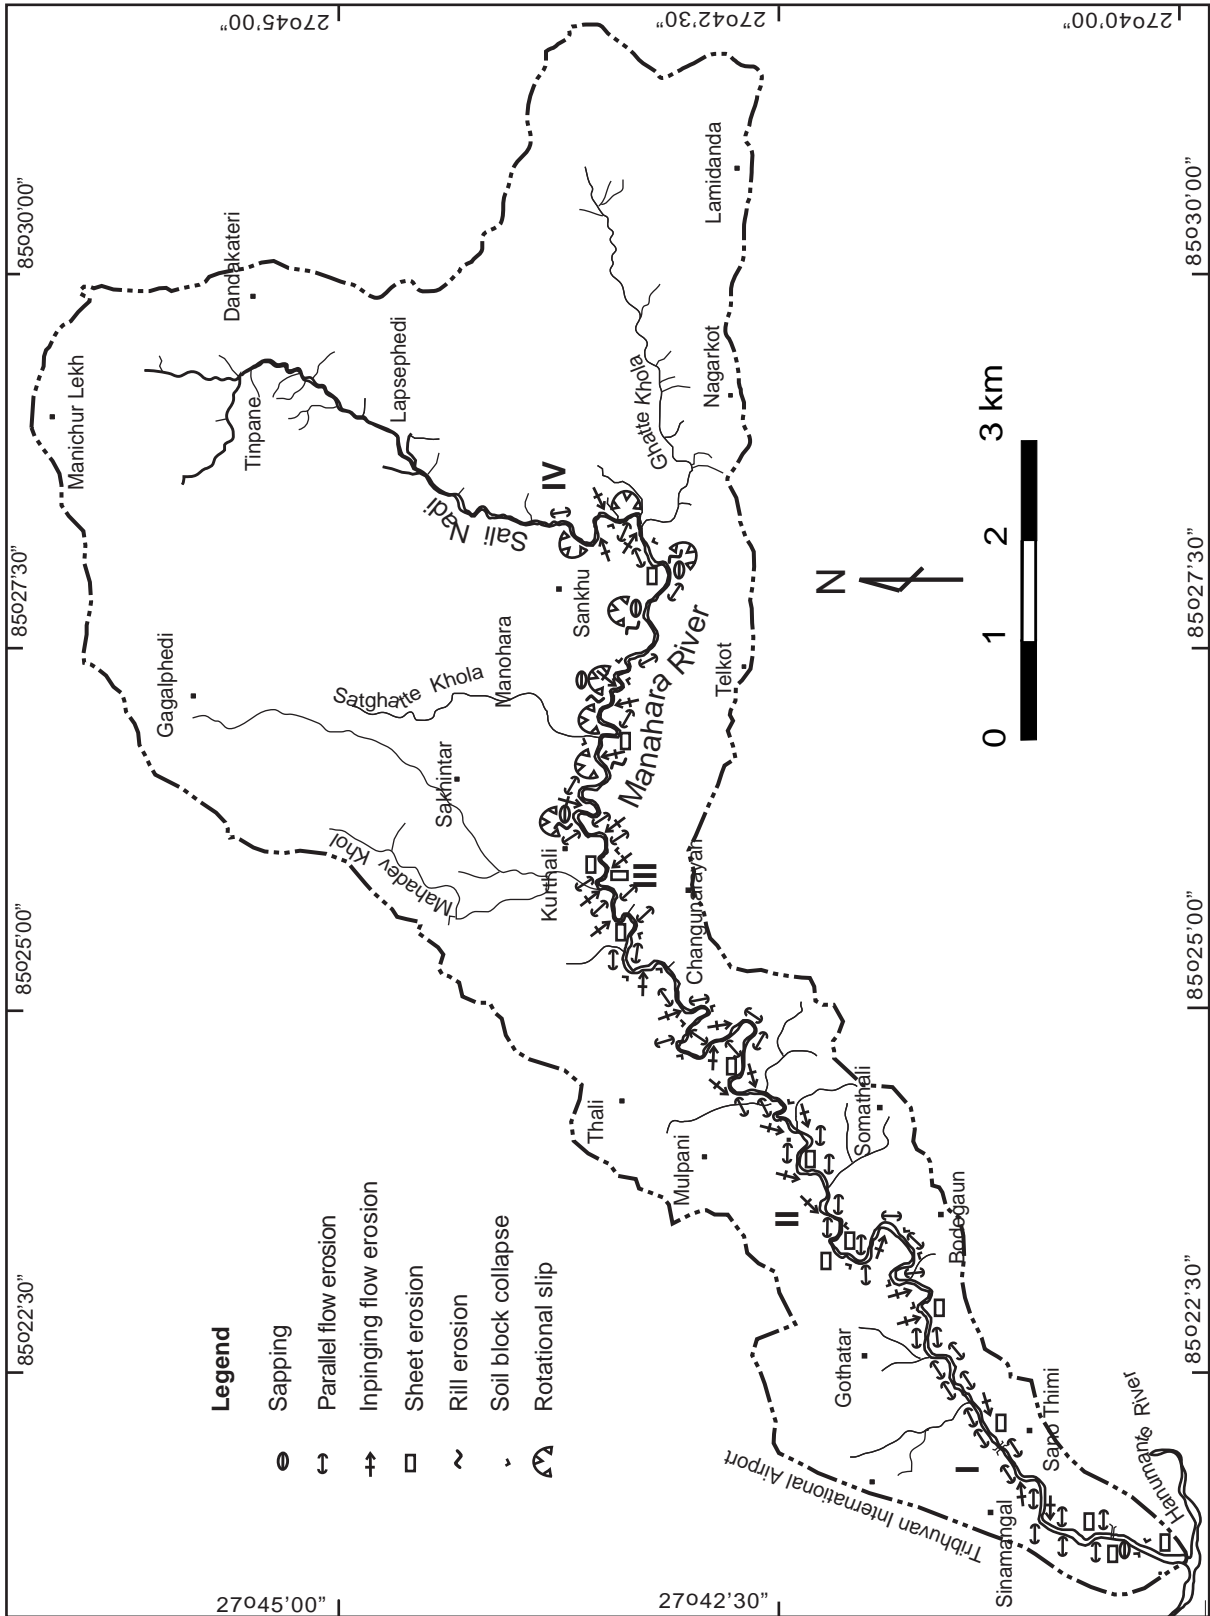
The bank erosion and failure processes, which were recognized in MRB, can be categorized as sub-aerial erosion, scour (mainly sub-aqueous), and mass failure. The distribution of various types of erosional processes is shown in Fig. 5.

Fig. 5 Distribution of various types of erosional processes along the Manahara River; I = Sano Thimi segment, II = Mulpani segment, III = Kurthali segment and IV = Sankhu segment

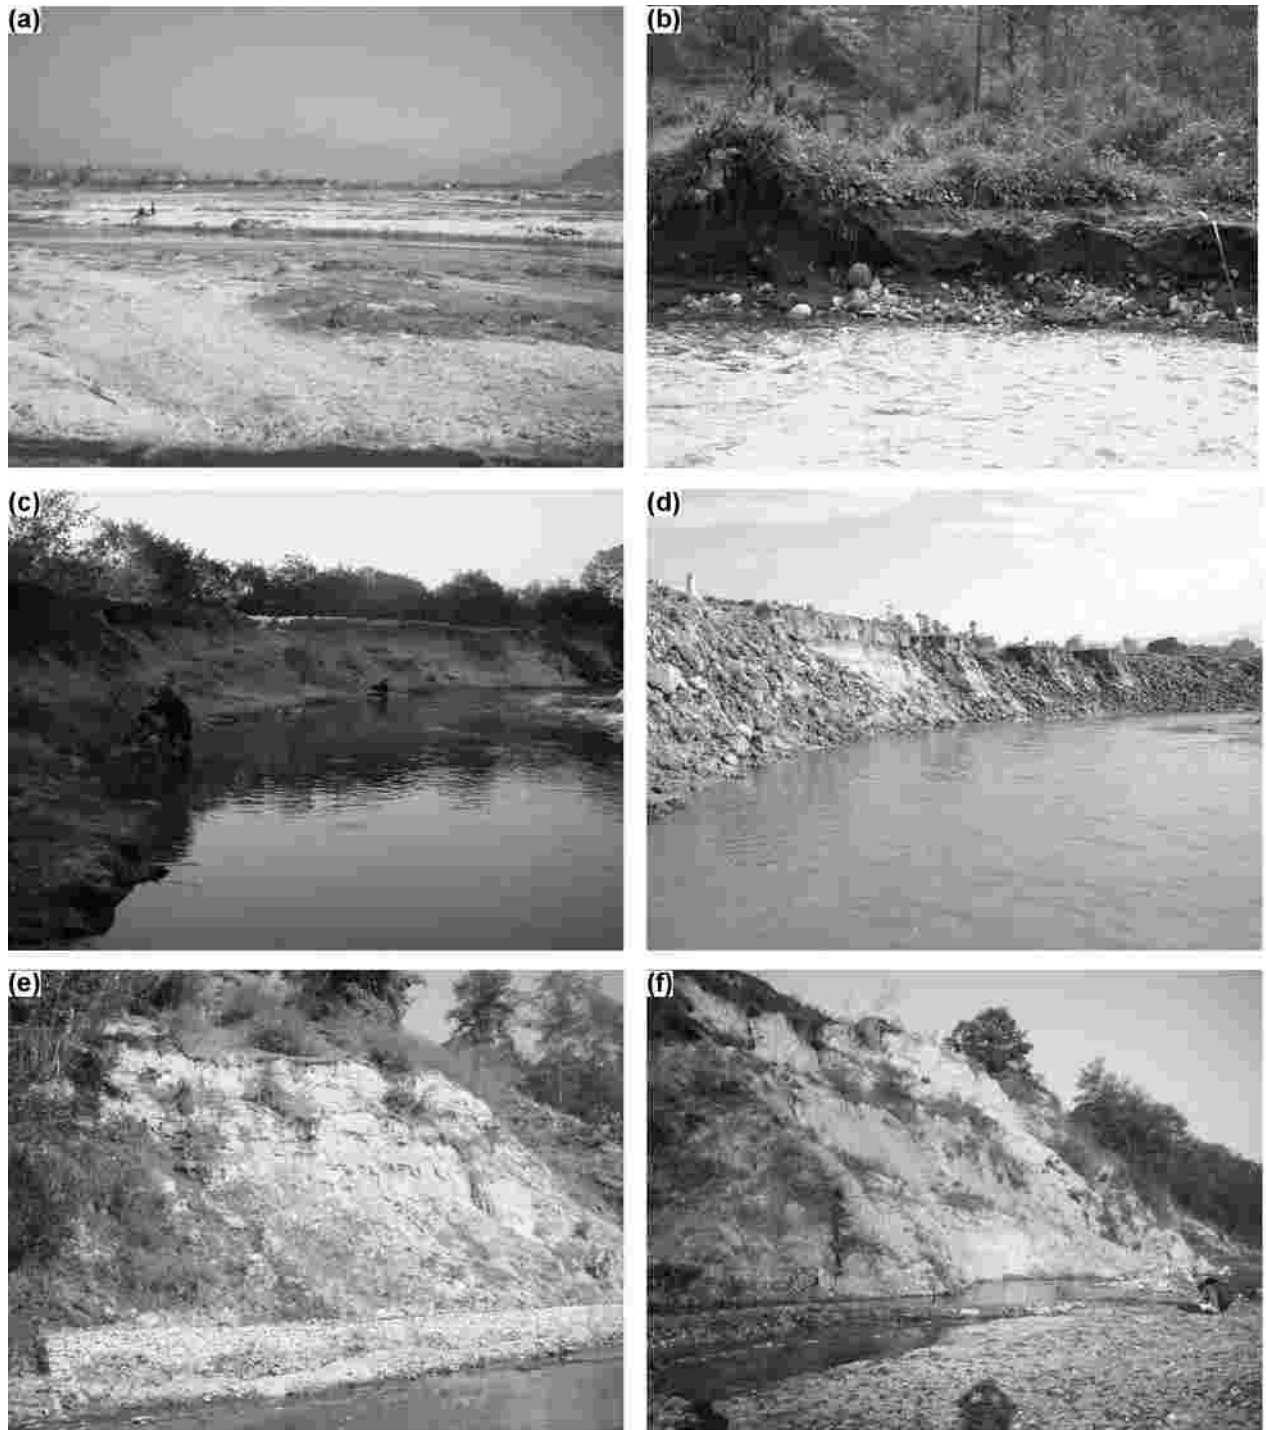
Scour is a direct removal of bank material by the mechanical action of flowing water and sediment mixture. Scour of riverbed and bank is common in the Manahara River and it occurs due to impinging flow erosion and parallel flow erosion. Impinging flow erosion is detachment and removal of grains by the flow attacking a bank at a steep angle. Evidences of impinging flow are documented at about entire length of the river from upstream to downstream. At upstream stretches such phenomenon occurs mainly due to deflection caused by large debris in channel and turbulence generated down the step. At downstream stretches, between Sankhu and Jadibuti areas impinging flow occurs where tight meander bends occurs (Fig. 6b). Parallel flow is another scour phenomenon in which flow parallel to bank face takes away bank material. Such occurs when flow velocity is high. Parallel flow erosion (Fig. 6c) also occurs from upstream to downstream stretches.

Fig. 6 Photographs: (a) Floodplain prone to sheet erosion near Bodegaun, (b) Bank scouring by impinging flow erosion at the left bank of the Sali Nadi near Sankhu, (c) Bank scouring due to parallel flow erosion near Chapro (upstream view), (d) Slumping of streambank near Bodegaun (downstream view), (e) Slumping present at the left bank of the river downstream from Kurthali, and (f) Large-scale slumping at the left bank of the Manahara River at Salambutar

Bank scouring is observed through out the river corridor and bed scouring is basically concentrated in upstream stretches between Dandakateri and Sankhu areas where river has high gradient and flows over bedrock, where stream is in youth-full stage and has tendency of headward erosion. Headward erosion is potential for bank erosion at Mulpani and Sano Thimi areas where mining of the riverbed has been continuing for many years.

In the Manahara River, bank scouring contributes slumping, which is accelerated throughout the river corridor. In most of the segments, a small-scale slumping, due to toe undercutting by river flow is present (Fig. 6d). But at some locations as in Kurthali and Sankhu areas, a large-scale slumping is present. Most of these landslides are observed in terraces of the fluvio-lacustrine sediments existed as the banks of the river (Fig. 6e). These landslides are triggered by groundwater seepage present at the contact of black clay layer and coarse-grained sand. The slumping observed near Salambutar is about 50 m high and >100 m long (Fig. 6f). Other large-scale slumpings are observed near Kurthali at the base of the Telkot Hills, at the confluence between the Sali Nadi and the Ghatte Khola at Sankhu.

Slope of eroding bank is very steep. At most of the areas very steep scarps and undercutting banks are present (Fig. 6c), which are thickly distributed along the Manahara River indicating high susceptibility of bank erosion. Bank erosion risk rating of studied sites falls on 0.6 to 1 rating.

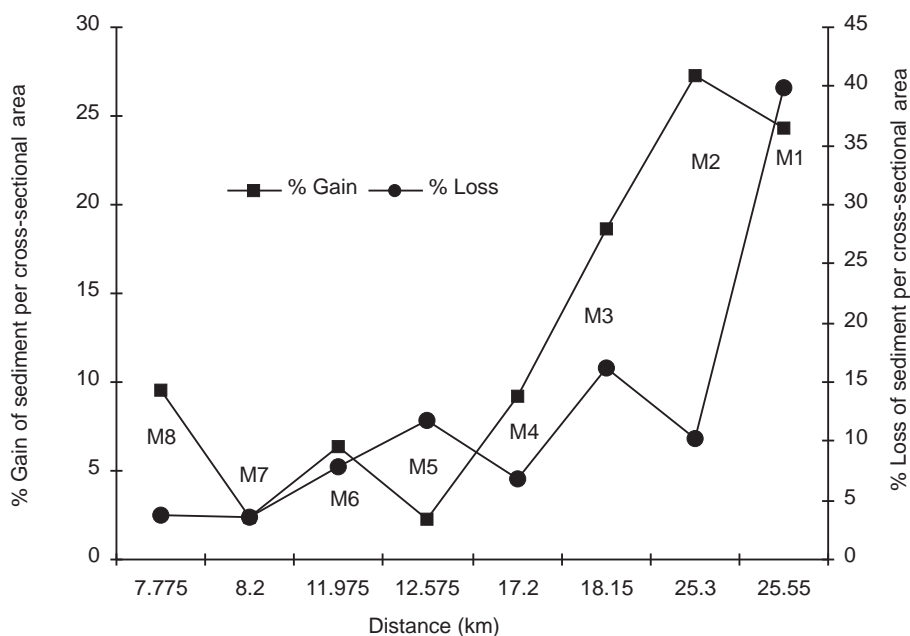
Fig. 7 Amount of sediment loss and gain from different transects of the Manahara River

Also percent of loss of sediment per cross-sectional area correlates positively with downstream distance. With increase in distance from origin, percent gain and percent loss of sediment from transects also increase (Fig. 7). The percent gain in downstream portion exceeds percent loss, therefore the river is aggrading therein. On the other hand there is no correlation between distance and bank material loss. This indicates that probability of bank material loss depends on local factors other than the distance of origin of the river.

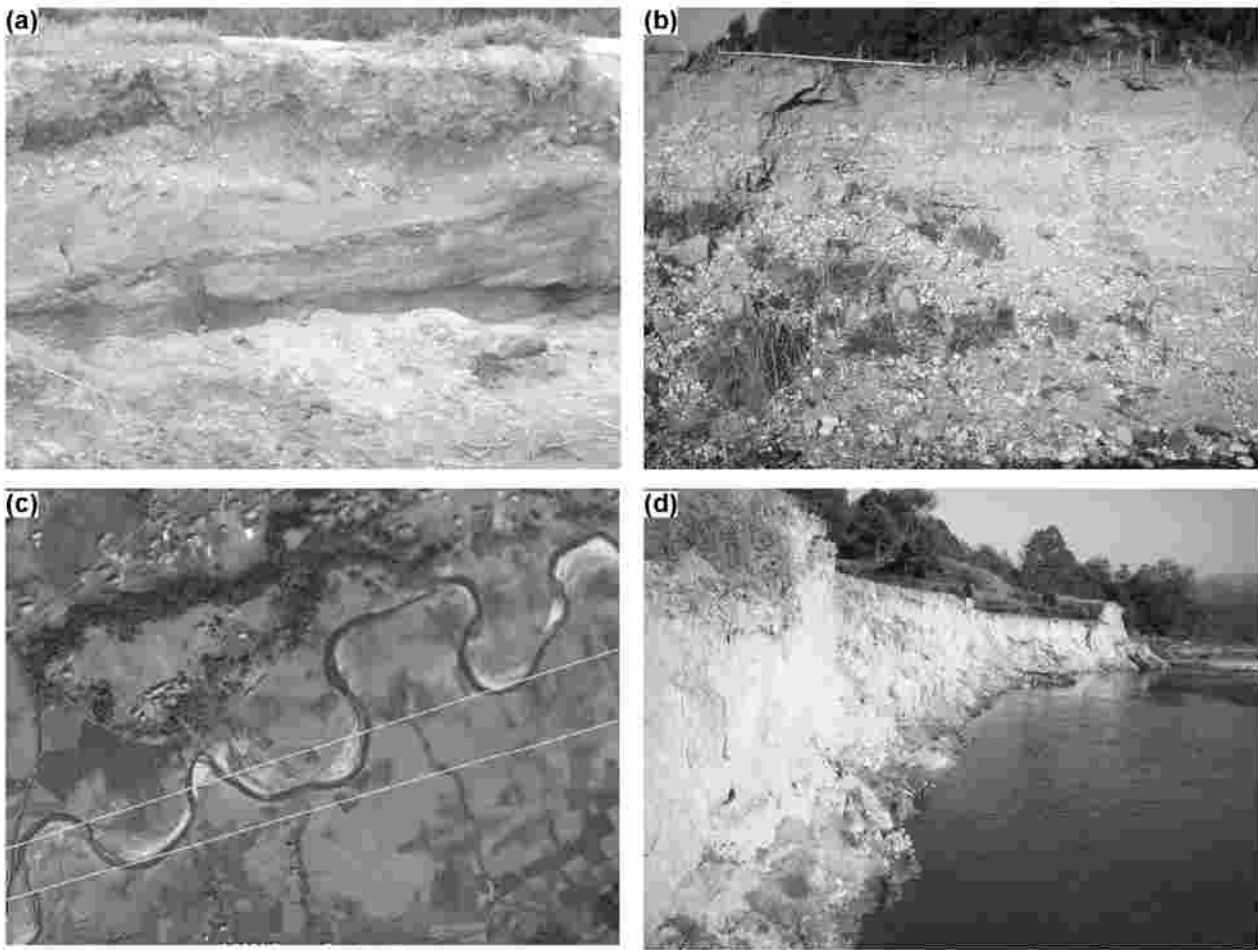
Almost all of the banks of the Manahara River are composed of non cohesive silt, sand, gravel and cobbles (Figs. 8a & b), except at the locations where river flows through bed rock and black clay. The bank material texture of all studied sites falls on rating 1, indicating high susceptibility for erosion (Table 3).

alignment with least potential of bank erosion. But, when it starts to flow over loose and unconsolidated substrate it becomes a meandering river forming several meander bends. So, bank erosion is mostly confined in this stretch (Fig. 8b). Therefore stream alignment is one of the criteria for assessing bank material loss potential. Ratings of stream alignment fall on 0.6 to 1.

Fig. 8 Photographs showing nature of bank material in the Manahara River: (a) Non-cohesive bank material present in the right bank near Bodegaun, (b) Non-cohesive bank material present at the right bank near Kurthali, (c) Alignment of the river around Salambutar area showing sharply meandering bends, and (d) Eroding bank present at the right bank of the river near Salambutar showing rapid rate of erosion (upstream view)

of erosion. An additional indicator is the presence or absence of vegetation on the depositional bar. A lack of vegetation signifies a rapid erosional rate. Point bars of twenty four sites have very gentle slope (10-15 degrees) and absence of vegetation indicating rapid rate of erosion (Fig. 8 d). The bank erosion risk ratings of all studied sites fall on rating 1, indicating rapid rate of erosion.
