## STRUCTURAL FAILURE ANALYSIS OF EARTHQUAKE AFFECTED BUILDINGS IN GORKHA (NEPAL) EARTHQUAKE 2015 IN KATHMANDU VALLEY

### Abstract

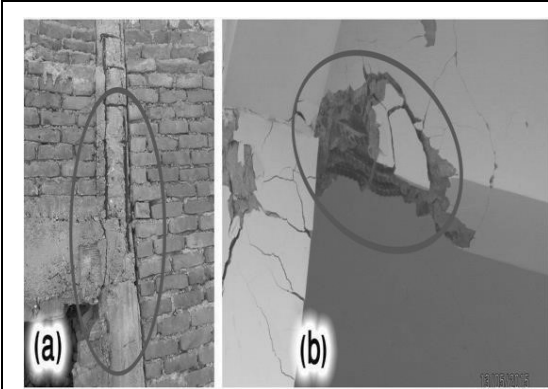
Fig. 13: Beam failure: (a) shear failure; and (b) flexural failure.

Failure mode Types of Damages		Causes	Fig. no.
Beam failure Shear failure	Cracks developed at 45° angle normally), spallation of concrete at the middle or near the joints	<ul style="list-style-type: none"> <li>• Stirrups provided in the Beams are not sufficient (spacing of rebar 175 mm to 300 mm)</li> <li>• Rebar size that is used is of minimum diameter (5 mm to 7 mm)</li> </ul>	13a
Flexural failure	Crumble of concrete yielding of rebar, horizontal cracks near the joints	<ul style="list-style-type: none"> <li>• Hoop provided is 90° with minimum hoop length (20 mm to 50 mm)</li> <li>• Stirrups are not placed correctly</li> </ul>	13b
Beam–column	Joints failure	<ul style="list-style-type: none"> <li>• Main rebar provided in the beam are not sufficient (using four bars of diameter ranging from 10 mm to 12 mm)</li> <li>• Overlapping length is minimum (usually 150 mm to 300 mm)</li> <li>• Overlapping location is also not appropriate (major problem)</li> <li>• Confinement reinforcement are not provided</li> <li>• Size of the beam is 230 mm by 230 mm (including slab thickness)</li> </ul>

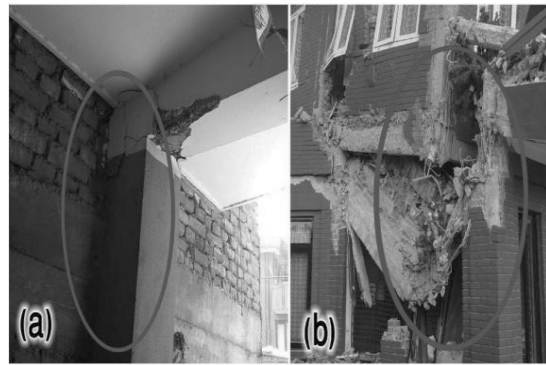
Fig. 14: Beam–column joint failure: (a) shear failure; and (b) brittle failure.

Shear failure	Cracks develop at the beam–column joint, crumble of concrete at the joints	<ul style="list-style-type: none"> <li>• Lack of use of confinement rebar near the joints</li> <li>• Lack of use of confinement rebar inside the beam–column junction</li> <li>• Use of poor quality concrete</li> </ul>	14a
Brittle failure	Separation of beam from column, crumble of concrete	<ul style="list-style-type: none"> <li>• Adequate anchorage length of the beam is not provided (major problem)</li> <li>• Main bar provided in the beam and column is not sufficient</li> <li>• Extra bar that need to provide in the beam column joints are omitted</li> </ul>	14b
Shear failure	Diagonal cracks of the column near joints and at the middle of the column, crushing of the column majorly near the joints	<ul style="list-style-type: none"> <li>• Stirrups provided in the column are not sufficient (Single hoop).</li> <li>• Rebar size that is used is of minimum diameter (usually 5 mm to 7 mm)</li> <li>• Hoop provided is 90° with minimum length (20 mm to 50 mm)</li> </ul>	15a

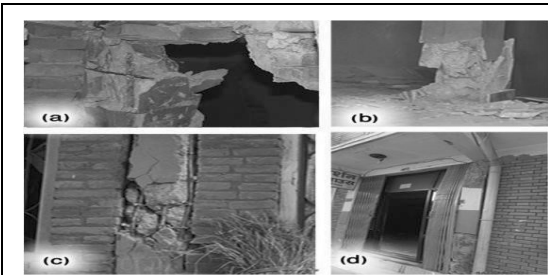
Fig. 15: Column failure: (a) shear failure; (b) flexural failure; (c) brittle failure; and (d) Buckling failure.

Flexural failure	Crumble of concrete, yielding of rebar, racks near the joints, formation of hinge (ultimate condition)	<ul style="list-style-type: none"> <li>• Main rebar provided in the column are not sufficient (normally four bars of diameter ranging from 10 mm to 12 mm).</li> <li>• Overlapping length is minimum (usually 150 mm to 300 mm)</li> <li>• Overlapping location is also not appropriate (major problem)</li> <li>• Confinement reinforcement are not provided</li> <li>• Size of the column is 230 mm by 230 mm majorly</li> <li>• Orientation of the column is not appropriate</li> </ul>	15b
Brittle failure	Separation of beam from column	<ul style="list-style-type: none"> <li>• Adequate anchorage length of the column is not provided (major problem)</li> <li>• Main bar provided in the beam and column is not sufficient</li> <li>• Extra bar that need to provide in the beam column joints are omitted</li> </ul>	15c

Buckling failure	Buckling of column, spalling of the concrete, bending of the rebar	<ul style="list-style-type: none"> <li>• Due to slenderness of the column</li> <li>• Axial loads transfer to column is in the critical state</li> </ul>	15d
Flexural failure of slabs	Cracks in concrete, sagging of the slab, delaminating of concrete covers	<ul style="list-style-type: none"> <li>• Main rebar is not sufficiently layout</li> <li>• Meshing of the rebar is same for any kind of slab size</li> <li>• Thickness varies (100 mm to 175 mm)</li> <li>• Lack of proper detailing of the slab rebar</li> <li>• Poor concrete quality</li> </ul>	16

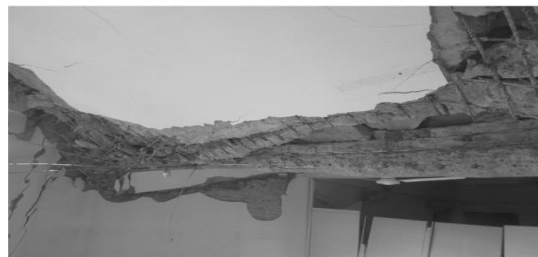
Fig. 16: Flexural failure of slab.

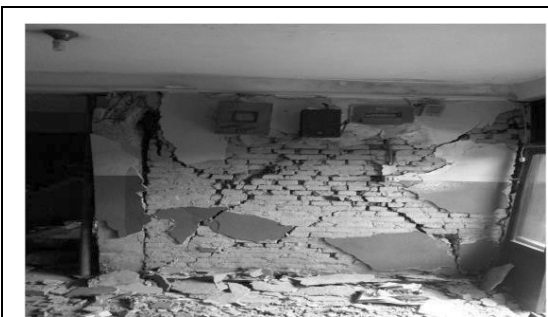
Fig. 17: Diagonal shear failure of infill wall.

Failure mode	Types of damages	Causes	Fig. no.
Infill wall	Out of plan damage, crushing of wall diagonally or at toe and heel, shearing of bed joints, separation between the wall and the frame	<ul style="list-style-type: none"> <li>• Lack of sill band and lintel band</li> <li>• Diagonal strut action</li> <li>• Due to strong infill surrounded by a strong frame</li> <li>• Weak joints and strong members</li> <li>• Strong infill and strong frame but vibrate differently</li> </ul>	17
Water tank failure	Bare framed supporting polythene tank collapsed, formation of plastic hinges in the upper and lower edges of column	<ul style="list-style-type: none"> <li>• Large inertia forces due to water tank mass</li> </ul>	18
Staircase	Damage at the junction of the landing and the flight, sagging or drop down of the landing, total collapse	<ul style="list-style-type: none"> <li>• Rebar detailing problems</li> <li>• Minimum use of main bar (8 mm to 10 mm)</li> <li>• Short column effect</li> <li>• Deck thickness varies from 75 to 125 mm</li> </ul>	19

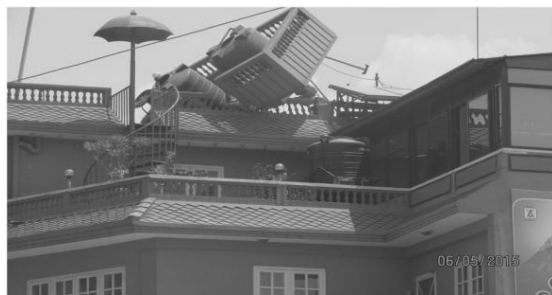
Fig. 18: Water tank collapse.

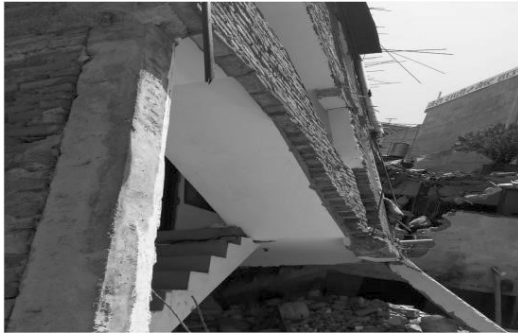
Fig. 19: Staircase failure.

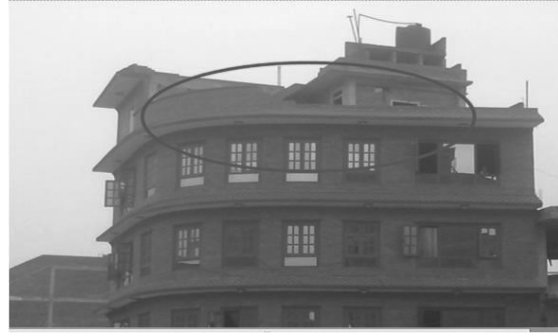
Fig. 20: Parapet failure.

Parapet failure	Partial and totally collapsed	<ul style="list-style-type: none"> <li>• No anchorage is provided</li> <li>• Built as secondary element with no proper design</li> </ul>	20
Poor quality of materials	Cop-outs and spalling of concrete, material deteriorates effortlessly, breakage of corroded rods, loss in capacity of rods, corrosion can to spread to other parts, possibility of vanish of rods due to corrosion	<ul style="list-style-type: none"> <li>• Pilling out/cop out the cover of the concrete in structural components</li> <li>• Breakage of the rod due to size reduction of rebar due to corrosion</li> </ul>	21

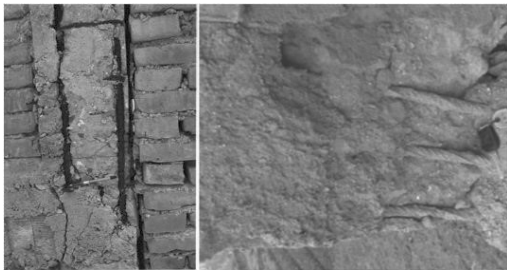
Fig.21: Poor quality of construction materials.

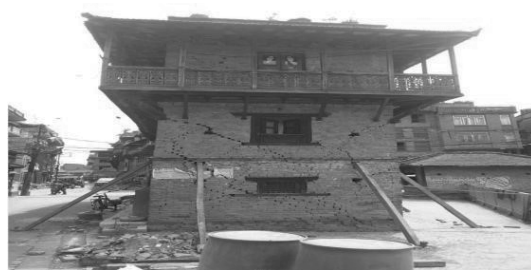
Fig.22: Shear failure of building.

Failure mode	Types of damage	Causes	Fig. no.
Shear failure	Diagonal cracks at corner of openings and at center of wall segment	<ul style="list-style-type: none"> <li>• Stress concentration at corners of windows and doors</li> <li>• Absent of sill and lintel band</li> </ul>	22
Tension failure	Vertical cracks at the center, ends or corners of the walls	<ul style="list-style-type: none"> <li>• Walls too high and too narrow</li> <li>• Openings too close to corners</li> </ul>	23
Out-of-plane failure	End masonry walls failure, bulging of masonry wall, delamination of wall leaf	<ul style="list-style-type: none"> <li>• Lack of structural integrity</li> <li>• Deficient bond at corners continuous vertical joints (wall to wall connection)</li> <li>• Flexible floor diaphragm</li> <li>• Trusting nature of sloping roof</li> <li>• Ineffective or lacking passing-through connections in multileaf masonry assemblages</li> </ul>	24

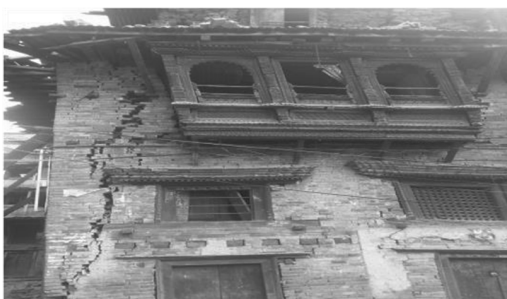
Fig.23: Tension failure of building.

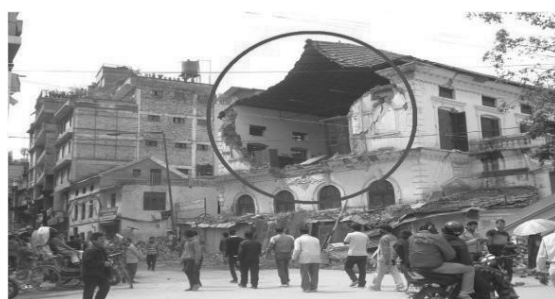
Fig. 24: Out-of-plane failure of building.

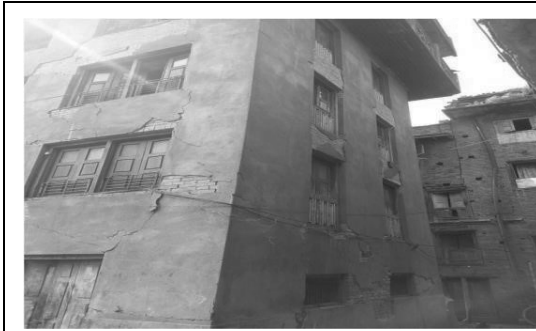
Fig. 25: Spandrel failure of building.

Spandrel failures	Cracks between two openings one above the other	<ul style="list-style-type: none"> <li>• Flexible floor diaphragm</li> <li>• Absent of sill and lintel band</li> </ul>	25
Pounding	Cracks at the floor level, sway of buildings	<ul style="list-style-type: none"> <li>• Lack of space between two buildings</li> </ul>	26
Torsion and warping Failure	Larger damage occurs near the corner of the building, excessive cracking due to shear in all walls	<ul style="list-style-type: none"> <li>• Unsymmetrical in plan and elevation of building</li> <li>• Imbalance in the sizes and positions of openings in the walls</li> </ul>	27
Mixed mode failure	Partial collapse or total collapse	<ul style="list-style-type: none"> <li>• Accumulation of in plane out of plane and corner effects</li> <li>• Corner buildings in row housing</li> </ul>	28
Roof failure	Dislodging of roofing material, separation of roof truss from supports	<ul style="list-style-type: none"> <li>• Improperly tied roofing material</li> <li>• Lack of tie rod or tie beam</li> <li>• Weak support connection</li> </ul>	29

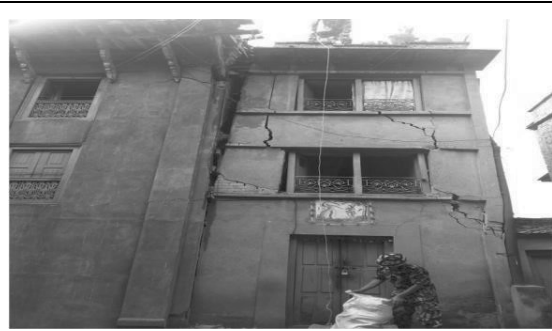
Fig. 26: Pounding effect between two buildings.

7. The trend of row housing should be discouraged and the built up area should be as per the code to prevent from pounding. As per Nepal building code, the height to breadth and length to breadth ratio should be restricted to less than 3.

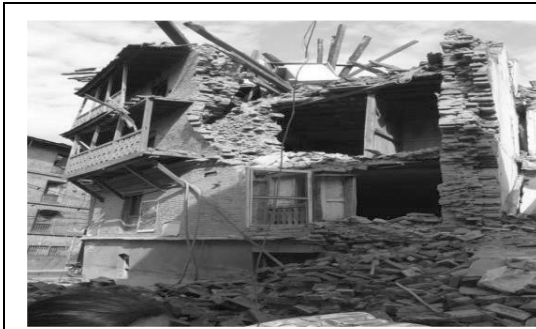
Fig. 27: Torsion failure of building.

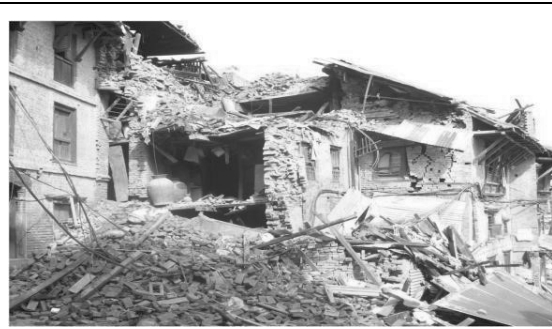
Fig. 28: Mixed failure mode of building.

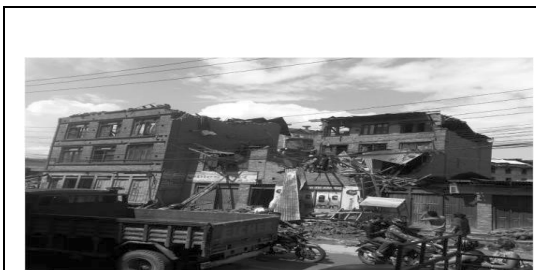
Fig. 29: Roof failure of building.

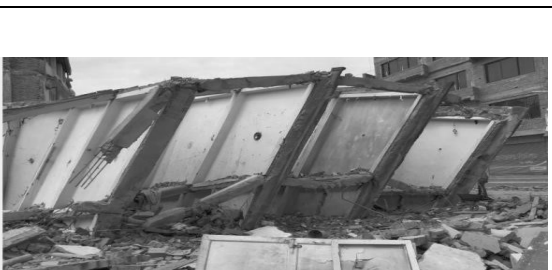
Fig. 30: Overturning of a 7 storey tall building in Kapan area, Kathmandu.

Overturning failure	Sliding of the whole building	<ul style="list-style-type: none"> <li>• Heavy roof material</li> <li>• Weak foundation design</li> </ul>	30
