# Geotechnical and Structural Aspect of 2015 Gorkha Nepal Earthquake and Lesson Learnt

**Key words:** Gorkha earthquake, field investigation, structural aspect, geotechnical aspect, local site effect

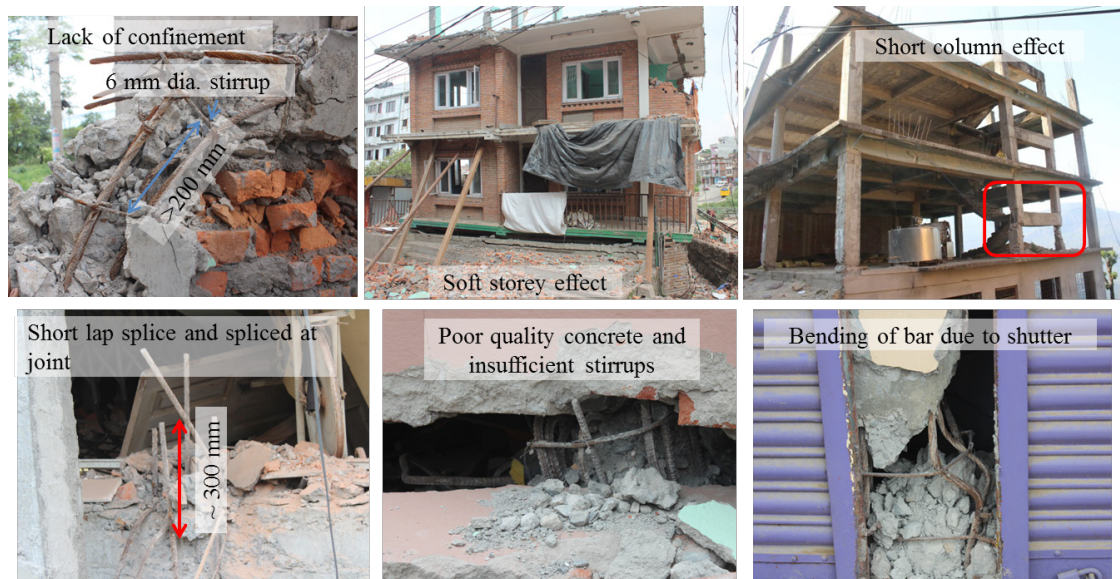
**Fig. 4: Typical failures observed in RC buildings.**

The primary mechanism of collapse was observed as shear failure caused by the absence of stirrup at or near the beam-column joint, wide spacing of the stirrups, buckling of longitudinal rebar, and the poor confinement of the core concrete. Embedded hook angle and length was not enough for stirrups to be effective. Thin column section (230mm\*230mm) was another reason of the damage. Insufficient longitudinal reinforcement (less than 1.0%) in columns and short lap splices of main bars contributed to the severe damages or collapses of buildings. Failures and damages of reinforced concrete buildings due to the soft stories were observed because of elimination of infill wall due to social or commercial needs (Fig. 4). Short column failures were widely observed during the field assessment. Short column is generally formed due to intermediate staircase landing in between two floors (Fig. 4) and partial infilled frames to fulfill functional requirement of lighting and ventilation. Many houses with rolling shutters at the ground level were severely damaged. The majority of rolling shutters were installed inappropriately, such that the adjacent RC columns were damaged; main reinforcements were exposed and welded with the shutter guide. Low quality concrete and more workmanship were manifested in the affected area and undermined the seismic performance of reinforced concrete buildings [19]. Damage and failures related to strong beam weak columns mechanism were observed (Fig. 5). In Kathmandu Valley, many buildings are constructed closely and therefore are particularly susceptible to the pounding damages. Water tank on the top of buildings are not considered in designed and suffered from severe damage (Fig. 5). Typical failures observed in RC buildings are shown in Figs. 4 and 5.

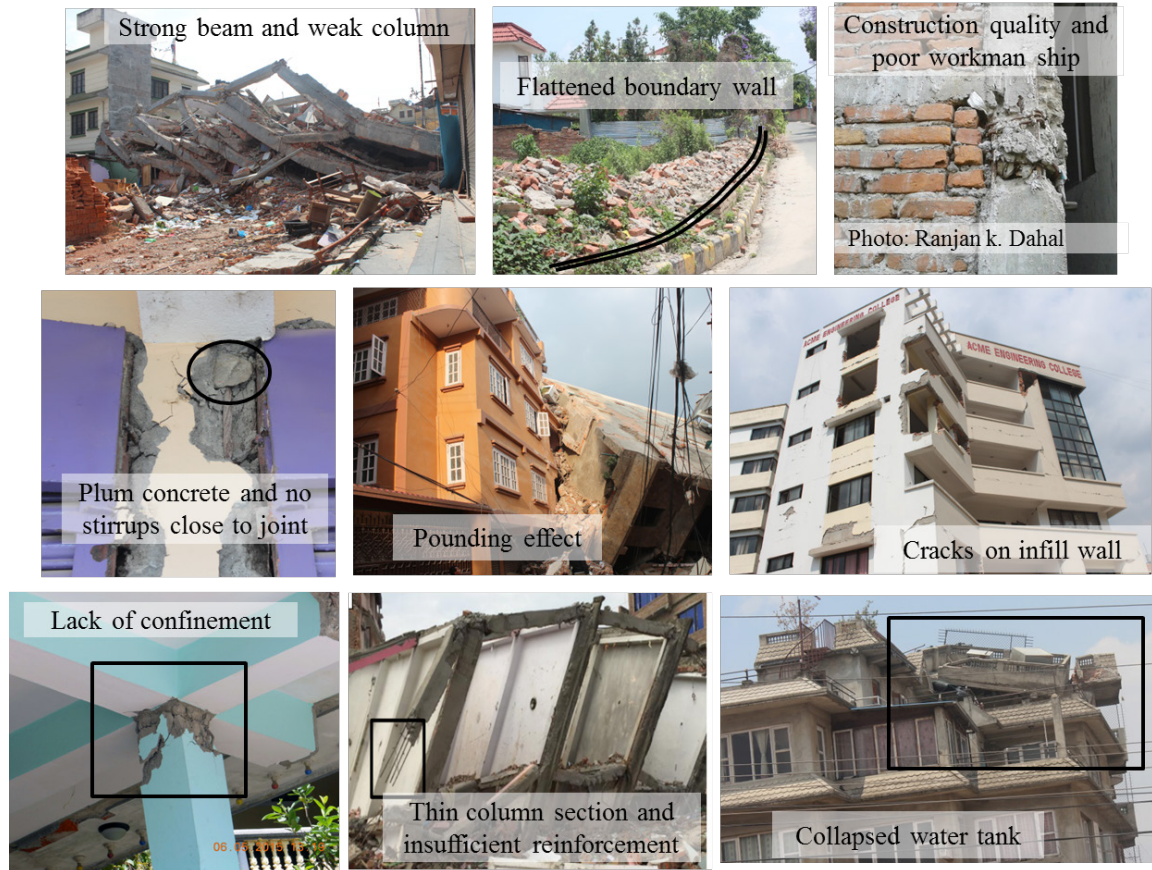
**Fig. 5: Typical failure observed in RC building during the reconnaissance.**

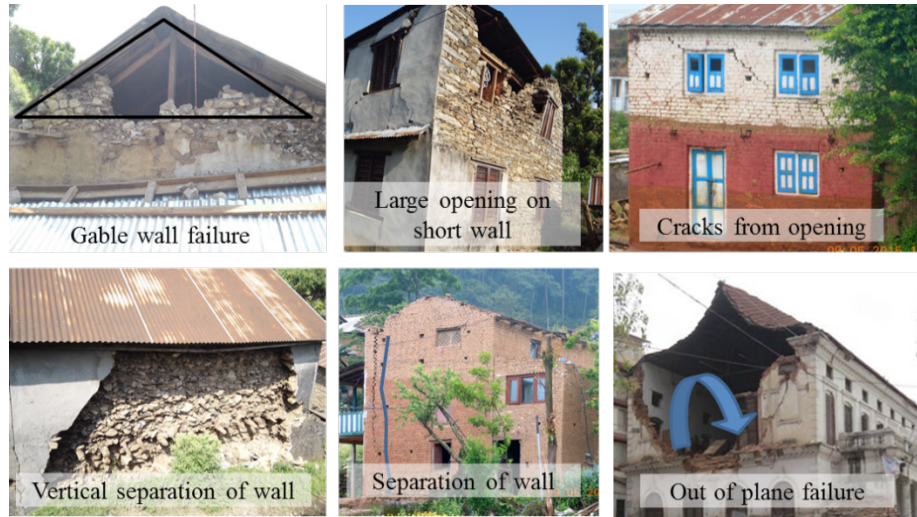
The causes of the damage of masonry buildings were observed to be poor construction detailing, poor masonry material properties, irregularly shaped stones having smooth surfaces, weak structural walls, unconfined gable walls, large openings on the wall and cracks at the corners of windows and doors. The masonry in these buildings was unreinforced and the walls were not tied to each other or to the floors and roofs. Earthquake-resistant features such as horizontal ties at various levels and stones at the corners are generally not provided in such constructions. Minimum reinforcement measures using through stones in the walls or using horizontal and vertical bands significantly improved the seismic performance of masonry buildings [19]. The typical failures observed during the reconnaissance study are shown in Fig. 6.

**Fig. 6: Typical failures observed in masonry buildings.**

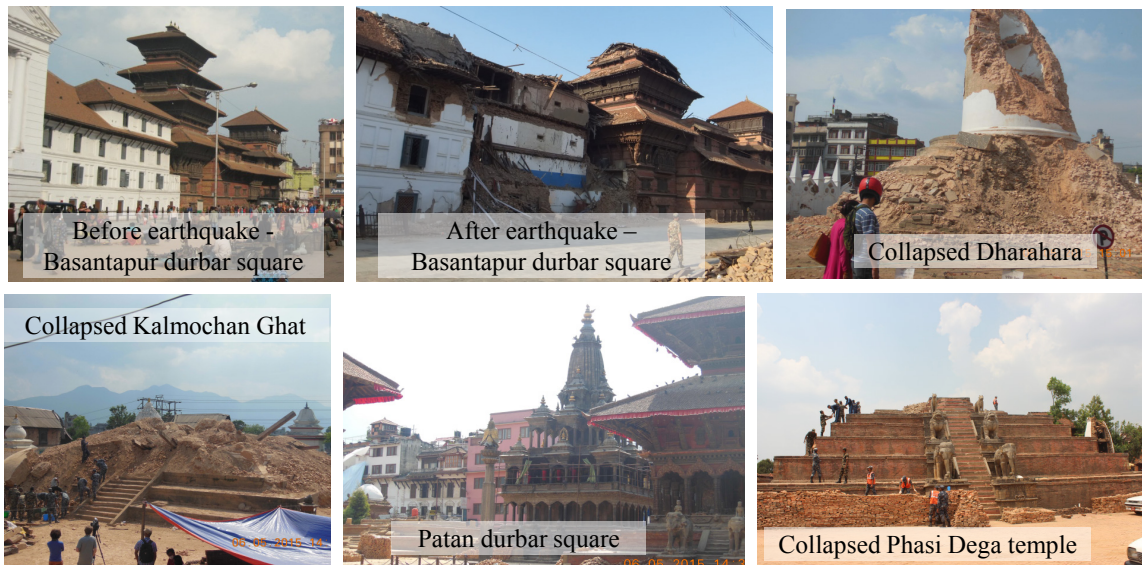
**Fig. 7: Typical failure observed in heritage structures in Kathmandu Valley.**

Many monuments and religious structures in Kathmandu Valley were destroyed by the earthquake. Temples in durbar square of Basantpur (Kathmandu), Patan, and Bhaktpur constructed several centuries ago were broken down during the earthquake (Fig. 7). Dharahara Tower, which was 9 storey high and built in 1832, was completely destroyed (Fig. 7). Most of ancient monument structures were of masonry type using bricks and earth mortar (mainly clayey mud) as a bonding-agent, with walls being capable of withstanding vertical static gravitational loads but not horizontal dynamic loads. According to the preliminary report of Department of Archaeology, the earthquake

has affected as many as seven hundred and forty-five monuments of twenty districts [7]. Out of them, one hundred and thirty-three monuments have completely collapsed, ninety-five monuments have partially collapsed and five hundred seventeen monuments are partly damaged. It is important to notice that the damage in Patan Durbar Square was observed minor compared to other historical monuments, due to the maintenance and retrofit activities completed prior to the earthquake. The retrofitting consisted of improving the structural integrity of horizontal floor and roof diaphragms by anchoring them to the supporting walls, replacing rotten wooden elements, strengthening frames, and improving the anchorages of both structural and non-structural elements [7].

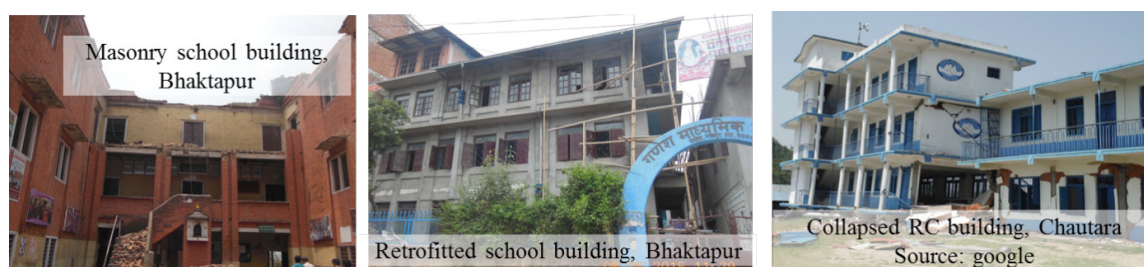
Many school buildings even in urban area built before the 1980s are unreinforced masonry buildings. Masonry buildings in Nepal were not designed and constructed in accordance with the National building code [9] Nepal. School buildings in remote area are constructed of stone, and adobe; in place of adobe have a poor clayey mud mortar. Generally, stone-masonry structures in the area are of undressed stones with mud mortar (Fig.8). In many cases, buildings designed for residential purpose are being used for school building. About 8,200 school buildings were damaged and about 16,000 schools were severely affected by this earthquake. As the earthquake occurred on a Saturday (Only weekend in Nepal), there were not severe human casualties in these buildings. A series of school buildings that were retrofitted prior to the earthquake performed very well (Fig. 8).

**Fig. 8: Performance of the school building during the earthquake**

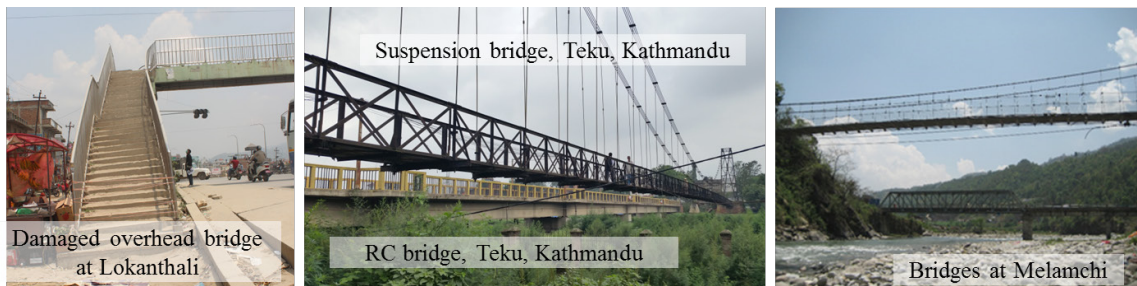
About 350 bridges out of 1,800 bridges in Nepal are located in the affected area including 30 bridges in the Kathmandu Valley [18]. It was estimated that almost half of the bridges in the valley could be impassable during the moderate earthquake, as most of the bridges are in dilapidated condition. Dixit et al. [18] emphasised potential damages on bridge in Kathmandu Valley due to liquefaction. However, no single bridge has been reported damaged due to liquefaction. Most bridges investigated during the field reconnaissance suffered from minor damages on expansion joints and decks, while several decks were slightly displaced. For example, Teku Bridge (Fig. 9) over Bagmati River built in 1950 experienced the opening of expansion joints. The bridge appears to be functional despite that a nearby RC building collapsed [18]. Some overhead bridges in Kathmandu and Bhaktapur sustained severe damage; these structures can be operable after some repairs. Bridge shown in Fig. 10 is a newly constructed bridge (3 span and 75 m length) at the distance about 3 km from epicentre of  $M_w$  7.8 earthquake, no cracks and settlement were found.

**Fig. 9: Typical bridges investigated during the reconnaissance**

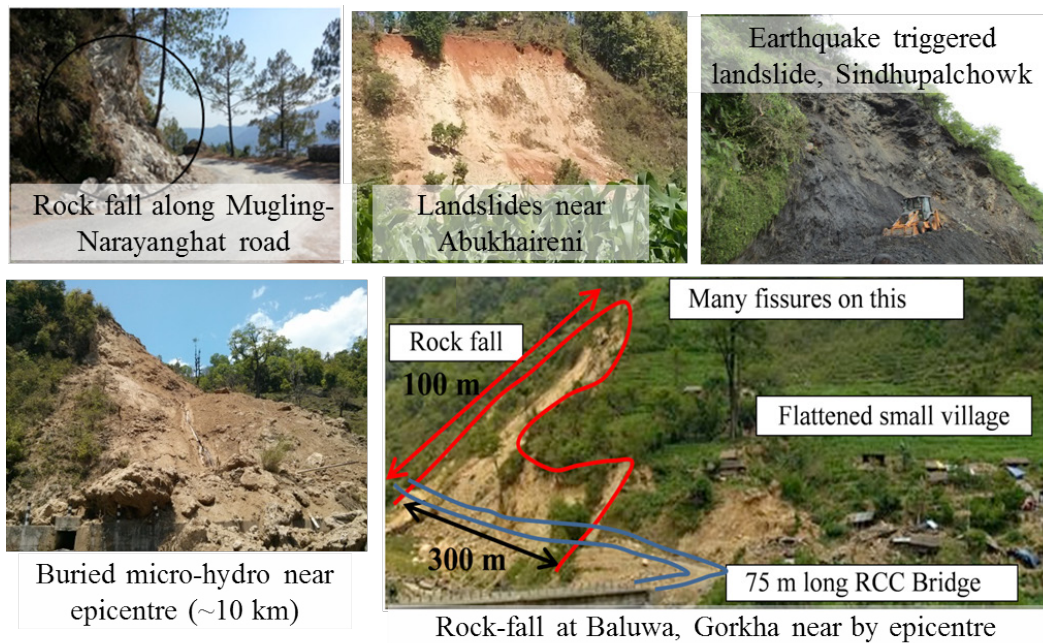
Landslide is one of the most prevalent hazards in Nepal because of the active seismicity, great relief, intense monsoon rains, and accelerated erosion due to deforestation and rapid construction. About 3,600 landslides of small to mega scales were identified within 200 km of the epicenter after the main shock and  $M_w$  7.3 aftershock, causing enormous economic and socio-environmental loss [2]. Most landslides were shallow, typically involving the top several meters of weathered bedrock, regolith, and soil [18]. Many of the landslides were still active during the field trip. Rock falls along Mugling-Narayanghat highway (Fig. 10), which was active since the main shock kept on obstructing the highway frequently.

**Fig. 10: Earthquake triggered mass movement observed during the field visit**

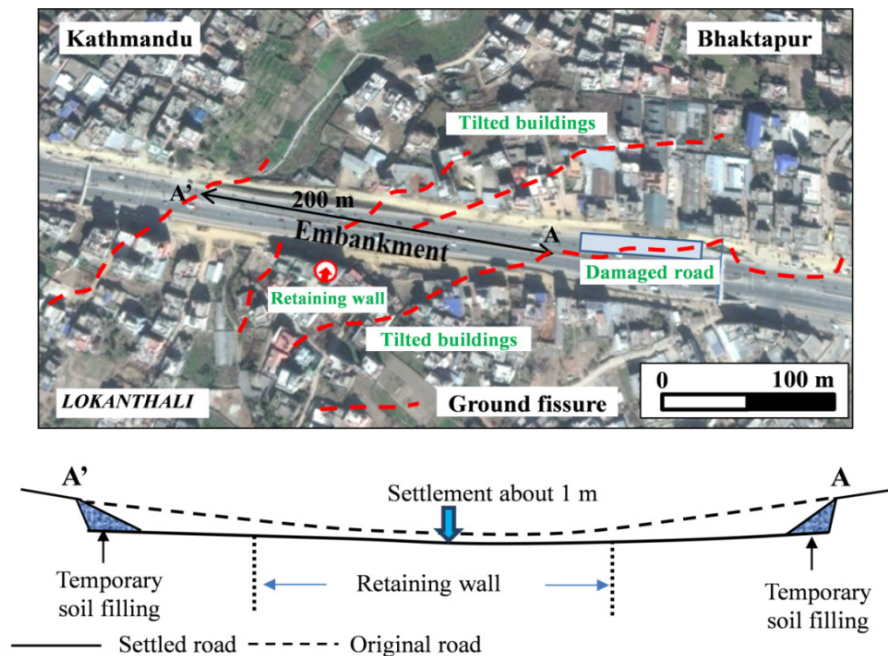
The earthquake had caused minimal lateral spreading and settlement. One of the most highlighted cases is the 6 lane highway at Lokanthali, as shown in Figure 11. 200-m-long embankment segment of the 6 lane Araniko highway suffered from substantial settlement of approximately 1 m due to the main shock, as shown in Fig. 11. Ground fissures, settlement, tilting of buildings and road pavement damage were observed in the surrounding areas (Fig. 12). As a result of the settlement, soil was used to fill the vertical gap immediately after the earthquake to build a temporary access as shown in Fig. 11. Ground fissures extended several hundred meters diagonally across the highway leading to the damage and tilting of many buildings and boundary walls (Fig. 12). Improper compaction, lateral spreading of side walls and subsidence of saturated soil beneath the embankments were the causes of the embankment settlement [18]. Apart from the subsidence, the embankment performed very well during the earthquake. Due to the critical importance of the 6 lane Araniko highway, detail geotechnical investigation shall be conducted to thoroughly understand the cause of the geotechnical issues observed.

**Fig. 11: Location of damage observed in Lokanthali along the Araniko highway (top) and longitudinal view of the subsidence of Araniko highway embankment (bottom)**

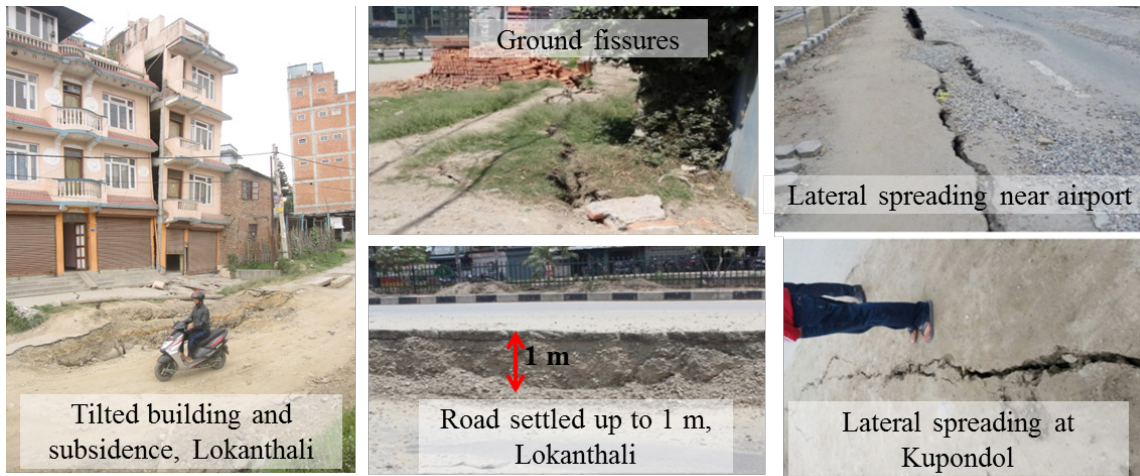
Lateral spreading were minimal and were localized to the eastern edge of Kathmandu Valley. Longitudinal cracks on a compacted road embankment caused by the lateral spreading were found in Sinamangal (near airport), Kathmandu, and Kupondol, Lalitpur (Fig. 12). Lateral displacement of slope and deep-seated slides may be attributed to the crack on the ground surface.

**Fig. 12: Typical lateral spreading and settlement caused by the earthquake**

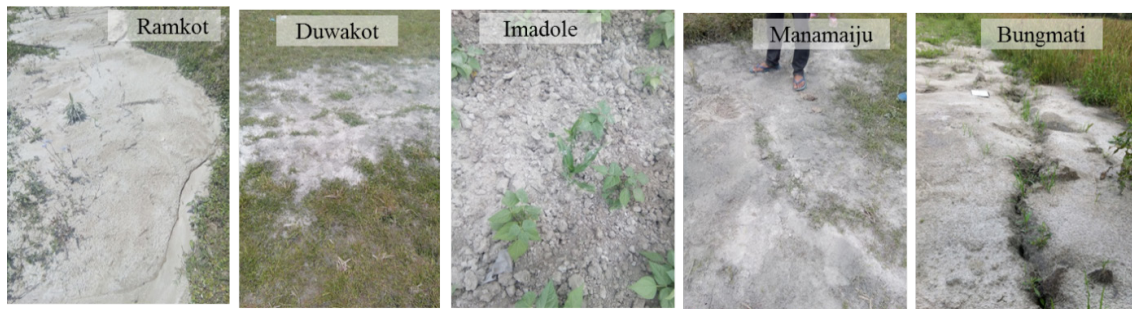
**Fig. 13: Observed liquefaction at various locations in Kathmandu Valley**

As the Kathmandu valley deposits are composed mainly of sand, silt and clay layers with a shallow ground water table, liquefaction is highly anticipated. Extensive liquefaction was also reported in Tundhikhel area during the 1934 Nepal-Bihar earthquake [14]. Past research also highlighted the liquefaction vulnerability at many locations in Kathmandu Valley [6, 25]. However, unlike in previous major earthquakes, the liquefaction triggered by the Gorkha earthquake appears to be fairly limited and localized. This may be attributed to low amplitude ground motion and low ground water table at the time of earthquake event. The areas where liquefaction was observed are Ramkot, Manamaiju, Bungmati, Jharuwarasi, Hattivan, Imadol, Mulpani and Duwakot [18, 20]. Sand boils were formed by freshly ejected sand forced out of over-pressurized ground surface. At most sites, sand was ejected to agricultural fields having thickness up to few centimeters (Fig. 13). The soil profile of the liquefaction affected areas comprises silty clay or silt on the top followed by low-plasticity silty clay locally known as black cotton clay 0.5-1.5 thick and loose fine sand up to 3 m depth. These deposits coincide with shallow water table up to 1.3 to 4 m below ground surface. It was found that the ejected soil was fine sand containing 50% non-plastic silt. Liquefaction-induced damage to structures in these areas was not found except buildings in some places tilted slightly. Incipient liquefaction was also observed at many places including Gongabu, Kaushaltar and Lokanthali. More details of the liquefaction caused by 2015 Gorkha earthquake can be found in Sharma et al. [20] and Subedi et al. [22].

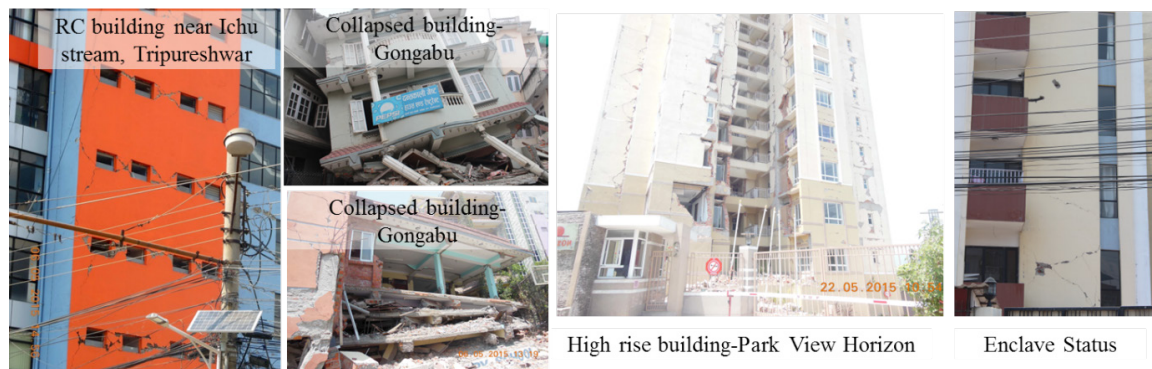
The basin effect of Kathmandu Valley is evident from the long period ground motion recorded at KATNP station located in the core of valley (Fig. 2). Moreover, severe damage to well-designed tall buildings (high-rise apartment) in Kathmandu Valley strongly revealed the basin effect (Fig. 14). The scattering of failed high-rise apartment throughout the cities of Kathmandu, Bhaktapur, and Lalitpur implies that the damage may not be purely attributed to the poor quality construction materials or inadequate design, because similar apartment buildings with fewer stories were observed to experience much lesser damage [21]. Structural damage concentrated in a few pockets of the Kathmandu Valley such as Gongabu, Balaju, Machha Pokhari, Ramkot and Naikap might be attributed to the loose fill and young deposits [18]. Building damage was concentrated at the top of an isolated hill at Swayambhu Nath as shown in Fig. 15 which is attributed to the ground motion amplification due to ridge. The damage to the Chautara town was very severe though it is far from the epicenter and earthquake fault (Fig. 15). The reason could be the amplification of narrow mountain ridge. School building and temple are often constructed on hilltops in Nepal. Many school buildings and temples located on the top of hill were destructed (Fig. 15), might be attributed to topography effects.

**Fig. 14. Severely damaged well-designed buildings**

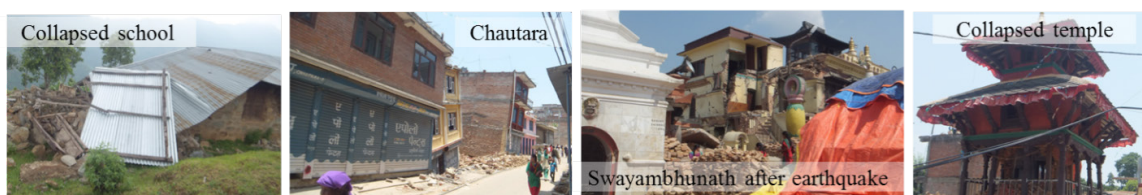
**Fig. 15: Damage observed at the top of hill or along the ridge**
