Current Status of Small/Micro Hydropower in Nepal: A Case Study of Giringdi SHP

Giringdi Khola hydropower plant is a micro hydropower plant of 75 kW capacity located at Daga Tumdada, Baglung. It was developed with the support of World Bank, UNDP, DDC, VDC and Community people for the Daga Tumdada VDC. It has been in operation since 2065. The salient features of the plant are mentioned in Table 3.

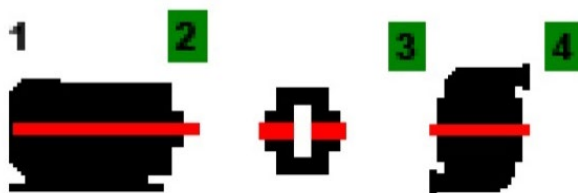
Figure 2: Diagram indicating different testing locations

Location 1 is the end of generator and Location 2 represents the connection of one end of belt drive and generator, Location 3 indicates the connection of other end of belt drive and turbine, Location 2 and 3 together represent the belt driven connection and Location 4 indicate the free end of turbine. Location 1 was taken as reference by the testing equipment and the rpm varied from 975 to 1000.

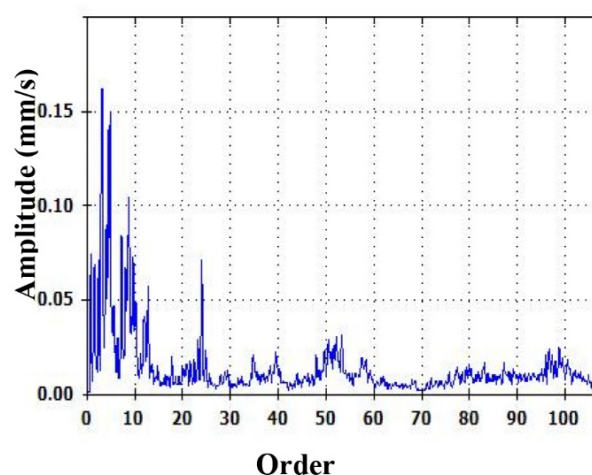
Figure 3: Vibration graph for axial direction of Location 2 (before maintenance)

The graph of the vibration data for axial direction of Location 2 before and after repair can be seen in the Figure 3 and Figure 4 respectively. The vibration for pre-maintenance seems to be more destructive than post maintenance one with high level of noise per cycle. The number of events per revolution (order) goes on increasing with time.

Generally, order of one to two times can be caused by looseness, misalignment, bent shaft and imbalance. First two or three distinctive harmonics indicate the misalignment, looseness of bearing, fault in bearings and bent shaft [10]. From the data of pre-maintenance shown above, it can be observed that the plant had fault in bearings looseness and misalignment of turbine shaft. The data also indicates some non-standard problems experienced by the plant. The problem in bearing was arising due to the chain effect of failure. Erosion of turbine leads to eccentricity in rotation of turbine, which lead to shaft misalignment and which ultimately lead to problems in bearings. This is also validated by the data seen above as location 2 (end of generator shaft) showed higher amplitude vibration in comparison to location 4 (turbine). While inspection too, bearing clearance problem was found and the problem was solved by the local technicians, bearings also had to be replaced. From analysis, it was seen that bearing at location 2 was comparatively more damaged than location 3. After maintenance, data was again taken and it seemed that the chain effect of failure caused misalignment of shaft. This indicates that not only bearings were flawed, but there were problems in shaft alignment and turbine rotation. Preventive maintenance could have prevented the chain effect seen above. The main cause of this problem could be the breakdown maintenance practiced in Nepal.

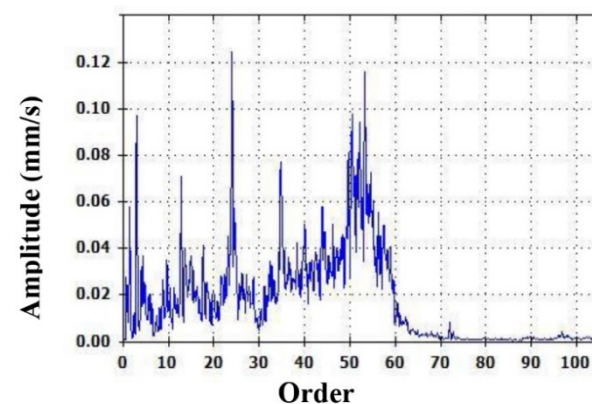
Figure 5: Vibration graph for tangential direction of Location 2 (before maintenance)

Similarly, the graph of the vibration data for tangential direction of Location 2 before and after repair can be seen in the Figure 5 and Figure 6 respectively. The graphs show the similar difference before and after maintenance work as seen above. The graph behavior for pre-post maintenance for other location say 3 and 4 seem to be quite less noisy than previous one though the number of events per revolution is not so less.

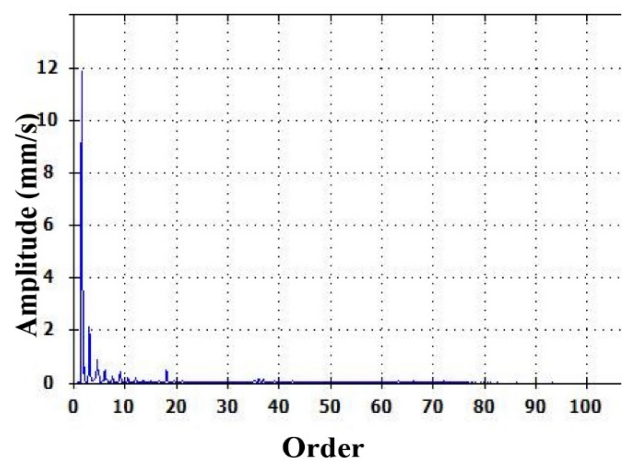
Figure 9: Vibration graph for axial direction of Location 3 (before maintenance)

The graph of the vibration data for axial direction of Location 3 before and after repair can be seen in the Figure 9 and Figure 10 respectively.

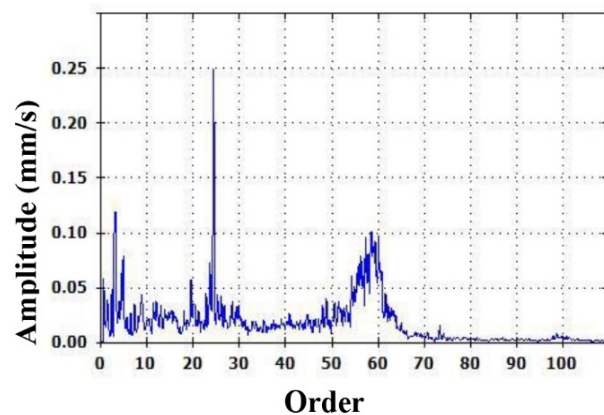
Figure 7: Vibration graph for radial direction of Location 2 (before maintenance)

And, also in the graph of the vibration data for radial direction of Location 2 before and after repair can be seen in the Figure 7 and Figure 8 respectively.

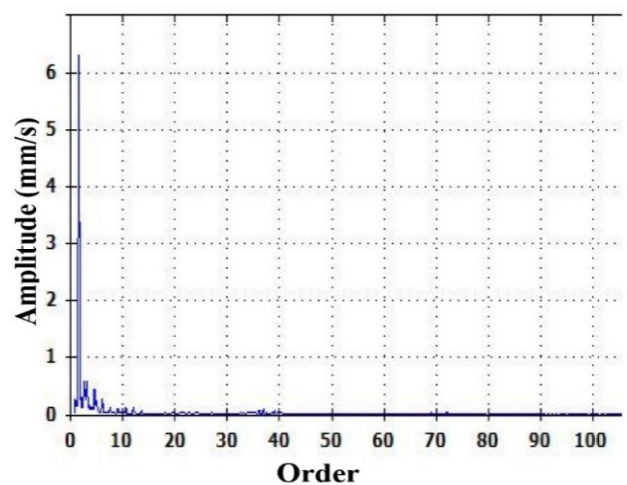
Figure 11: Vibration graph for tangential direction of Location 3 (before maintenance)

The graph of the vibration data for tangential direction of Location 3 before and after repair can be seen in the Figure 11 and Figure 12 respectively.

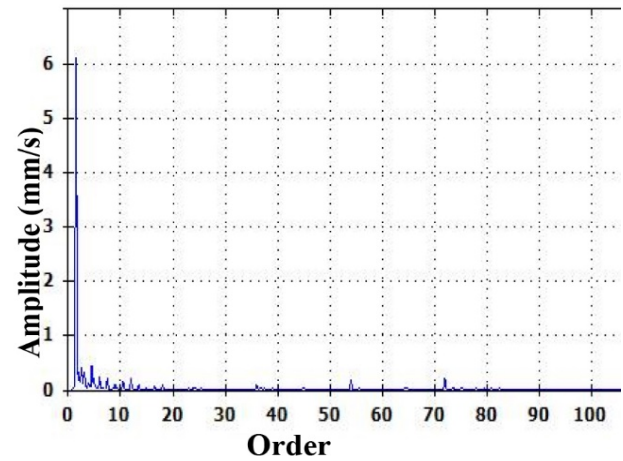
Figure 15: Vibration graph for axial direction of Location 4 (before maintenance)

The graph of the vibration data for axial direction of Location 4 before and after repair can be seen in the Figure 15 and Figure 16 respectively. The graph of the vibration data for tangential direction of Location 4 before and after repair can be seen in the Figure 17 and Figure 18 respectively.

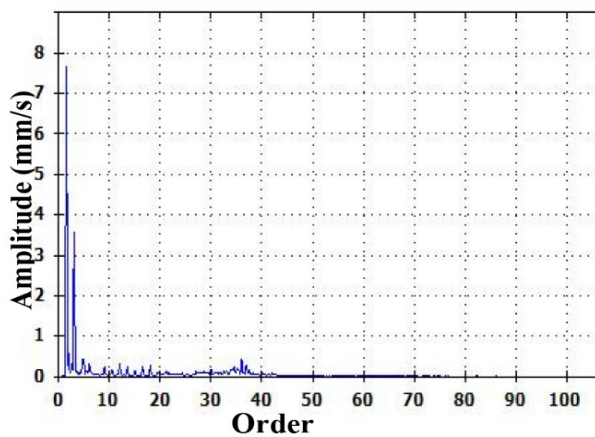
Figure 13: Vibration graph for radial direction of Location 3 (before maintenance)

The graph of the vibration data for radial direction of Location 3 before and after repair can be seen in the Figure 13 and Figure 14 respectively.

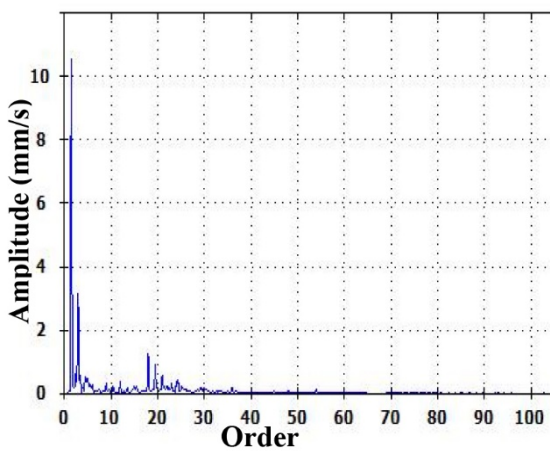
Figure 19: Vibration graph for radial direction of Location 4 (before maintenance)

The graph of the vibration data for radial direction of Location 4 before and after repair can be seen in the Figure 19 and Figure 20 respectively.
