Horizontal drilling drainage as a preventive measure for water induced landslide risk reduction: A case study from Sindhuli Road, Section I, Nepal

*Shanmukhesh Chandra Amatya¹ and Mikihiro Mori²

²Nippon Koei Co. Ltd. Japan

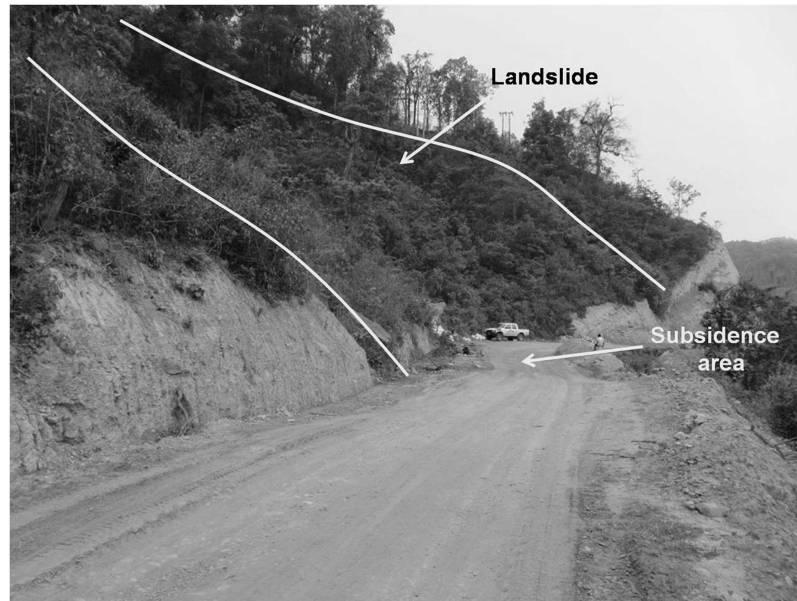
The major issue at 29+300, Kamalamai village area, Section I of the Sindhuli Road (National Highway), Sindhuli District, was generating subsidence and creeping of land mass each year since many years back. The landslide was activated due to pore water pressure and toe cutting by the Gwang Khola stream. The sliding land mass was crossing around 150 m length along the road and was disturbing the highway in each rainy season (Fig. 3). This study has made an effort to address the issue.

Fig. 3: Problem of the landslide area

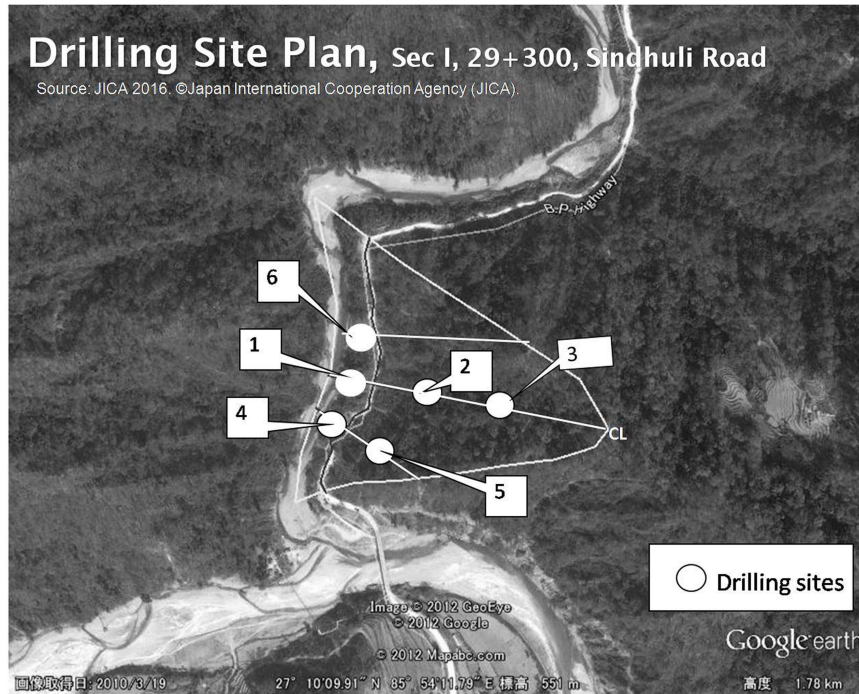
Fig. 8: Drilling site plan of the landslide (source: JICA, 2016)

drilling holes in the central line of the landslide, two drilling holes in the left side of the landslide and one drilling hole in the right side of the landslide (Fig. 8).

The geological conditions of the landslide site were reported after the completion of the core drilling as presented in the lithological log Table 1. The lithological log in the Table 1 shows the tentative slip surface of the landslide mass around 9.5 to 10.5 m below ground level (BGL) and the soil type were wet, muddy, like slurry with wet sand.

The water level recorded in the bore holes of central line of the landslide exhibits 7.8 m (BGL) in the head part, 2.5 m (BGL) at the body part and 12.1 m (BGL) at the toe part of the landslide which exhibits the existence of more pore water pressure at body part.

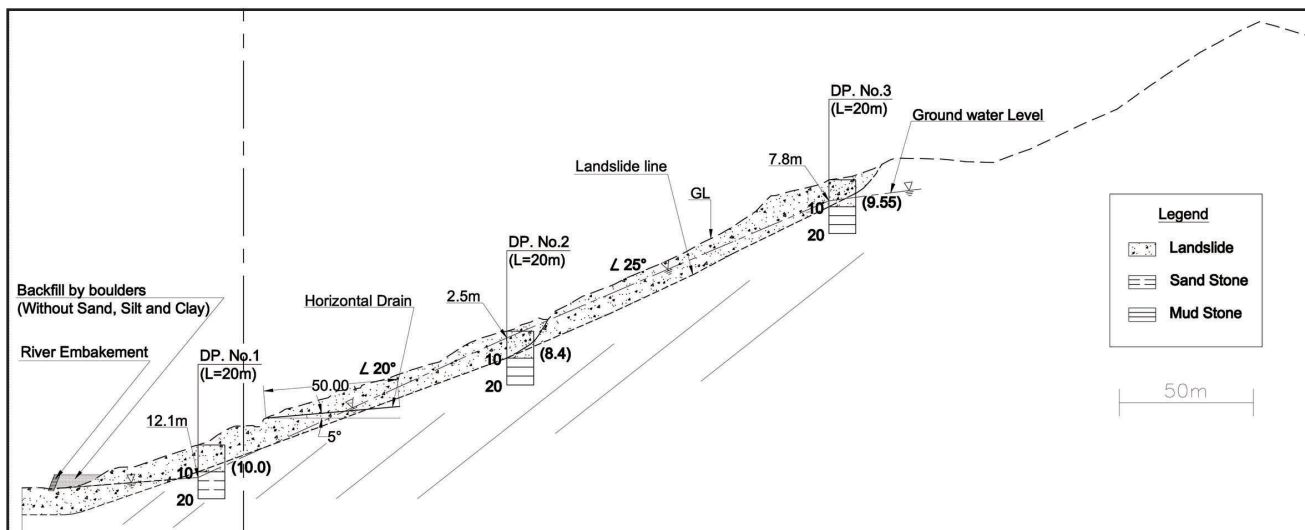
Fig. 9: Geological cross section at central line of the landslide (source: JICA, 2016)

data about the landslide. In this regard, the well known strain gauge technology was installed in all the six bore holes to have the precise slip surface of the landslide. The strain gauge was monitored each week from May to September 2012 that was from pre to post monsoon period. The strain gauge monitoring data analysis exhibited the slip surface of the landslide found at 10 m depth of the landslide which supports to the lithological log as well. The geological cross-section of the landslide at the central line (CL) is presented in the Fig. 9.

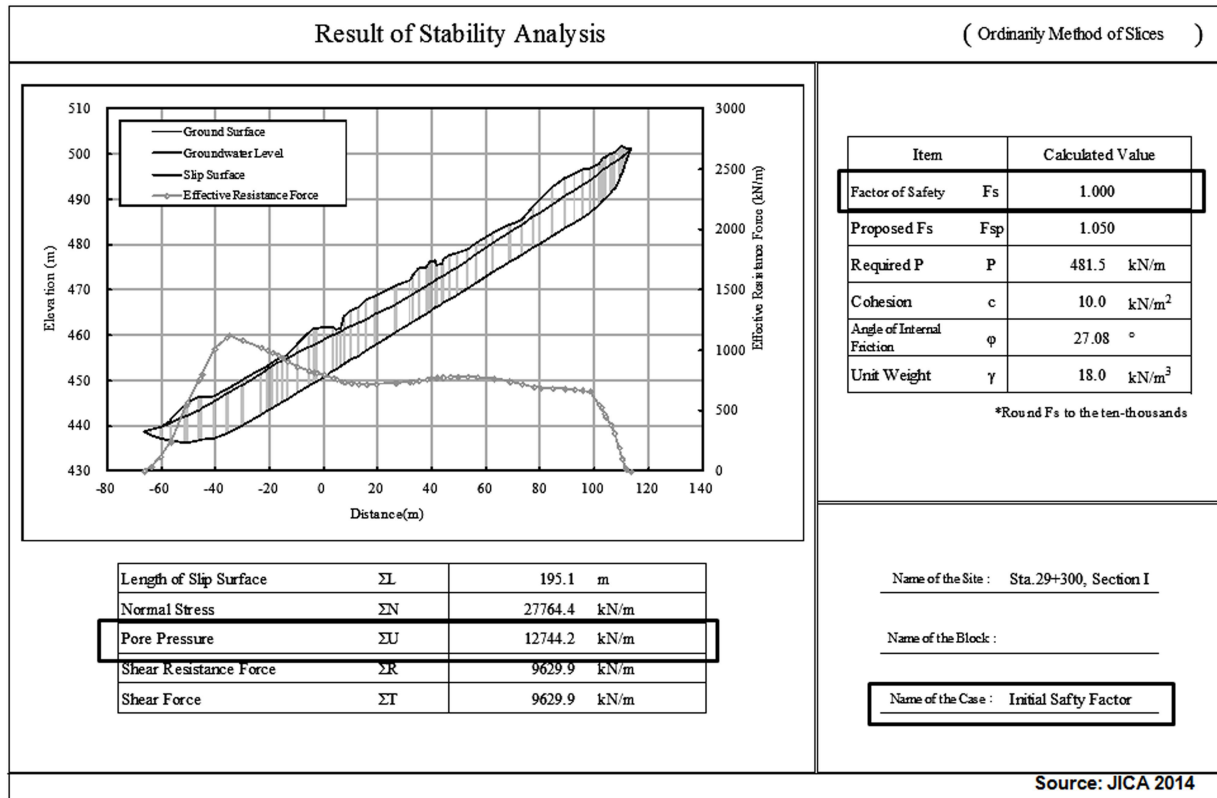
Fig. 10: Initial factor of safety (source: JICA, 2014)

values of cohesion c and the internal friction angle ϕ as shown in the Table 2. The scarps, bulges, settlement and cracked drainage show that the landslide movement is ongoing in rainy season and moving intermittently. In this regards, the initial factor of safety is considered less than 1 that is, 0.98. Based on the discussion with experts of the Project for the operation and maintenance of the Sindhuli Road, JICA Expert Team Sindhuli Road Maintenance Unit (SRMU), Department of Road (DOR) and Department of Water Induced Disaster Management (DWIDM), the designed safety factor was decided to be 1.10 for road.

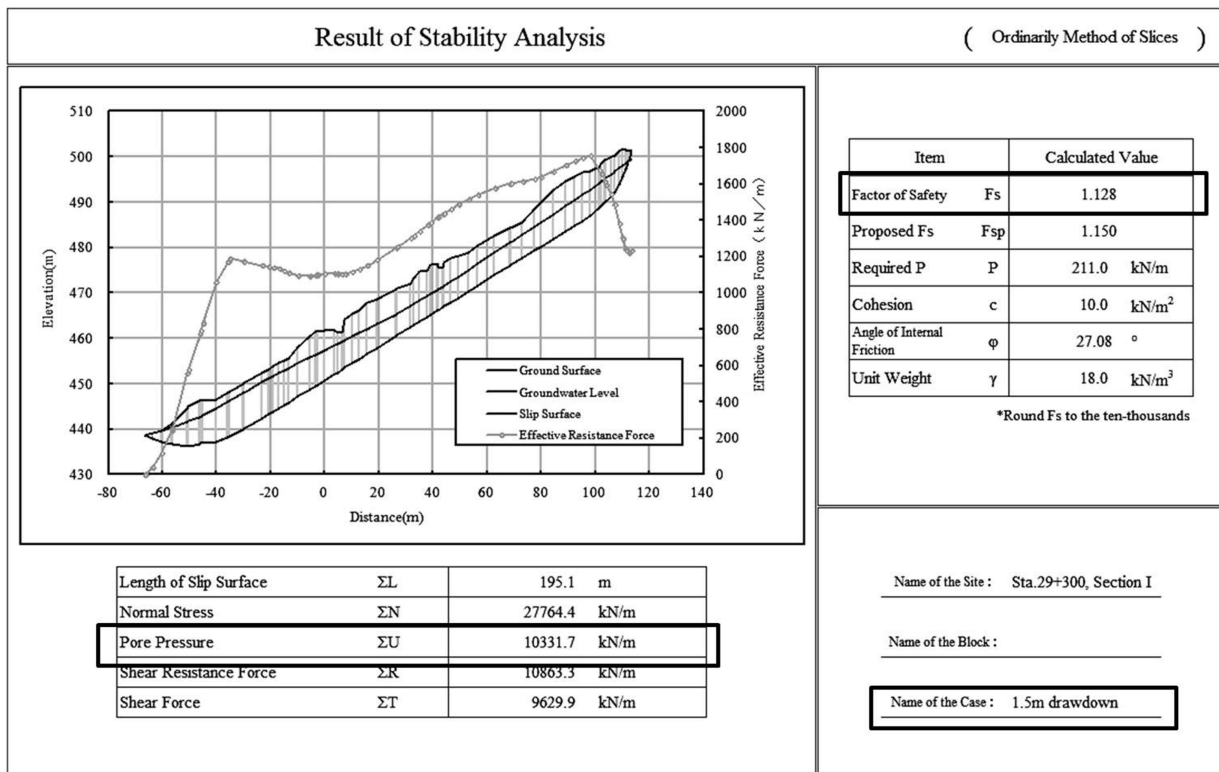
Fig. 11: Factor of safety in water level 1.5m drawdown (source: JICA, 2014)

The major cause of the landslide movement in the study area is due to the increase of pore water pressure which increases the weight of the landslide and moves down. In this regard, the factor of safety was back calculated with changing the values of water level decreased to 1.5 m, 3 m and so on in the landslide area. As a result, in the initial Fs, the calculated Factor of safety was 1.0 and pore water pressure ΣU was found 12744 KN/m (Fig. 10). If the water level is considered to be decreased by 1.5 m drawdown, the Factor of safety changed to 1.128 and the pore water pressure ΣU decreased to 10331 KN/m (Fig. 11).

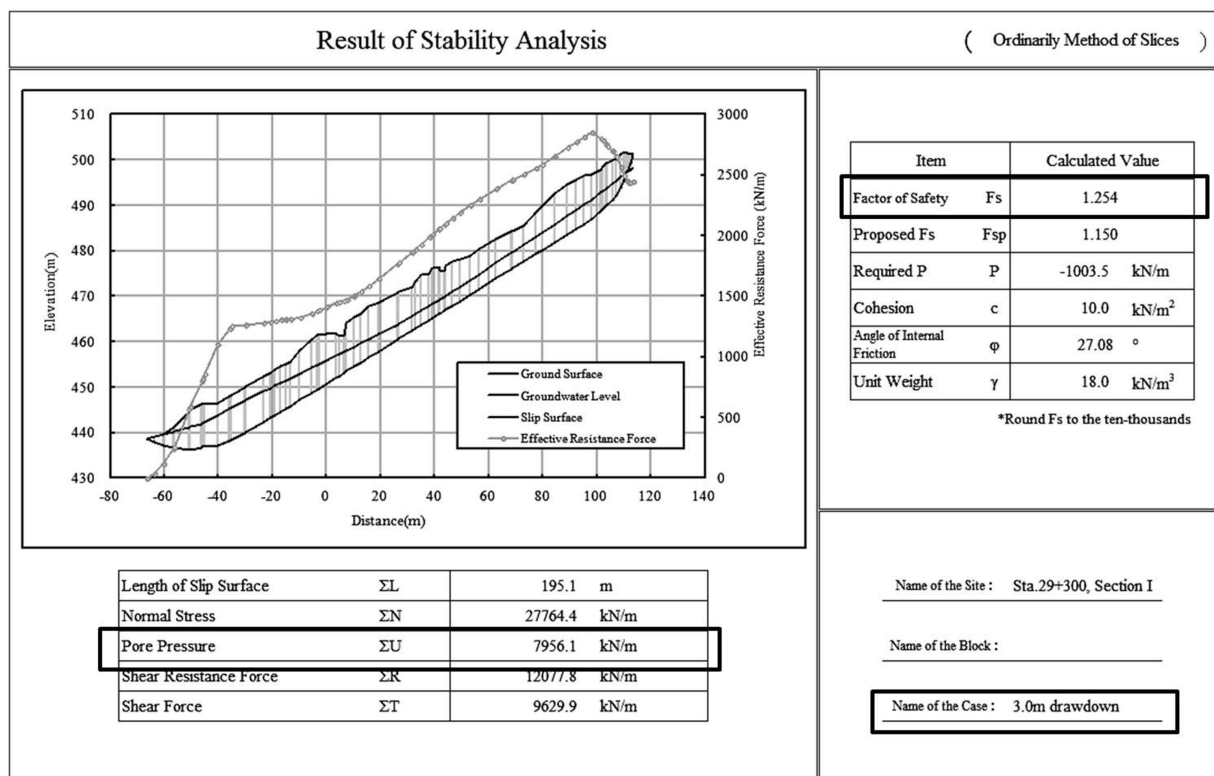
Fig. 12: Factor of safety in water level 3.0m drawdown (source: JICA, 2014)

In the same way if the water level is considered to be decreased by 3.0 m drawdown, the Factor of safety changed to 1.25 and the pore water pressure ΣU decreased to 7966 KN/m (Fig. 12). Thus if the water level decreases by 1.5 m drawdown the designed factor of safety will be satisfied but if the water level decreases by 3.0 m, it will be much more in safe side.

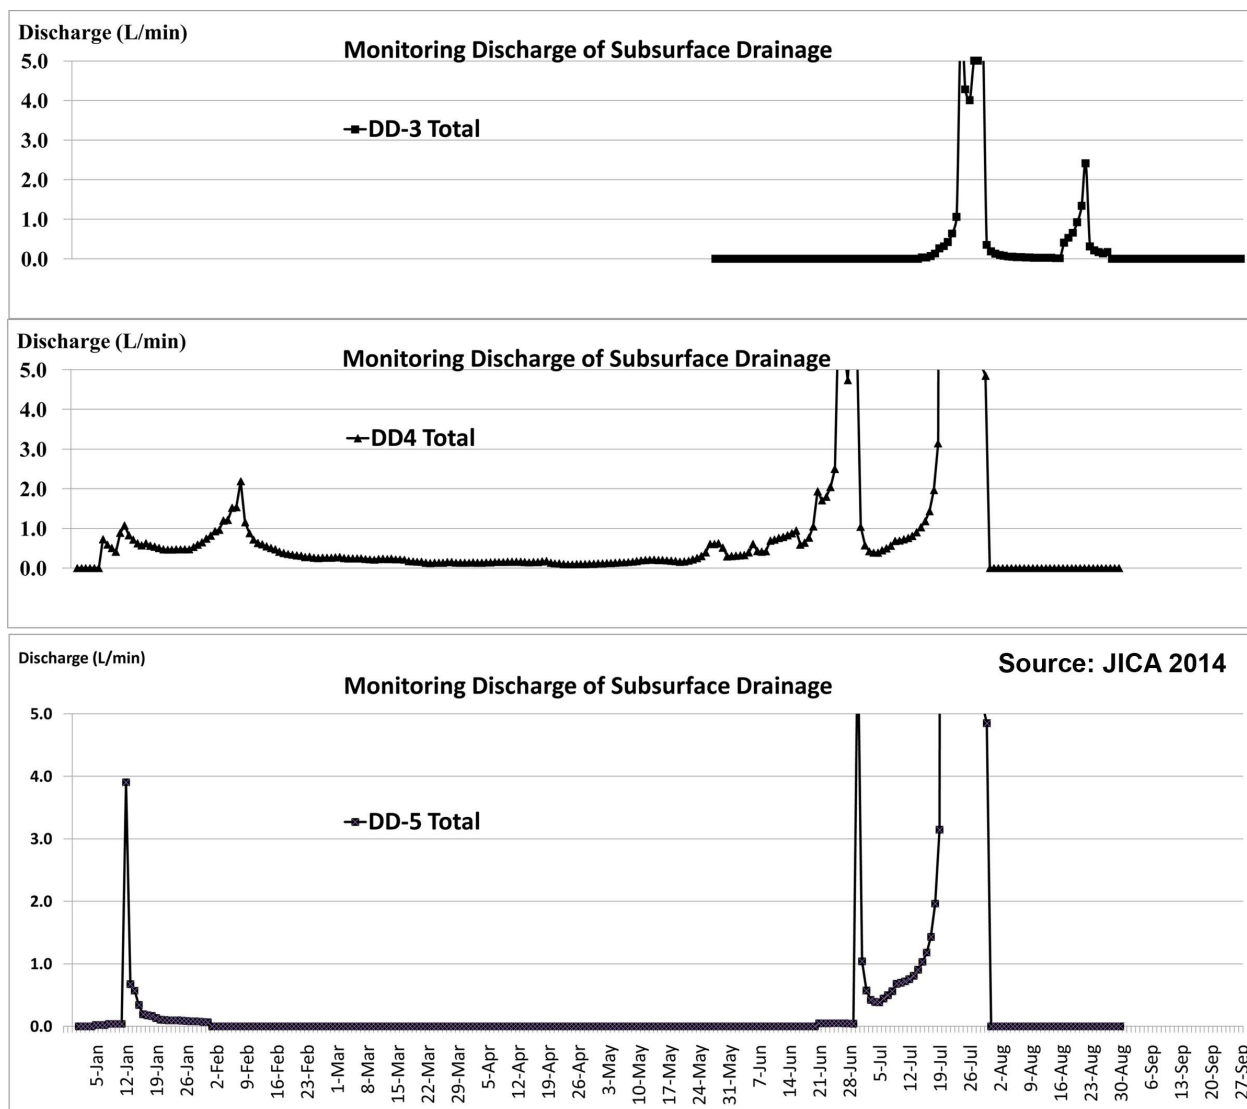
Fig. 17: Discharge graph of different clusters of horizontal drilling drainages (source: JICA, 2016)

drainages even in the dry period. The ground water level monitoring data collected from the six monitoring wells installed in the landslide area show the depletion of the water level which varies from 1.0 m to 4.0 m in different wells before rainy season (up to 2nd week of May). The discharges from the different clusters of horizontal drilling drainages were plotted in graph (Fig. 17).

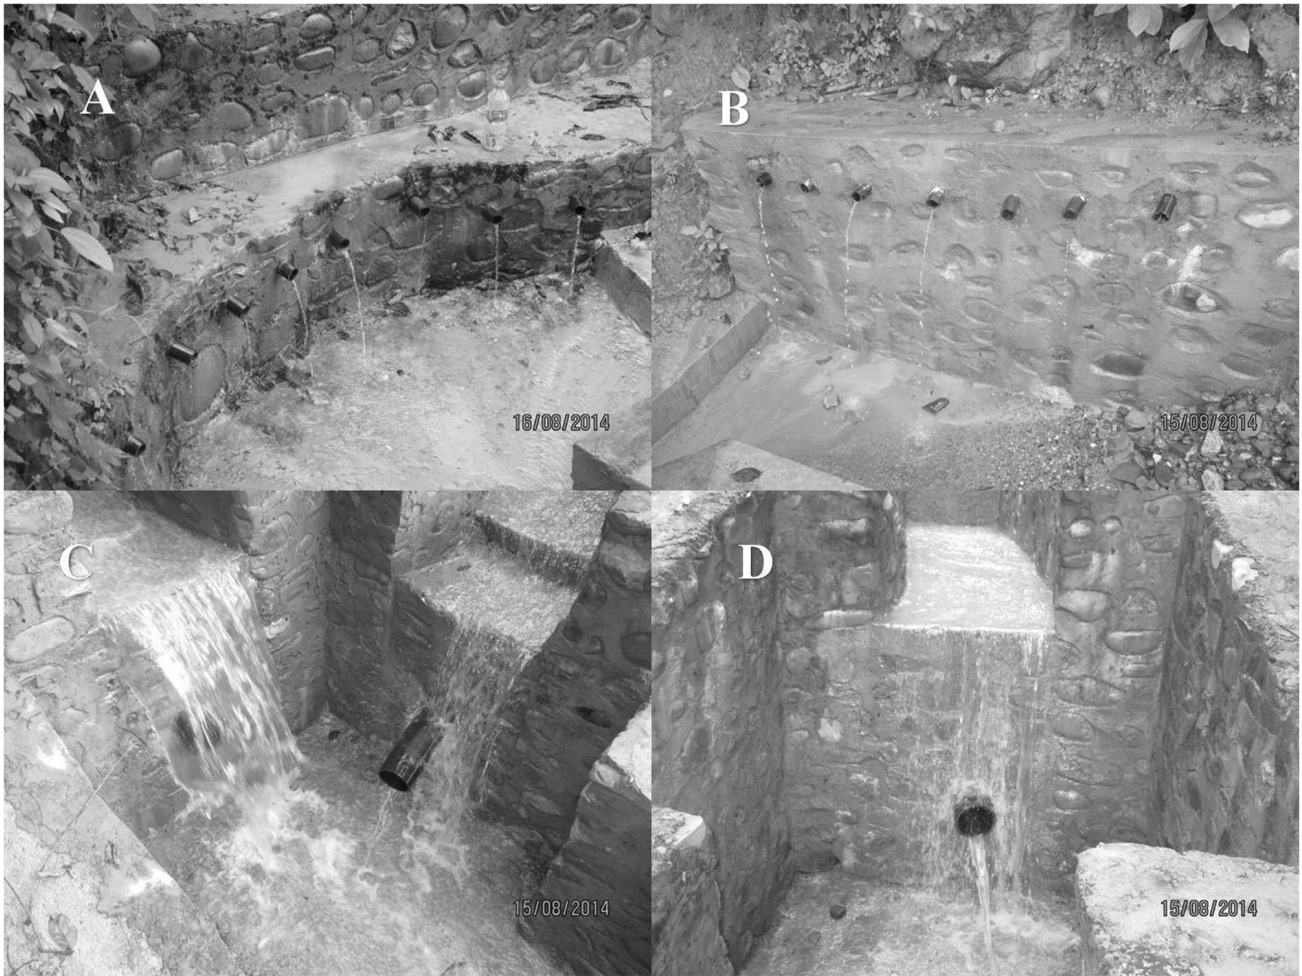
The ground water level monitoring data from the six monitoring wells show the water level is slightly increased in rainy season (May onward) in compare to the dry season. But the depletion of the water level nearly became stagnant 1.0 m to 3.0 m in different monitoring wells in rainy season (May onward). The discharge of water from cluster of horizontal drilling drainage and French drain and sub-surface drain are shown in Fig. 18.

Fig. 18: Discharge of water from cluster of horizontal drilling drainage and French drain in rainy season (A and B: Discharge from horizontal drilling drainages, C: Discharge from French drain, and D: Discharge from sub-surface drainage)

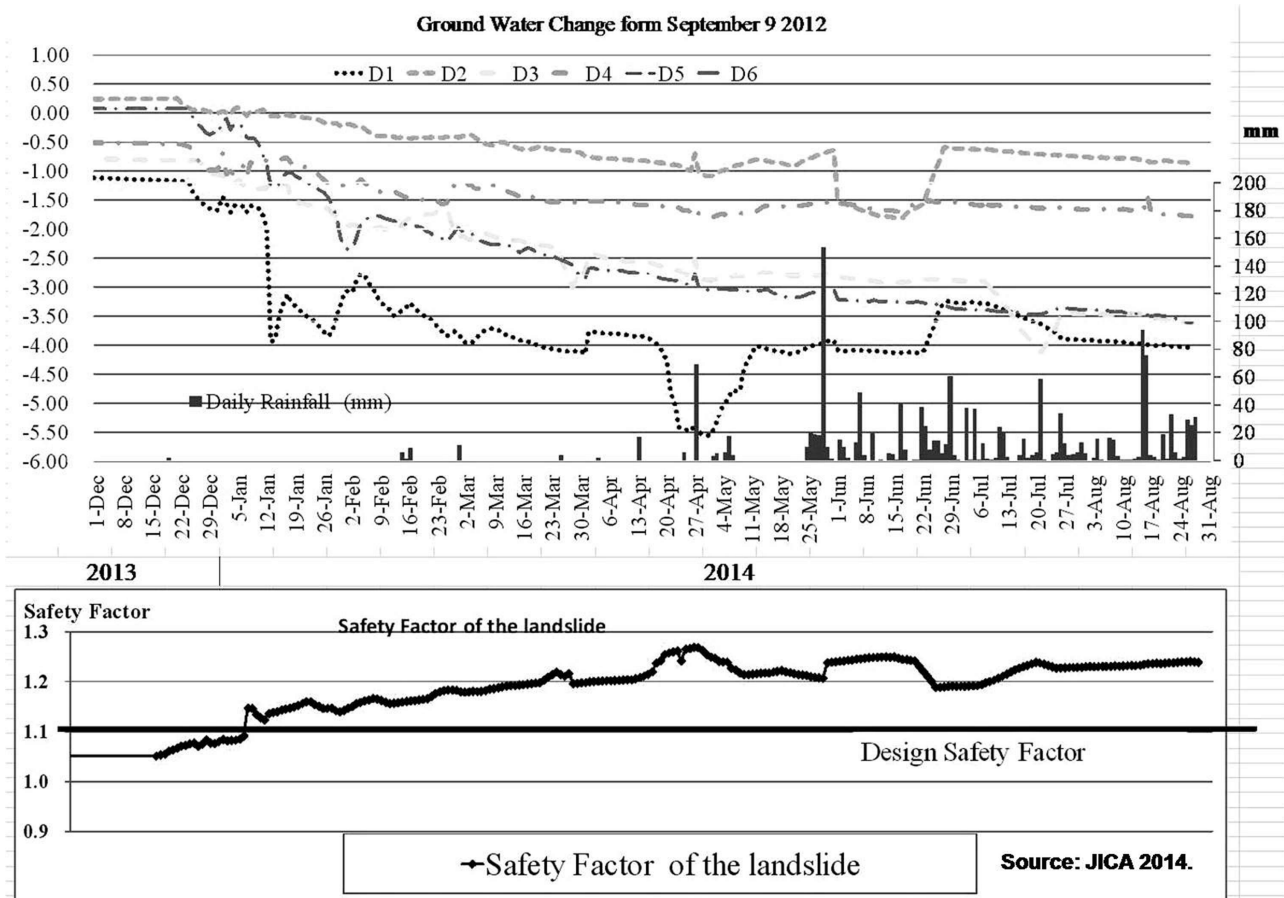
Fig. 19: Drawdown in different monitoring wells and factor of safety (source: JICA, 2014)

Thus, the designed Factor of safety 1.1 was satisfied with the drawdown of water level to 1.5 m. In addition, after completion of installation of all the horizontal drilling drainages and construction of French drain, Open drain and Gabion toe wall, the average drawdown in dry and wet period was found around 3.0 m that gave the Fs to 1.25 which shows much more safe side from the landslide. The drawdown in different monitoring wells in the landslide area were plotted in graph and in the mean time the Fs was calculated and plotted in graph as well (Fig. 19).
