Engineering geological problems of shear and fault zones in Nepal Himalaya

Subas Chandra Sunuwar

Butwal Power Company Limited, Kathmandu, Nepal

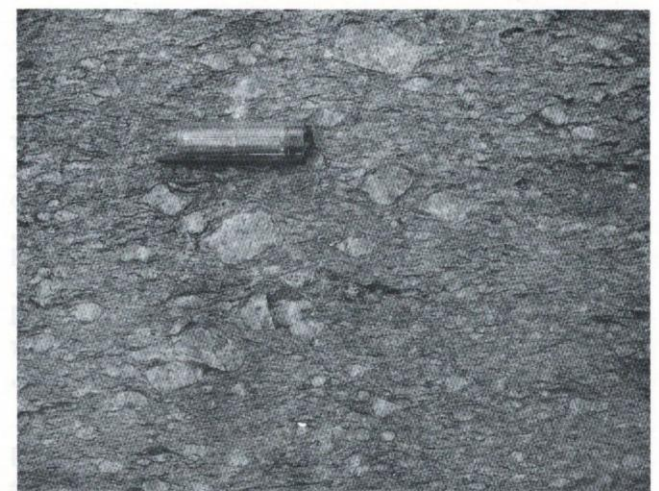
Fig. 3: Cataclastic rock containing clasts and matrix, Khimti I Hydropower Project

zones during the excavation of various tunnel sections (Table 3). The zones were characterised by very weak, sheared, crenulated, altered, and decomposed rock and bands of clay gouge with strong angular clasts (Fig. 3). The shear or fault zones contain more than 80% of clay matrix and less than 20% of lenticular quartz clasts. The matrix is rich (60-70%) in non-swelling clays such as illite and chlorite (Sunuwar 2002). The thickness of the shear or fault zones varies from 5 m to a maximum of 60 m. The squeezing of walls was evidenced by the cracked and converging shotcrete whereas in some sections the invert was also heaving. According to the monitoring data, squeezing generally lasted for 5 to 6 months. The maximum deformation recorded was 40 cm (i.e. 13% of the tunnel diameter) in Adit 5 at Chainage 245 m (Table 3). Tunnel excavation was very slow (i.e. 7-10 m per week) in the squeezing sections, where 25 cm thick fibre-reinforced shotcrete with grouted rock bolts was provided to overcome the problem.

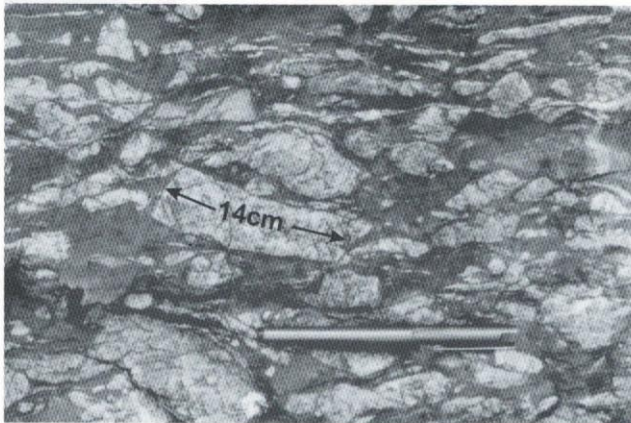
It contains 25–75% of clasts and generally develops in strong and brittle rocks such as quartzite, dolomite, and gneiss. It is characterised by sheared and shattered rock with strong, angular clasts supported by soft silty sand matrix (Fig. 4). The clay content is low. The size of clasts varies from a few millimetres to a few metres. This type of shear or fault zone bears a huge amount of groundwater.

Fig. 4: Brittle shear zone containing about 40% of rectangular to lenticular clasts and 60% of weak matrix

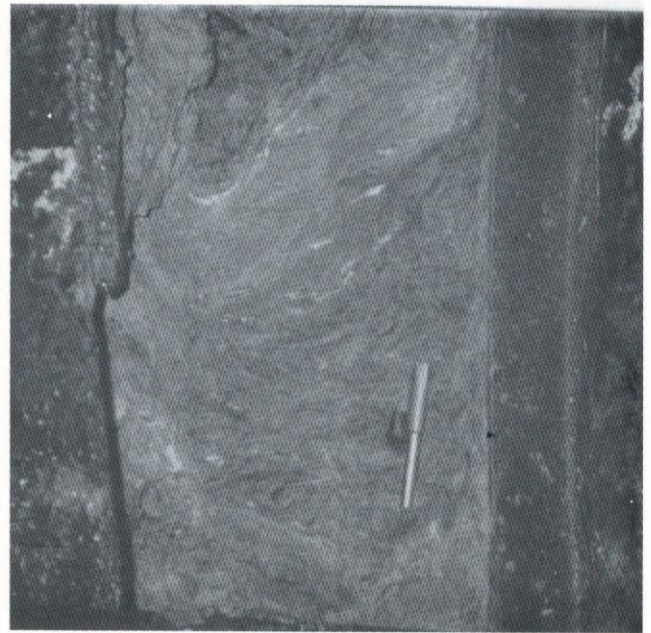
This shear or fault zone generally develops in weak rocks and appears as a very weak, sheared, crenulated, clay-like zone preserving rock textures (Fig. 4). It is also characterised by decomposed rock and clay gouge bands with strong angular clasts (Fig. 5). It contains more than 75% of clay matrix and less than 25% of lenticular clasts. Sometimes all sheared and shattered rock fragments are decomposed and altered into clay except strong lenticular clasts. This type of shear or fault zone is generally observed within a single rock type such as schist, phyllite, slate, and mudstone. Its matrix consists mostly of non-swelling type of clay. Though the shear or fault zone itself contains not much water, frequently there is a lot of water just above it.

Fig. 5: A clayey brittle shear zone with more than 75% of clay matrix and less than 25% of clasts

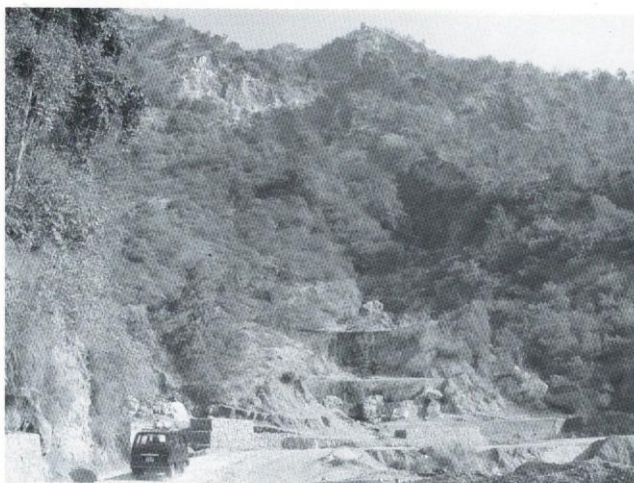
The landslide problem on the Butwal–Tansen Road at Hiunde Khola near Karabari was generated by the MBT (Fig. 6). The MBT can be considered to be a blocky brittle shear or fault zone. It is characterised by the sheared and shattered rock with strong, angular clasts supported by soft silty sand matrix. The size of clasts varies from a few millimetres to a few metres. It is more than 60 m thick. The problems on the road have been encountered since the time of its construction and they are related to the debris flows from upslope, road subsidence, and blockage. Though many retaining structures

Fig. 6: MBT brittle fault zone on Butwal–Tansen Road at Hiunde Khola near Kerabari

and landslide stabilisation works have been constructed in this stretch, the area is still unstable.

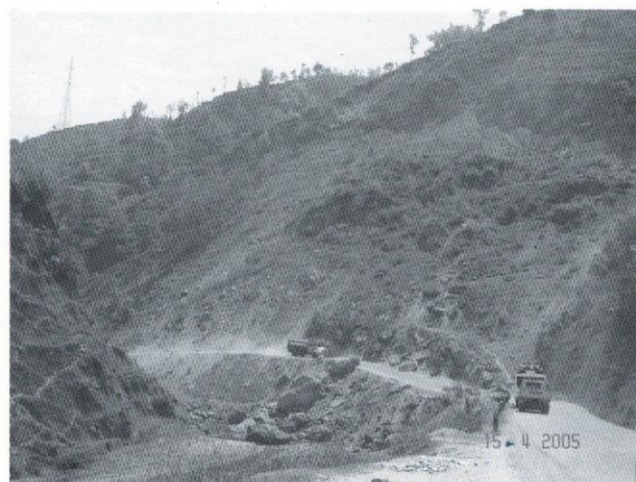
The problems on the Arniko Highway near Dolalghat (Fig. 7) occurred in July 2003 due to road subsidence and blockage by landslide debris. The slide initiated when the toe support was undercut by the Cha Khola. The slide developed on the clayey brittle shear zone which is more than 40 m thick and characterised by shattered rock with small clasts supported by clay matrix. The shear zone is developed in the Benighat Slates and is observed on both riverbanks. It is steeply ($>60^\circ$) dipping due north and consists of loose rock fragments with bands of clay gouge.

Fig. 7: Dolalghat Landslide which destroyed Arniko Highway on July 2003
