Geology of slopes in the Crocker Range, Sabah, Malaysia

***F. Tongkul, H. Benedick, and F. K. Chang**

*Geology Program, School of Science and Technology
Universiti Malaysia Sabah*

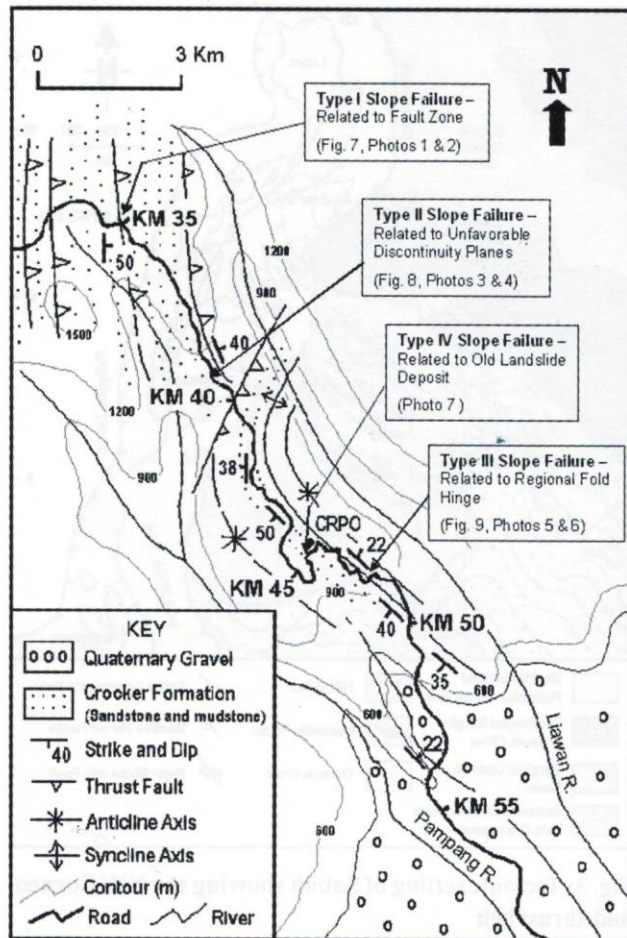
Based on the geological study, the slopes examined are found to be unstable due to two main reasons, firstly related to the weak nature of the rocks itself and secondly due to the unfavourable orientations of discontinuities and slope face cuttings. The following four main potential sources of failure were recognised: 1) related to the presence of intensely sheared mudstones within a localised fault zone; 2) related to the presence of sandstone beds with their joint planes and bedding parallel or sub-parallel to the slope face; 3) related to the presence of intensely fractured and sheared sandstone and mudstone beds within a regional fold zone; and 4) related to the presence of old landslide deposits. Examples of each source of failure are described below.

Fig. 6: Location of selected slope failures controlled by lithology

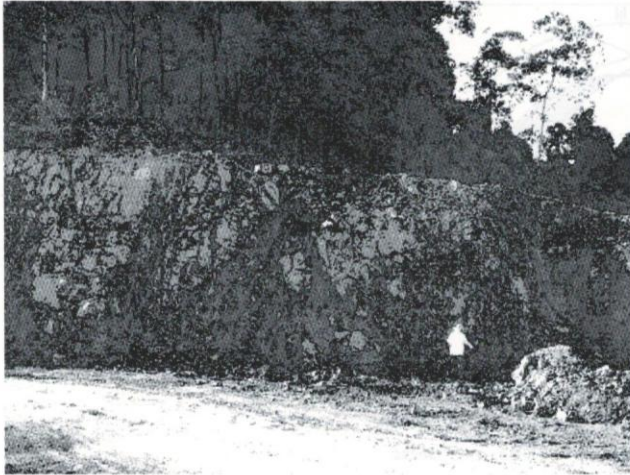
This is the most common source of failure. The fault zones range in width from a few metres to tens of metres. A good example of this type of failure can be seen on the slope at Km 35 (Fig. 6).

The sandstone and mudstone beds are oriented between N35°E and N20°E with dips from 55 to 65 degrees to the east. The beds are quite dismembered due to the presence of a major fault zone. The fault zone is characterised by the presence of broken sandstone beds and intensely sheared mudstones (Figs. 7 and 8). The sandstone beds are also heavily jointed showing at least four sets (Fig. 9).

Fig. 7: Intensely sheared mudstone and deformed sandstone beds in a local fault zone at Km 35

The four sources of slope failure require appropriate stabilisation techniques. In this study the stabilisation options recommended involved grading of slope, establishment of vegetation, and spraying of concrete (gunite) apart from providing a good drainage system. To stabilise the fault zone (Type I) concrete may be sprayed or pumped on the unstable slope face to prevent weathering

and spalling of the rock surface as well as to knit together the surface of the slope. To reduce failure of the sandstone beds along the bedding plane (Type II) grading of the slope cut to match the dip of bedding may be necessary followed by the establishment of appropriate vegetation. The slope failure related to regional folding (Type III) may require lowering the slope face angle considerably and spraying concrete onto the surface of the slope to hold together the intensely fractured mudstone and sandstone. The Type IV slope failure related to old slump deposits may require cutting the slope further and establishment of vegetation.

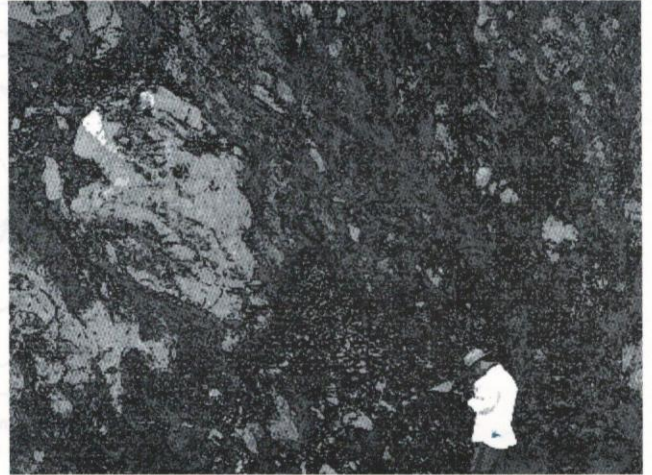
Fig. 8: Close-up view of sheared grey mudstone and highly deformed sandstone beds at Km 35

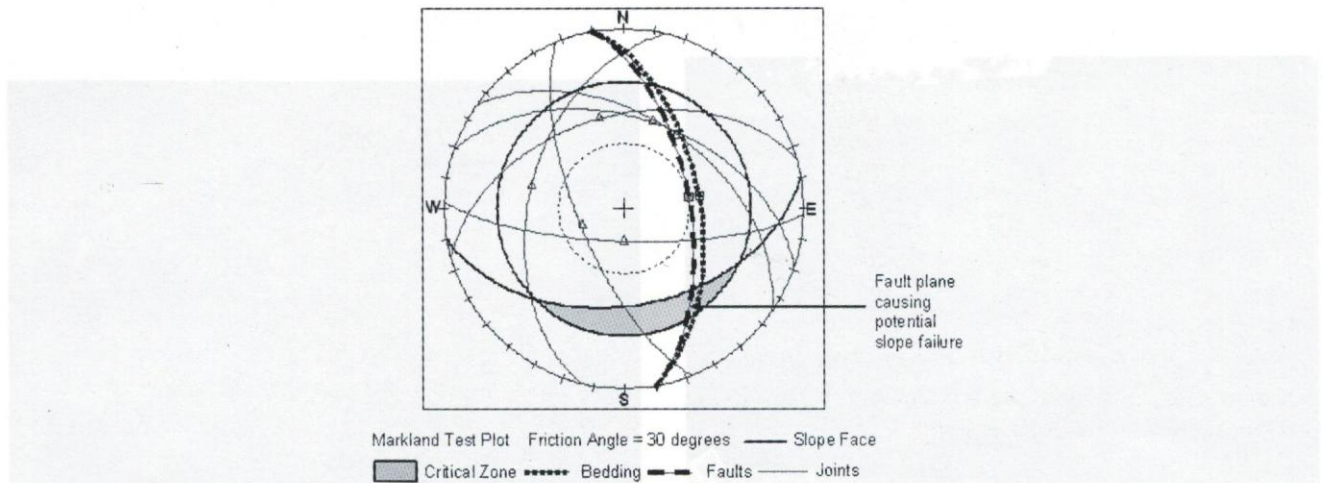
Fig. 9: Stereographic projection of discontinuity planes at Km 35 showing potential failures (equal angle lower hemispherical projection)

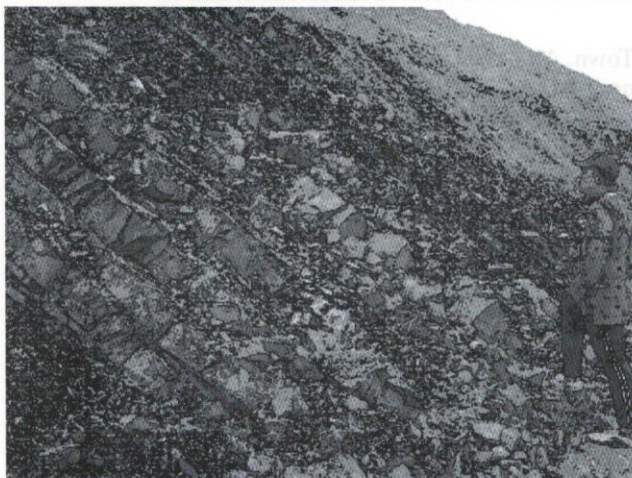
The sandstone and mudstone beds are oriented N34°E with dip angles between 30 and 40 degrees eastwards. The beds are quite persistence throughout the length of the slope. The orientation of bedding is nearly parallel to the slope face and the bedding dips out of the slope face (Figs. 10 and 11). Jointing in the sandstone beds is quite common with its spacing from 5 to 30 cm. At least three sets of joints occur, causing toppling failures (Fig. 12).

Fig. 10: Highly jointed sandstone and mudstone beds oriented parallel to slope face at Km 38

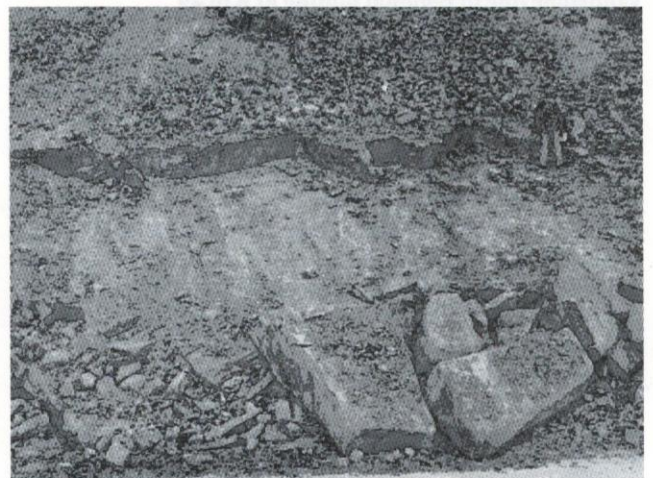
Fig. 11: Toppling failure due to unfavorable orientation of bedding plane at Km 38

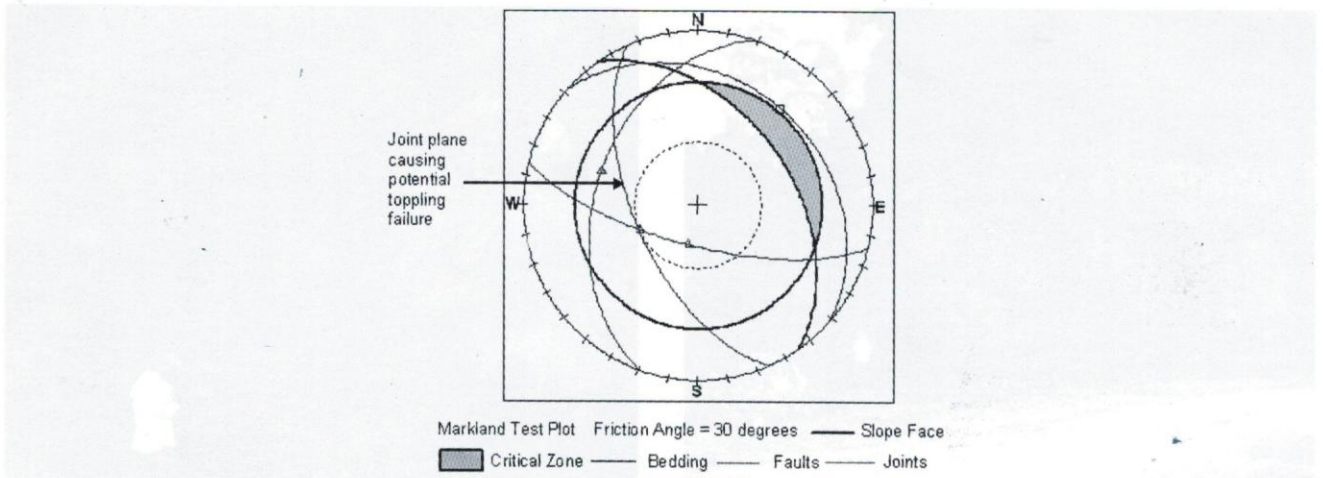
Fig. 12: Stereographic projection of discontinuity planes at Km 38 showing potential failures (equal angle lower hemispherical projection)

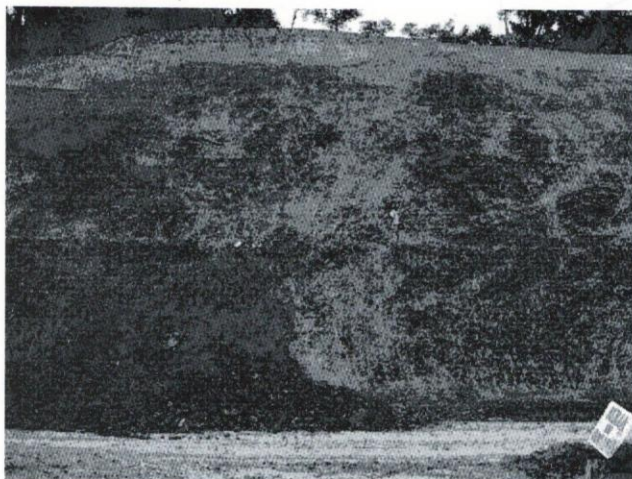
Fig. 13: Intensely sheared mudstone and fractured sandstone due to regional folding at Km 49

The mudstone beds which are intensely sheared and fractured do not show clear bedding (Fig. 13). However, the thin sandstone beds at the bottom of the slope are oriented around N30°E with dip angles between 30 and 40 degrees eastwards. The mudstone and sandstone beds are heavily jointed (Fig. 14) with its spacing from 3 to 20 cm (Fig. 15). The fracturing of mudstone and sandstone is related to the occurrence of a huge fold in this area.

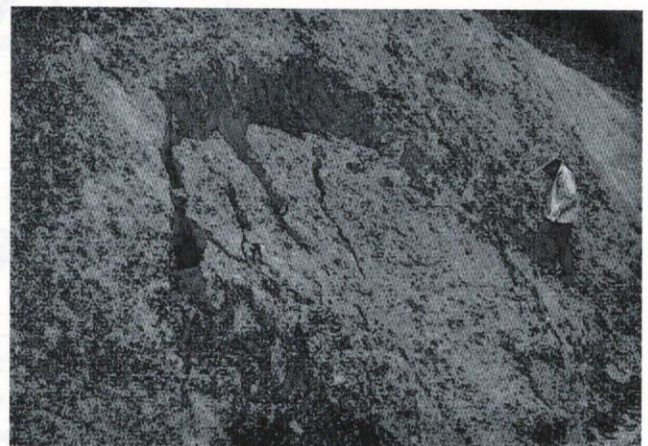
Fig. 14: Close-up view of wedge failure on sheared mudstone and fractured sandstone at Km 49

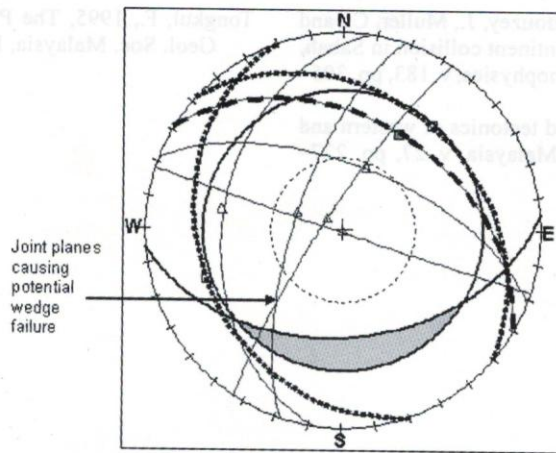
Fig. 15: Stereographic projection of discontinuity planes at Km 49 showing potential failures (equal angle lower hemispherical projection)

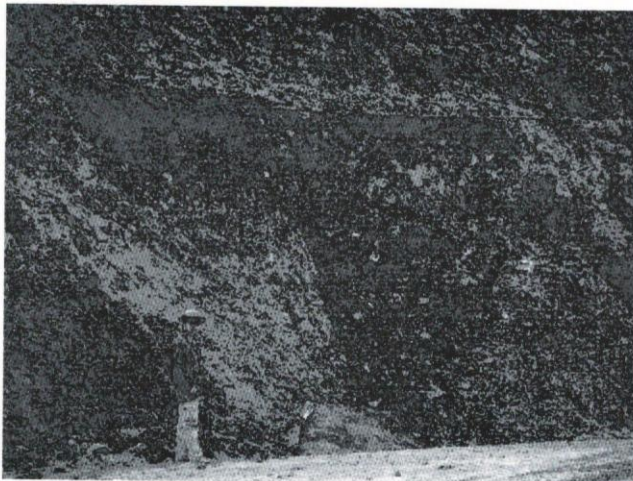
Town. A good example can be seen on the slope at Km 46 near the Crocker Range Park Office (Fig. 6). This failure is characterised by the presence of sandstone fragments chaotically mixed with grey and red mudstone (Fig. 16). The sandstone fragments measure 1–10 cm. No bedding was observed. The surrounding area is covered by grass.

Fig. 16: Chaotic mixing of grey and red mudstone with blocks of sandstone in an old landslide deposit at Km 46
