## **Environmental-friendly countermeasures applied to control instabilities in a high vertical rock slope: an example from Oita prefecture, Japan**

**Tara Nidhi Bhattarai**

### **ABSTRACT**

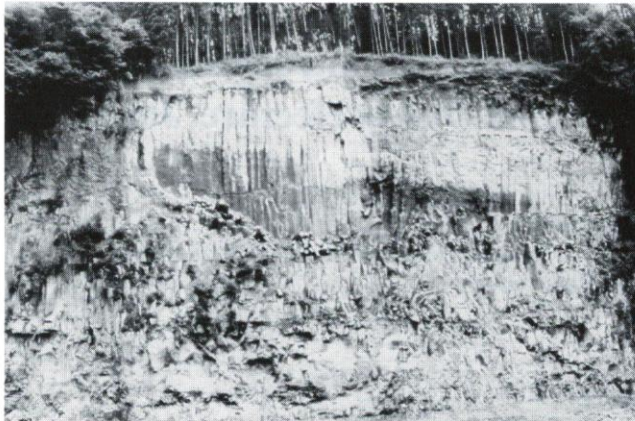
The rock slope (Fig. 1) is vertical, 400 m long and ranges in height from 30 to 60 m. On May 14, 1997 the area experienced rainfall of 33 mm/hr, which triggered a failure of the rock slope at this site resulting in 16, 150 m<sup>3</sup> of rock debris. The slide was approximately 100 m wide and 3 m deep. During sliding, some rock blocks bounced off to the left bank of the river and destroyed a window of a building. Besides, it also narrowed the river channel. In addition to this latest failure, the slope has failed twice in the past: first in 1920 and again in 1955 as revealed by available records.

Fig. 1: Photograph showing the rock mass (welded tuff) of the slope.

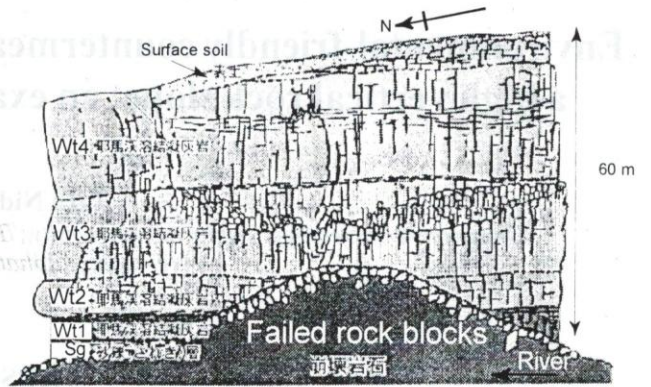
Although all of the four flow units were involved in the latest failure, main failure zone is confined in the 3<sup>rd</sup> and 4<sup>th</sup> flow units (Fig 2). There are numerous cracks seen on the cliff face in flow unit 3 and 4. But flow unit two has only a few cracks, whereas the flow unit one has no such cracks. At the ground near the top of the slope, there are some open vertical cracks of 0.1m wide and 4 m deep. These cracks are not inter-connected with the cracks lying further below on the slope face. Besides these cracks, the rock mass at the slope face consists of loose rock blocks of pillar like shape. The field investigation also revealed a possibility that the underlying gravelly palaeo-channel deposit may be eroded away by the floodwater creating a situation in which the overlying rock mass may slump down. These situations coupled with the vertical angle of slope make the site prone to failure. the failure may cause a disaster by blocking the river, particularly, if it leads to large volume of failed materials.

Fig. 2: Sketch (longitudinal section) of the slope showing joints and flow units (Wt1, Wt2 etc.) in welded tuff, which is underlain by gravelly palaeo-channel deposit (Sg). At the toe of the slope are failed rock blocks (after Esaki et al. 2000).

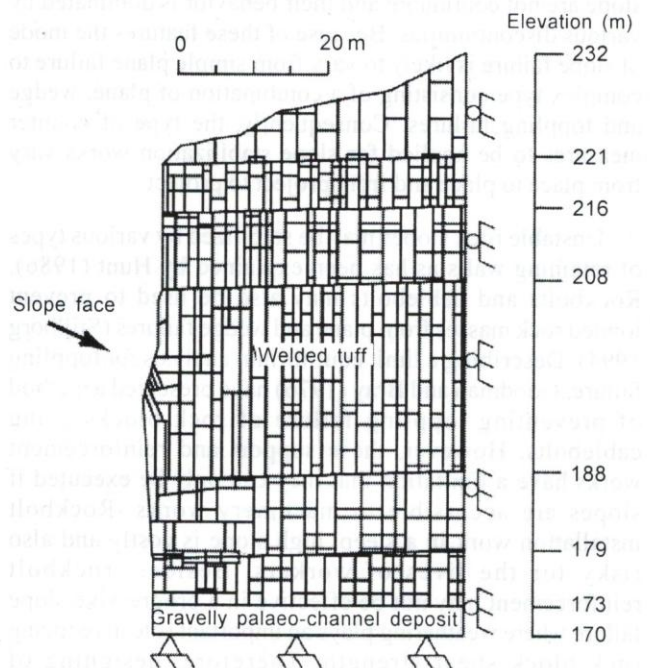
Fig.3: DEM analytical model of the slope also showing the boundary conditions employed during model run.

As already mentioned above, the rock mass of the site consists of welded tuff underlain by gravelly palaeo-channel deposit. Accordingly, the lowest band in the model (Fig. 3) is composed of gravelly palaeo-channel deposit and overlying it is the jointed mass of welded tuff. During DEM analysis, the right boundary of the model was assumed to have roller boundary condition, whereas the base of the model was assumed to have fixed boundary condition.

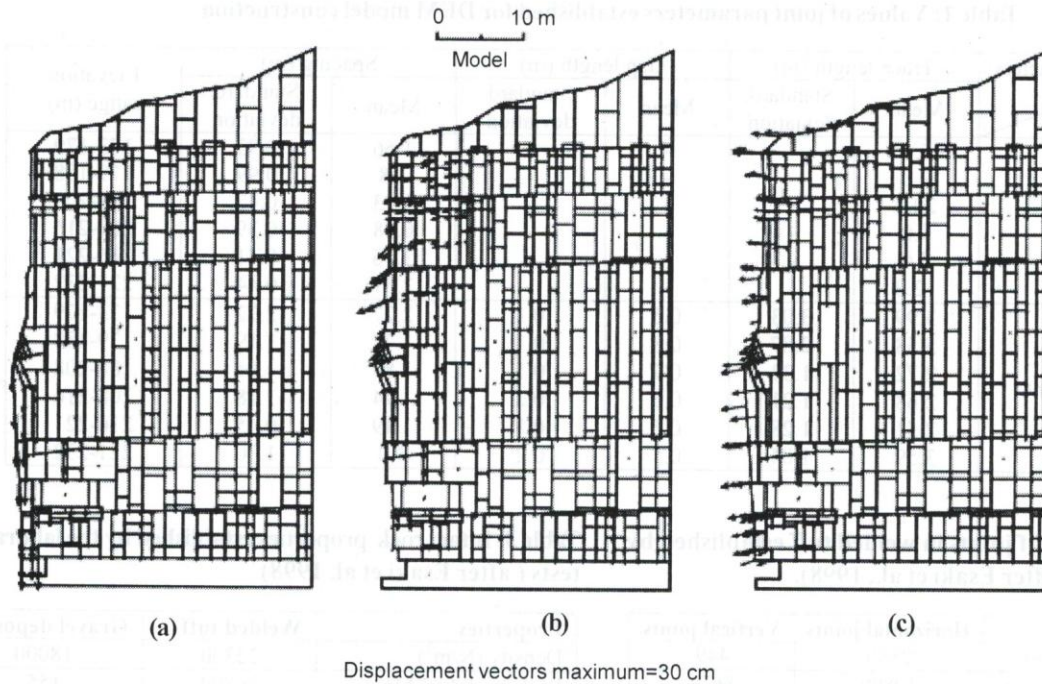
Analysis was performed to assess the response of the slope to a situation when an exposed portion of the underlying gravelly palaeo-channel deposit is eroded away. This situation is intended to simulate a flooding case when floodwater may wash out some portion of the poorly cemented gravelly palaeo-channel deposit. The model analysis shows that the rock mass lying above the gravel deposit slumps down, but the failure extends only up to about the mid-height of the slope (Fig. 4a). Afterwards, the failed rock blocks were removed and the model was run again using reduced strength properties. Fig. 4b shows the response of the model when the strength properties were reduced to 60% of the original value. This time, sliding of two blocks occurs in the upper part of the slope but the failure still appears to be confined locally. In the next case, to simulate an earthquake situation, a horizontal body force (based on static seismic coefficient = 0.1) was applied and the model was run using the original shear strength properties. In this case, the model predicts instabilities (Fig. 4c) of the whole slope, but the depth of failure does not exceed 3 m.

The results of the DEM analysis and field observations both, suggest that sliding (slumping) and toppling are the prominent failure modes of rock slope failure at the studied site. Preventive measures such as rock slope trimming, excavation for reducing the slope height and/or slope inclination may not be effective, because joint spacing is, in general, very small and thus a designed slope geometry will go on changing further inviting toppling of rock blocks. Rockbolt reinforcement may also not be a good choice, because the slope is very high and inaccessible to machinery works. Besides, the rock blocks are small in size, loosely packed and their strength will further reduce as weathering continues. This may lead to further reduction in the size of rock block and, consequently to reduction in shear strength as well. Consequently, rockbolt reinforcement may not be effective, as the smaller rock blocks tend to fall down and thus lead to progressive failure.

**Fig. 4: Displacement vectors developed in DEM models for different situations. (a): Erosion of gravel deposit, (b): Reduction of joint strength, and (c): Development of horizontal body force.**

Based on the field study and the DEM analysis it may be concluded that the sliding (slumping) can be restricted by constructing a concrete base structure, provided adequate provision for draining the slope behind the structure, is made. The concrete base structure protects the underlying palaeo-gravel deposit from being eroded away due to floodwater and thus prevents major instability, but as already discussed

above, toppling and sliding of individual rock blocks may still take place naturally in the upper part of the slope. As a result, the volume of the failed materials will be reduced considerably. A simple rock mass monitoring system may help to understand the critical condition of individual rock block that may fail and thus a swarming may be issued to safeguard public lives and properties including restoration works in the event of disasters.
