Mid-1997 tidal surge of bay of Bengal at Digha on the East Coast of India: Its damage evaluation and mitigation

A. Acharyya, B. Sengupta, and R. N. Ghosh
Geological Survey of India, Calcutta, India

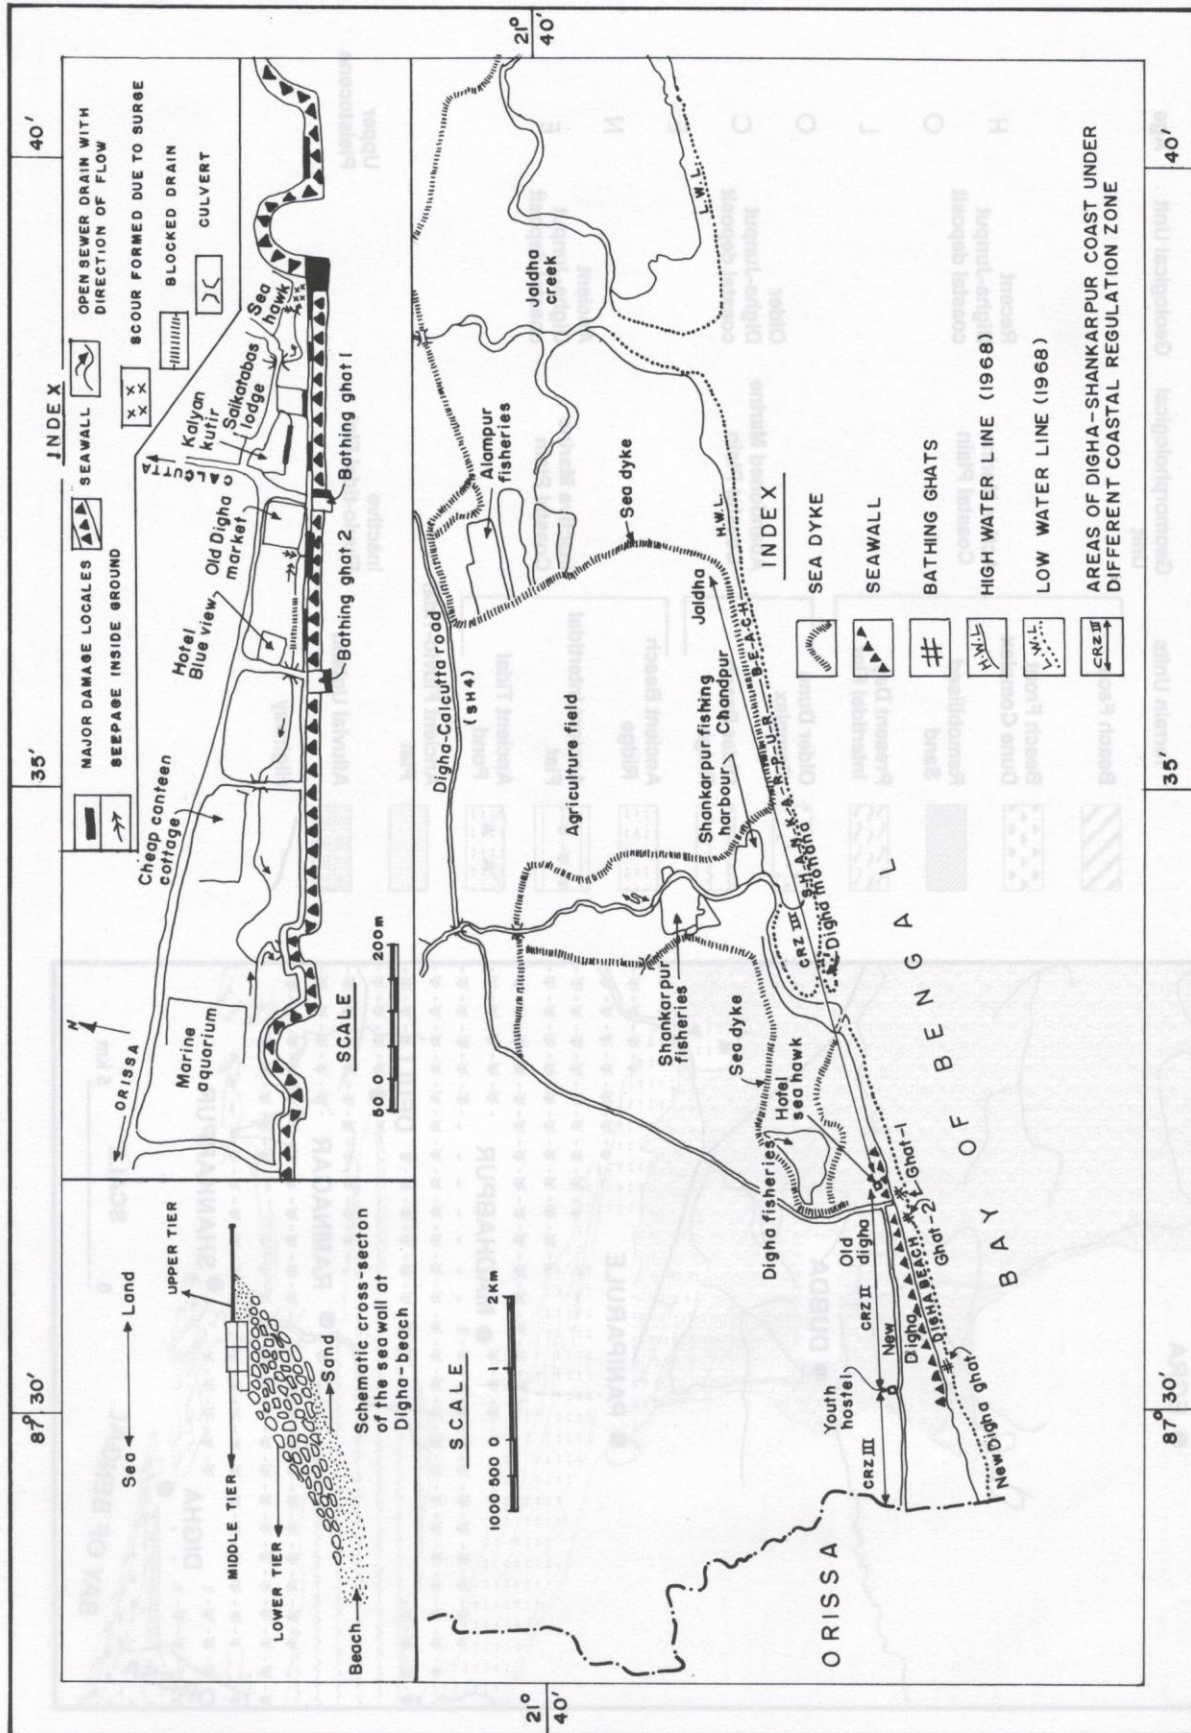
Fig. 2: The Digha-Shankarpur coastal plain prior to the mid-1997 surge

The major damage was observed in the seawall from its easternmost extremity to bathing ghat (ramp) no. 2 in the west (see top-right inset in Fig. 2). There was no major damage of the seawall west of bathing ghat 2 except local

The "Seadyke" right at the Shankarpur beach (Fig. 2) was buried under beach front dunes for last couple of years. That became exposed for a length of 312 m due to this tidal

surge. Dune cover over the brick wall was removed and the wall collapsed and displaced. The supporting underground column of the brick wall had markedly risen above the beach surface.

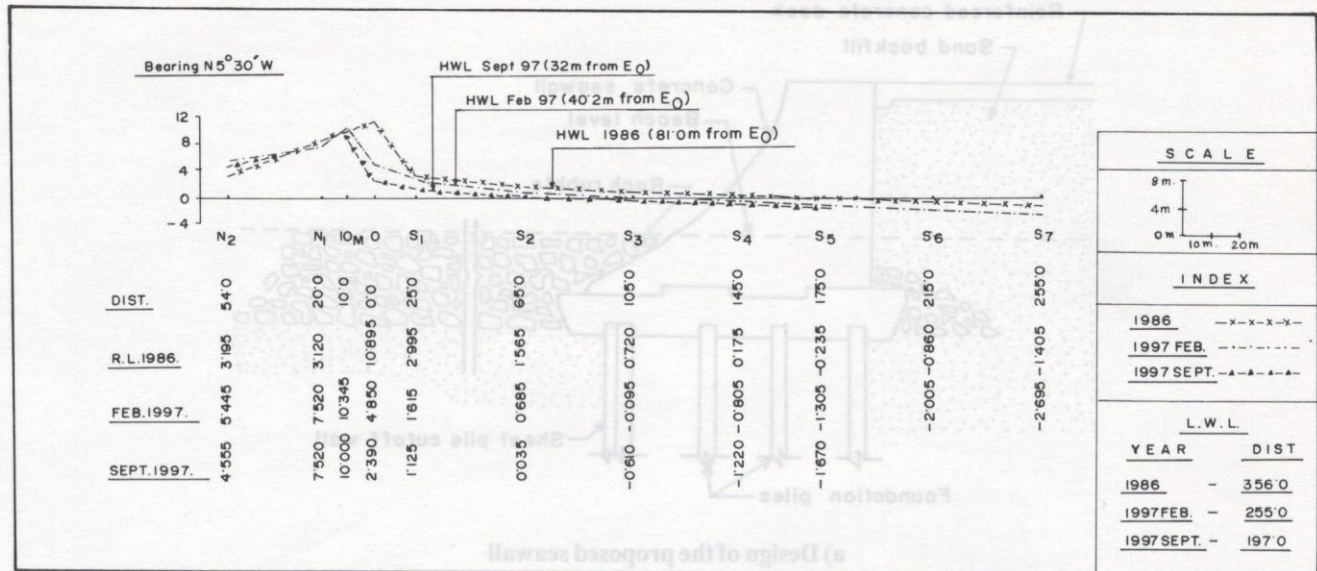
Fig. 6: Comparison of beach profiles at station E, Digha

The impact could be actually measured in one of the Geological Survey of India's ground monitoring stations (Fig. 1, Profile E). A comparison of profiles between 1986, February 1997, and September 1997 depicts the severity of damage to the natural barrier of dune as well as to the stretch of beach (Fig. 6).

On scrutiny of successive profiles at E-line, it may be documented that there was a remarkable lowering of beach front dune top due to the direct wave impact in the base. The 'O' position of the profile was stationed at the dune top with an RL of 10.895 m from msl in the year 1986. Measurements of the profile in February, 1997 revealed that the RL of 'O' position had been reduced to 4.850 m resulting in 6.045 m of total lowering in twelve years. However, a repeated measurement in September 1997 depicts the drastic lowering of 2.460 m solely induced by the disastrous tidal surge of 20 August 1997.

The 'S-2' position (65.0 m seaward from 'O' position) of the profile represents the upper beach face within the influence of the high tide. This shows beach lowering to the tune of 0.880 m between 1986 and February 1997. It is intriguing that the beach was eroded away for 0.650 m in this position within September 1997 as an aftermath of the storm event.

Now for quantifying lateral of dune face, maximum strip of dune cover in the lower slope of sea-facing side may be considered. This amounts to nearly 10.0 m of dune face removal as a result of the tidal surge. However, the dune face retreat was more or less gradual in the preceding years when nearly 12.0 m of thickness of sand from widest part of the dune face had been washed away.

Both high water and low water lines have been advancing towards land over the years. The HWL shifted 49.0 m landward between 1986 and September 1997. As a result, the beach face width of 275.0 m in 1986 has been reduced to 165.0 m in September 1997.
