Flash flood and debris flow in the Harihara River, Kyushu, Japan

N. Gurung¹, A. Rahman¹, and Y. Iwao²

ABSTRACT

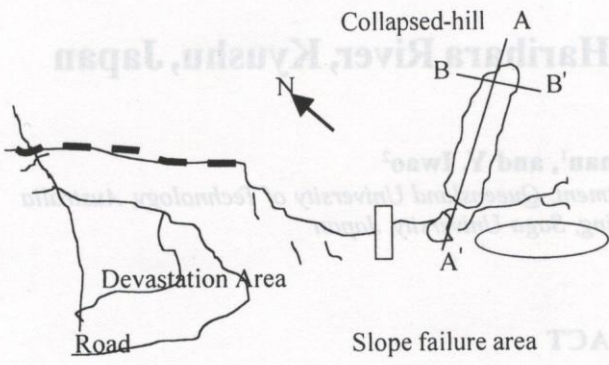
Fig. 1: General sketch of the landslide area

The detailed survey and measurements were carried out in the landslide area. The positions of the river, fan, collapsed slope, agricultural pond, and check dam are shown in Fig. 1. The cross-sections of the collapsed hill and longitudinal section are shown in Fig. 2 and 3 respectively. A summary of the field measurements is given below:

Collapsed volume:	about 150,000 m ³
Thickness of collapsed slope:	maximum 40 m
Capacity of dammed water:	1,200 to 4,000 m ³
Distance from failed slope to pond:	160 m
Volume of earth at original riverbed:	30,000 m ³
Capacity of pond:	16,000 m ³ (depth 3 m), 20,000 m ³ (depth 4 m)
Capacity of debris barrier (check dam):	20,000 m ³
Watershed area:	0.69 km ² , and
Slope of fan:	about 3°

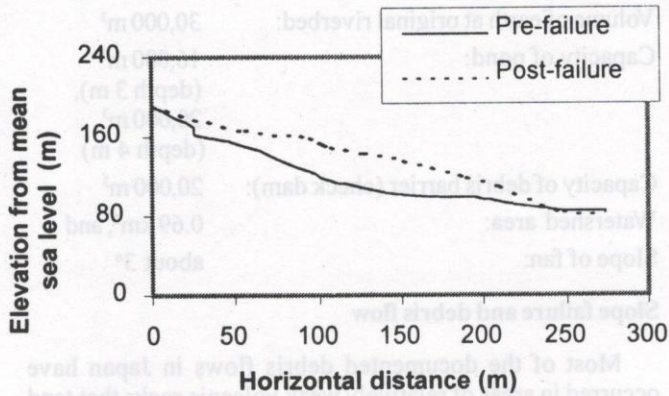
Fig. 3: Comparison of the pre- and post-failure longitudinal profiles along AA' (location is indicated in Fig. 1)

The longitudinal section (Fig. 3) shows the slopes along AA' before and after the failure. From the hydro-meteorological records of that day, the outflow of the Harihara River was back analysed, and obtained normal flow and maximum flood level are shown in Fig. 4.

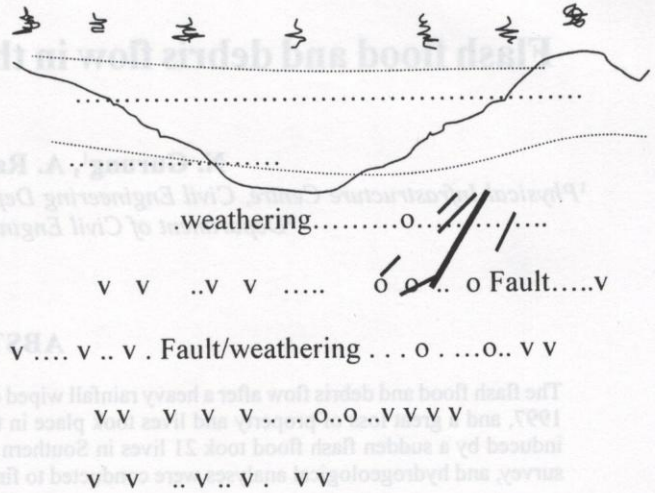
Fig. 2: Cross-section along BB'

The foothill slope lying between 100 m and 190 m and having a width of 70–80 m had failed in a deep scoop shape. The failed slope was composed of highly fractured autobreccia of andesite, and its upper part was weathered strongly. Fig. 2 illustrates the lithology of the failure region. The soil surface was covered by vegetation (many trees were found buried in the debris). A fault zone with many slickensides was observed on the left flank of the failed convex valley. There was an aquifer of perched groundwater as indicated by the springs around the fault zone. The formation of a landslide dam in the river and development of a muddy water pool behind it were inferred on the basis of floodwater marks on the trees near the junction of the slope failure and on the left bank of the Harihara River. The landslide dam was partially filled up by the debris. The breaching of dam led to a hydraulic jump of the debris-laden water. The debris flow rolled down and abraded on the left bank of the Harihara River, and then buried an orange orchard. The head of the debris flow was tongue-shaped with big boulders in front of it. The riverbed of Harihara was filled up by the debris and was converted into an extensive fan containing big boulders underneath the red clayey soil. Some trees were standing intact on the fan.

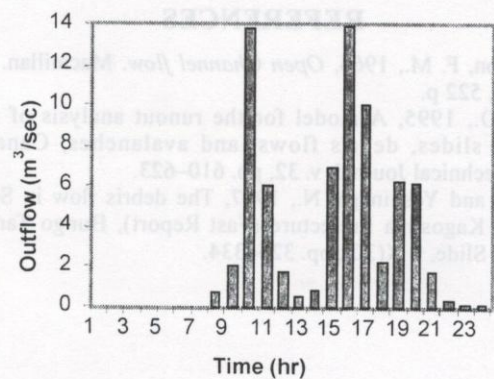
Fig. 4: Outflow hydrograph of the Harihara River

At 4 p.m. on the previous day, the water level in the river had reached to its maximum. The water had overflowed the riverbanks and submerged the orange orchard and garden. The flood subsided to the normal condition only after 11:00 p.m. Consequently, all the villagers went to bed. Only at midnight, the echoes of loud sounds had awakened them. But most of them could not figure out the reason and meaning of the sounds until it was too late for any safe runaway.
