## Reassessing the Building Construction System and Quality Issues in Relocated Settlement after the Gorkha Earthquake

**Rabindra Adhikari**

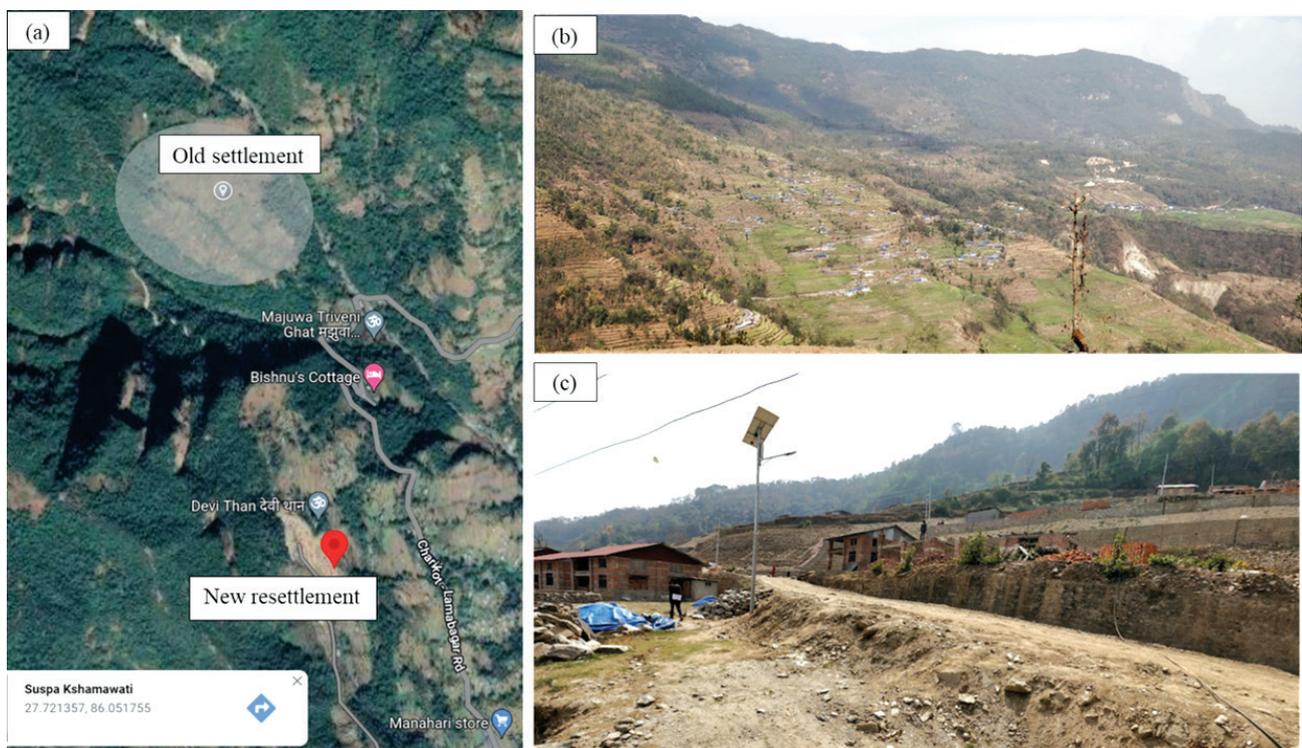
Figure 1. (a) Location of the old and new settlement, (b) The old settlement area, (c) The new settlement area.

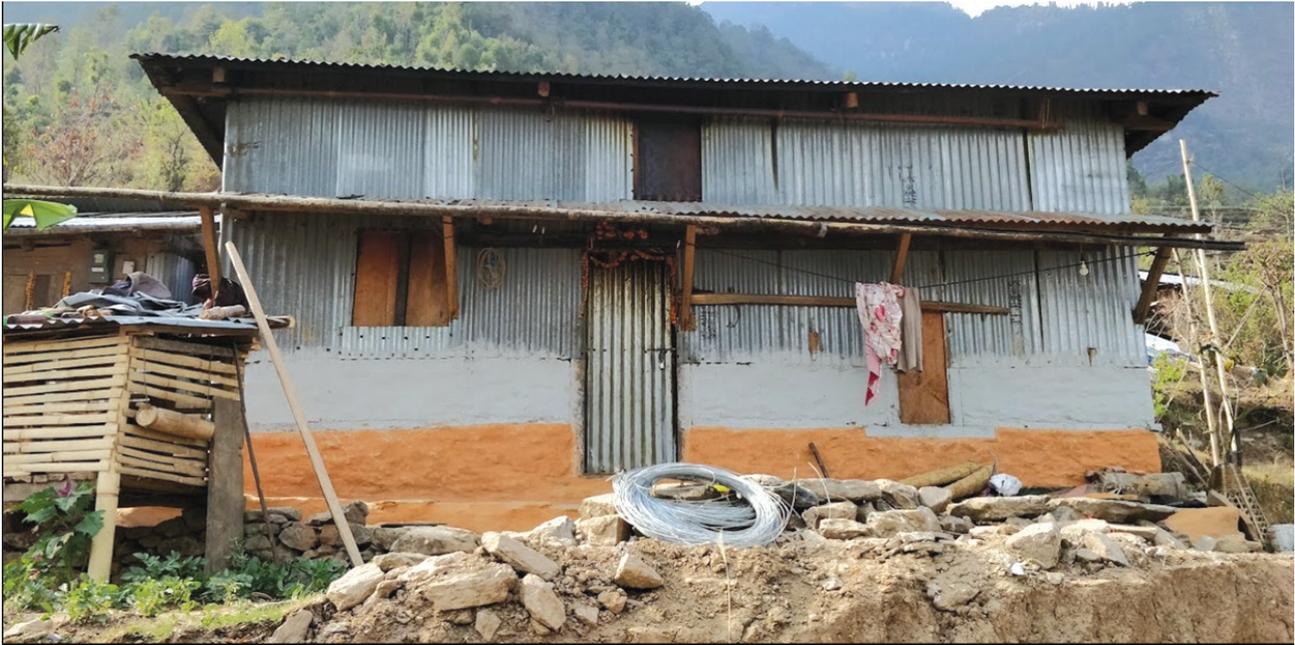
Figure 2. Half height of old building was retained to rebuild CGI sheeted two-storey building.

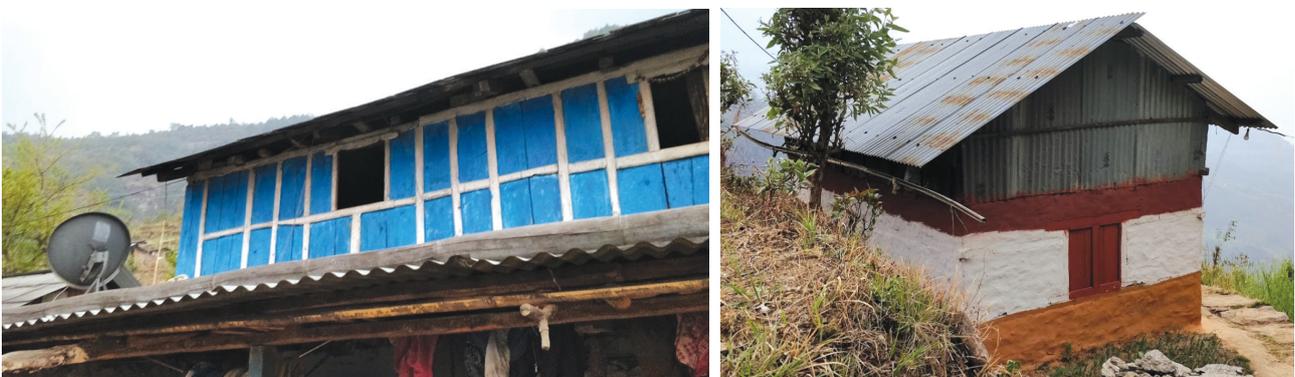
Figure 4. Reconstructed two storied buildings by building adding light timber frame structure over old first storey.

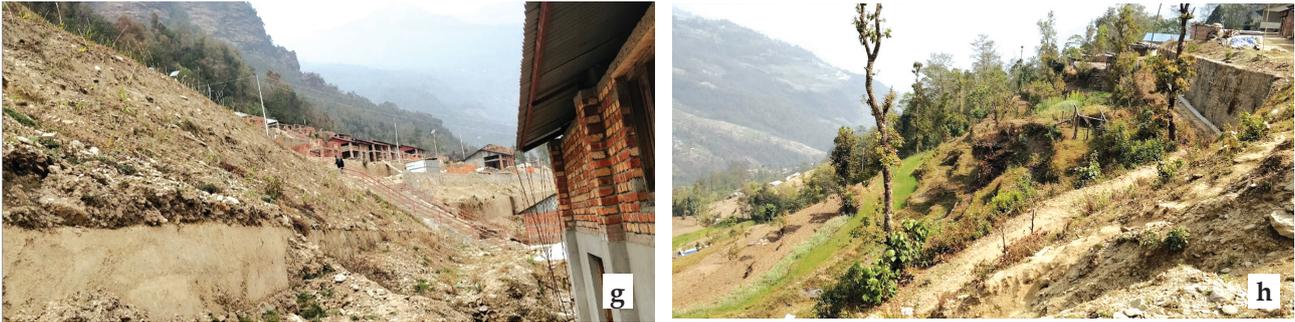
Figure 8. New Settlement area of Pani-Pokhari (a) Site located at the foot of cliff, (b, c) The steep terrain of the site (d, e) Retaining wall used for slope stabilization (f) Rock exposure at a site (g) Steep slope for a plot even after retaining wall (h) The lower side to the settlement, with a catch drain and steep terrain.

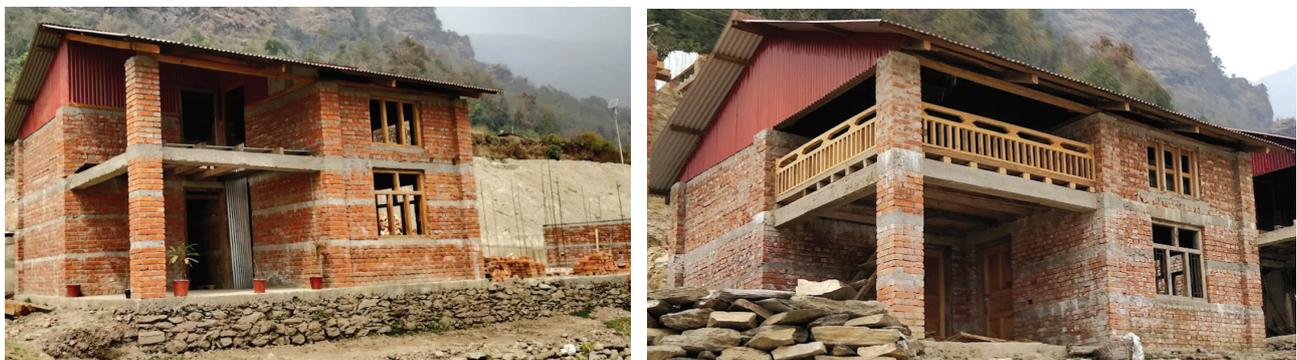
Figure 12. Two storey construction with missing dowel band in first floor

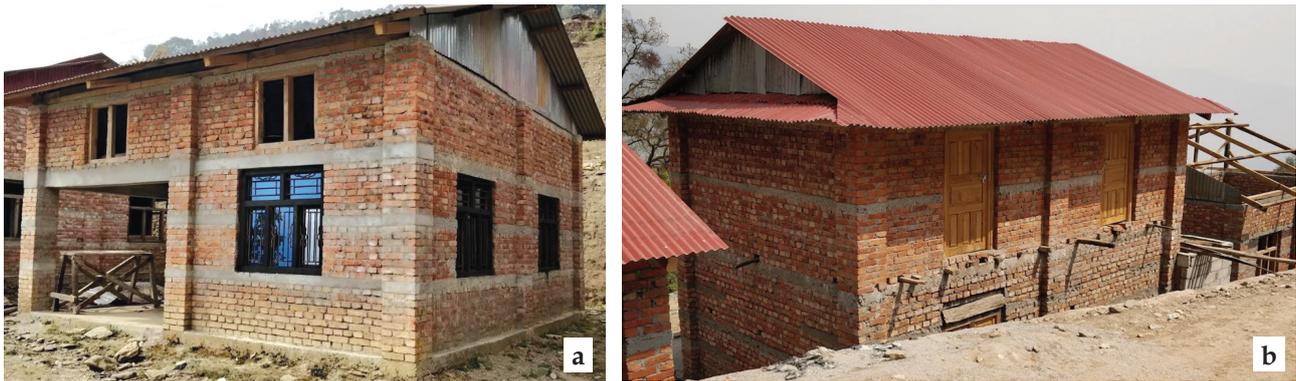
Figure 13. (a) Two storey construction (One plus tall attic) with brick wall in attic above veranda and opening in front and back only in attic (b) Complete two storey building built on valley-side of road with single band at mid-height level.

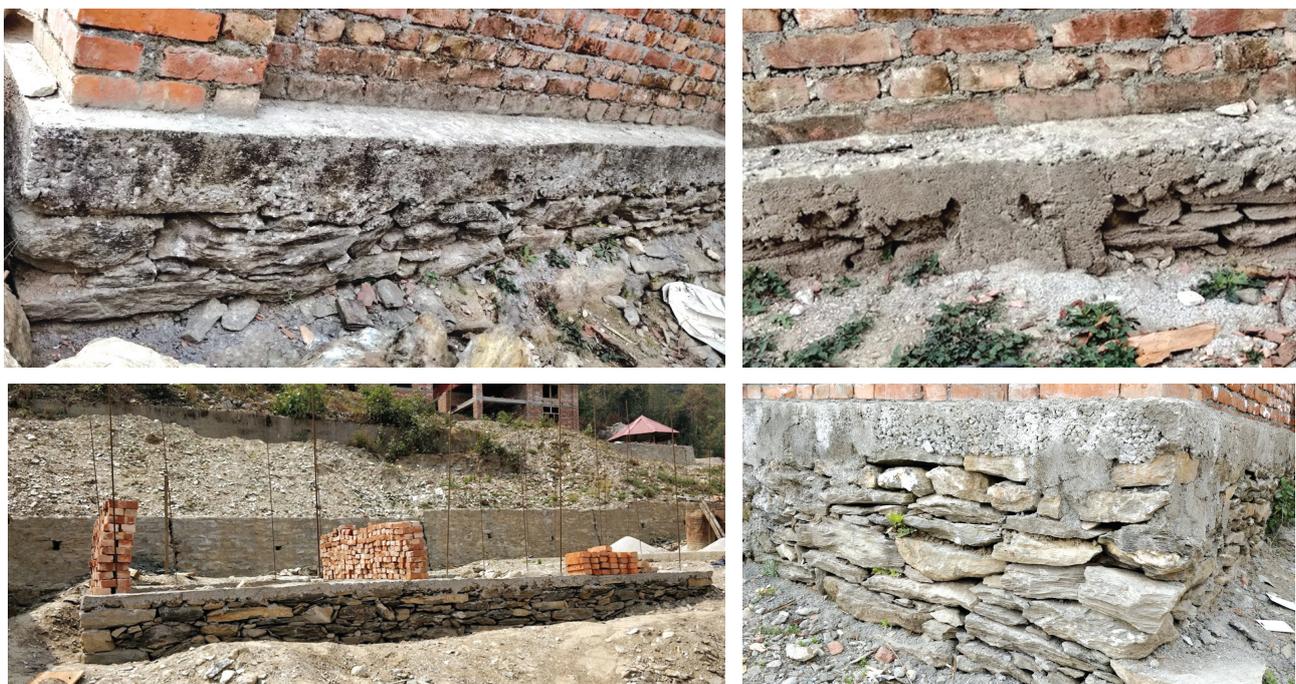
Figure 14. The plinth wall construction in dry stone

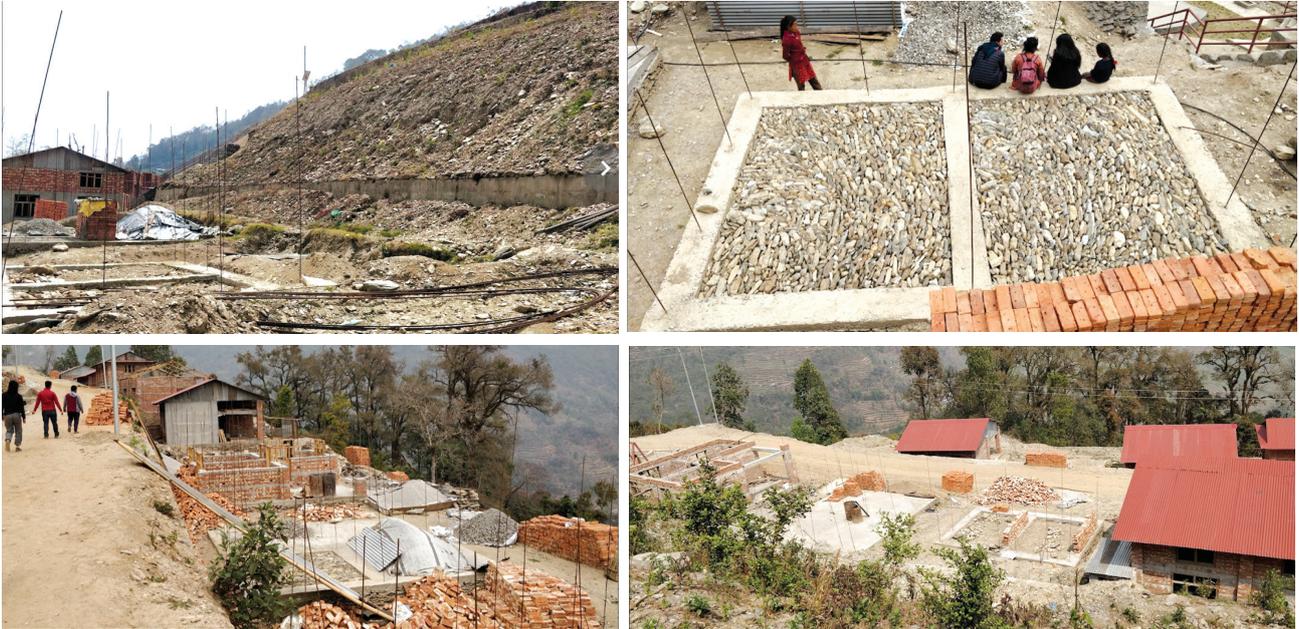
Figure 15. Plinth beam construction and laying of vertical rebars

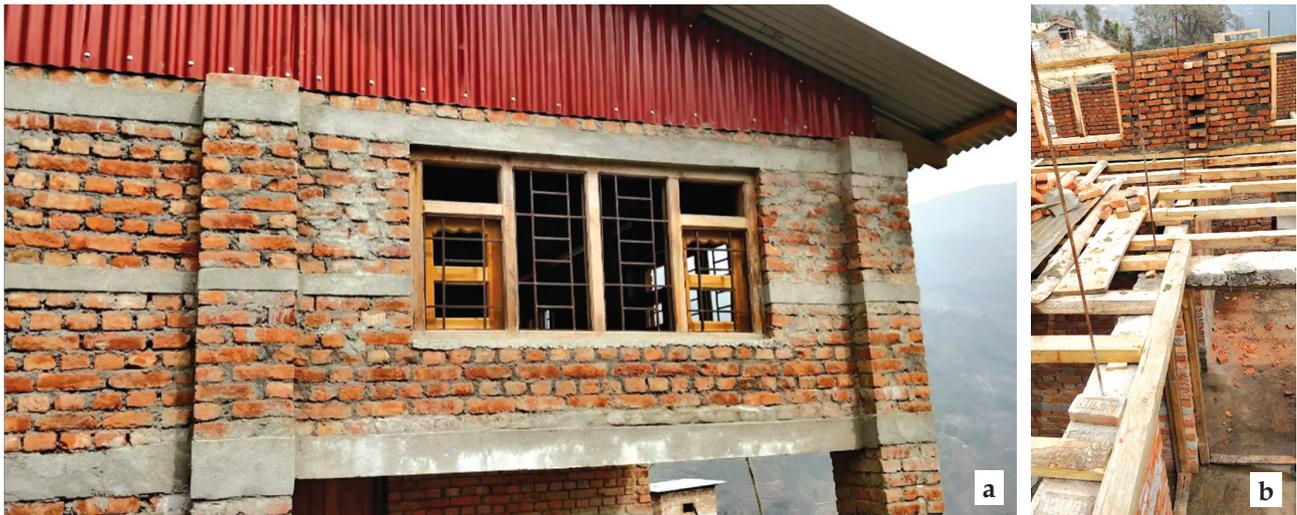
Figure 17. (a) Discontinuous band in attic. (b) Use of toothed construction practice

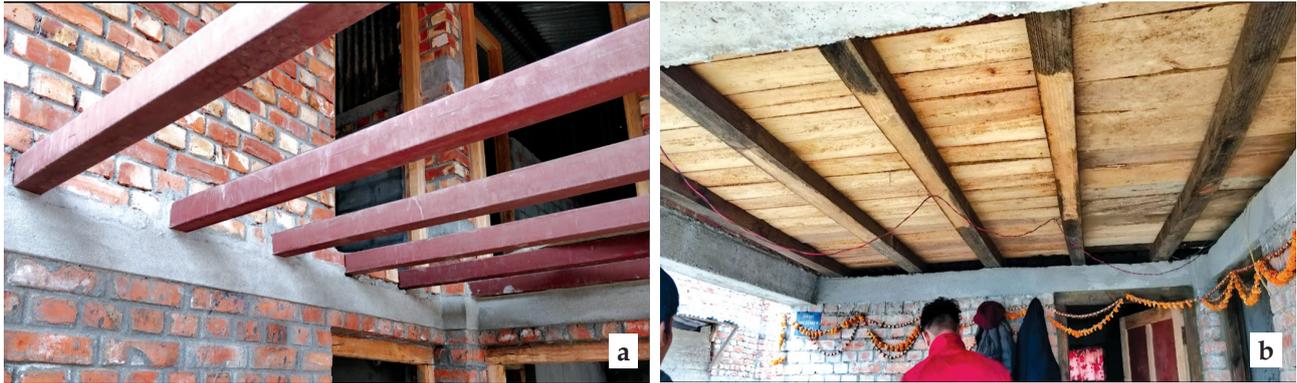
Figure 20. (a) Steel box section as floor joists (b) Typical timber joist flooring

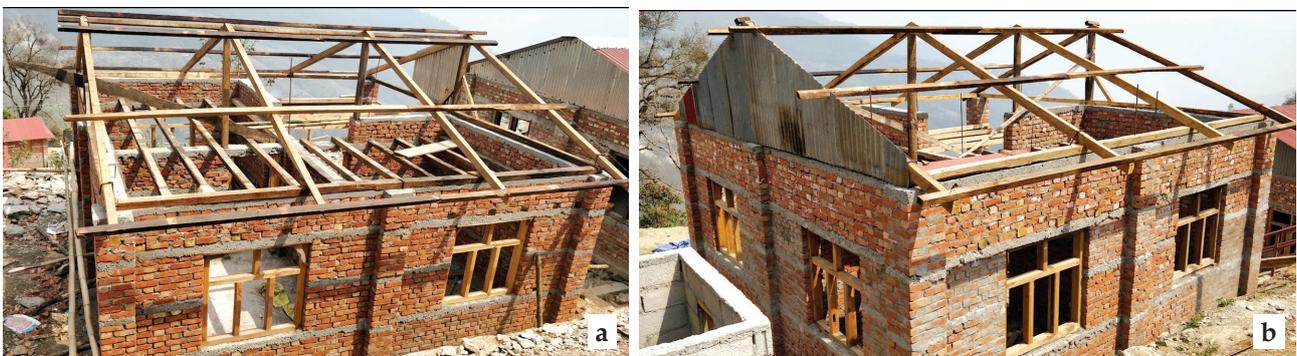
Figure 21. (a) Roofing structure and floor joists. Rafters are anchored by bending the vertical rebar around it. (b) Fixing appropriately cut gable sheet before fixing roofing sheet.

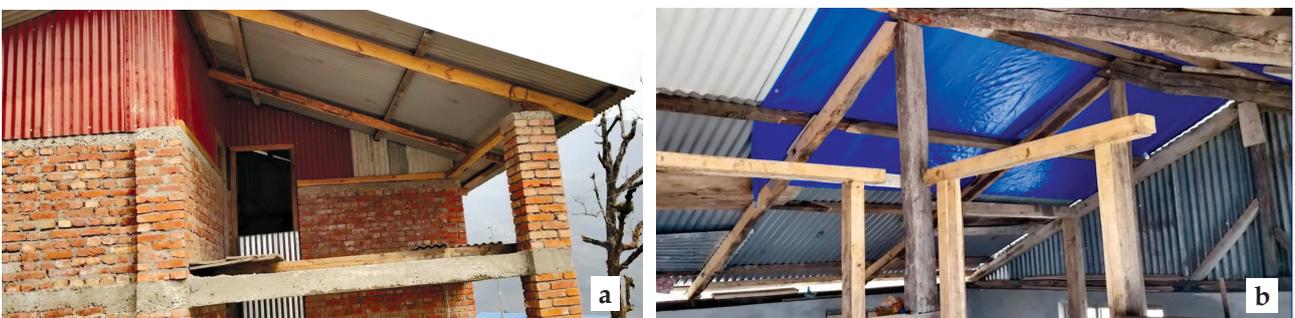
Figure 24. (a) Completed roofing structure, with rafter tied in vertical rebar. (b) Use of old and new timber in roofing structure, vertical rebar left unanchored, and wall in attic constructed only upto 4' height, remaining to be constructed in timber frame and light partition of CGI or timber.

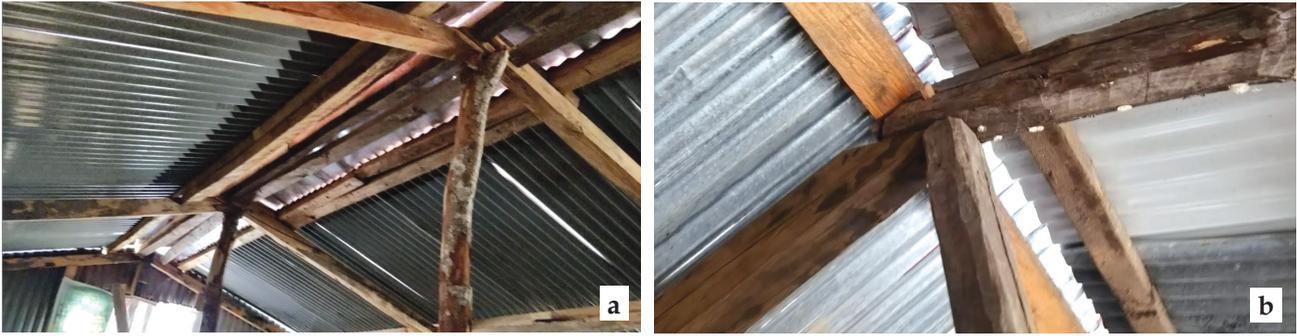
Figure 28. (a) Roof with ridge cover (b) Roof without ridge cover using overlapping technique.

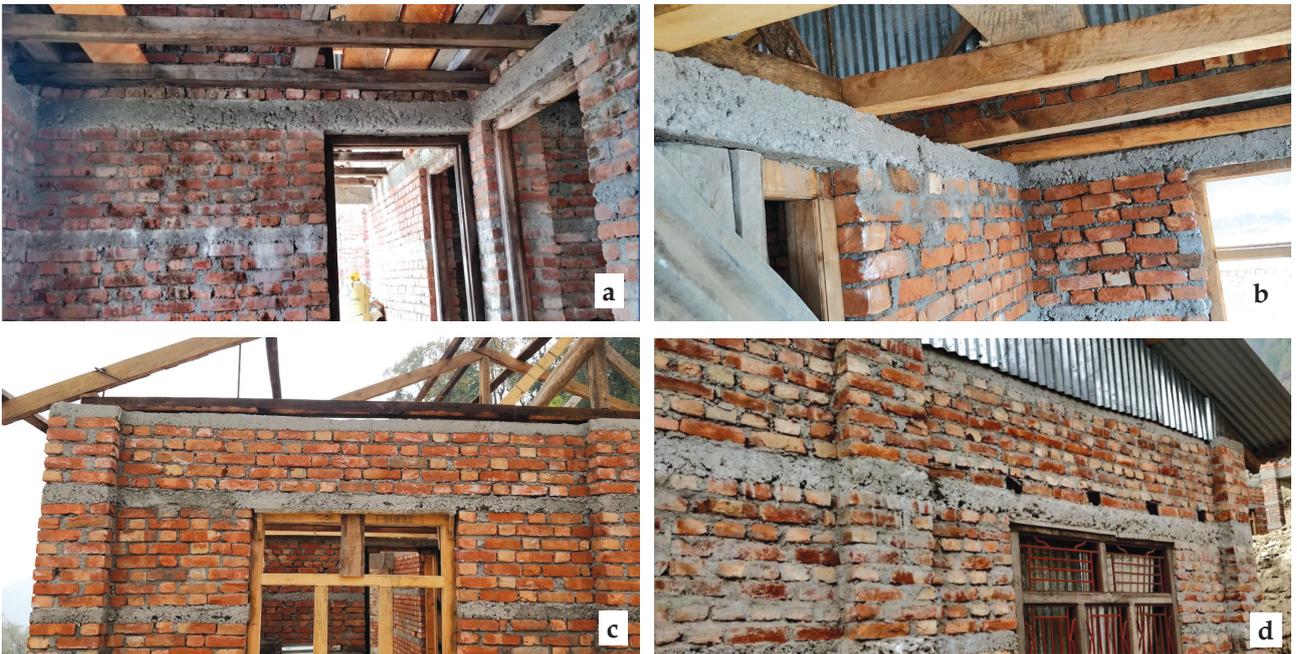
The quality of concrete was found to be compromised in several cases as shown in Figure 29. Honeycombing and rebar exposure were commonly observed in many reconstructed buildings. In few cases, very poor quality of concrete was observed which could be scrapped off even by finger nails as in fig 29(f).

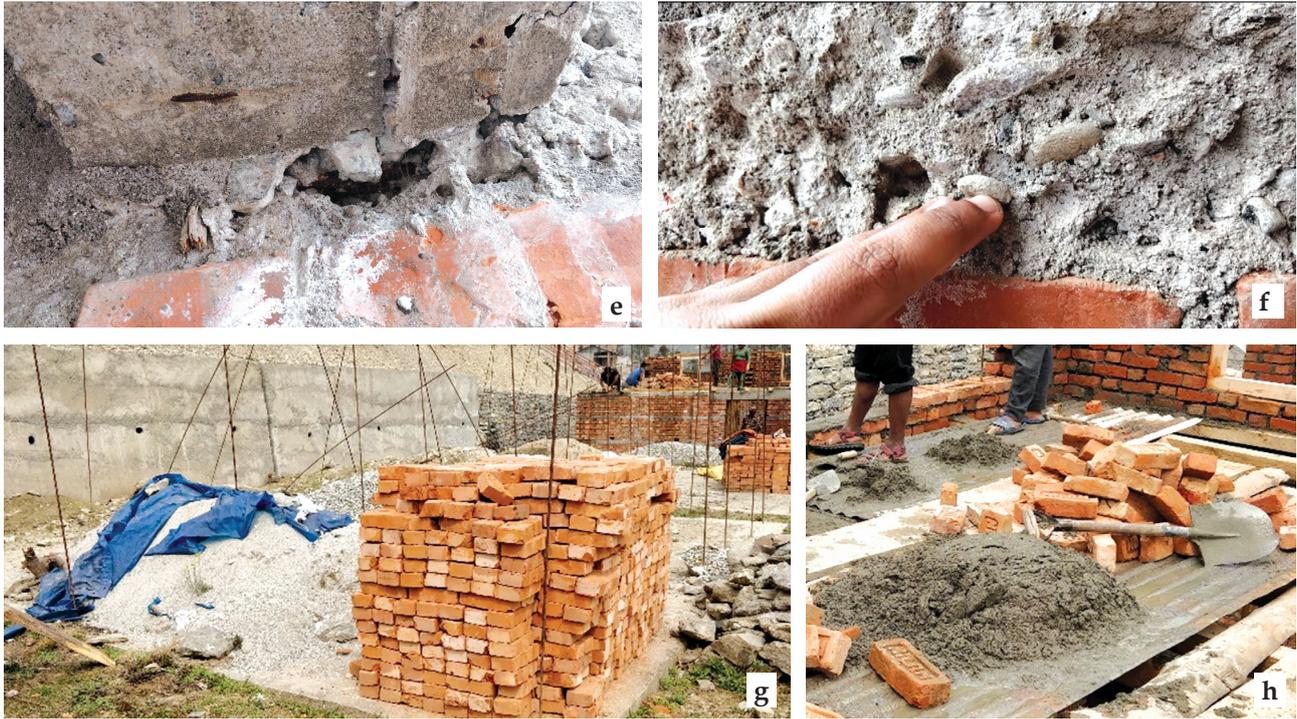
Figure 29. Various concrete defects in reconstructed houses (a-e) honeycombing and exposure of rebar in bands (f) very poor-quality powdery concrete easily scratchable by hand, (g) sand stockpiling with vegetation (h) prepared mortar for construction.

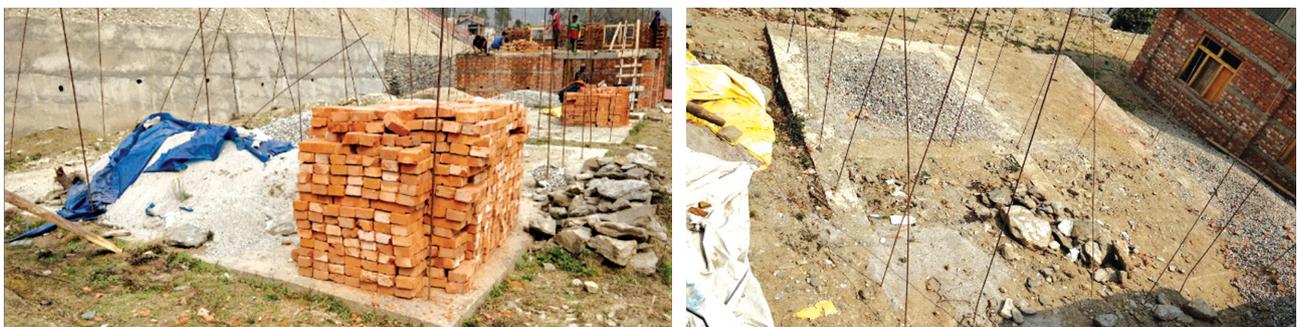
Figure 30: Vertical rebar left unprotected at plinth

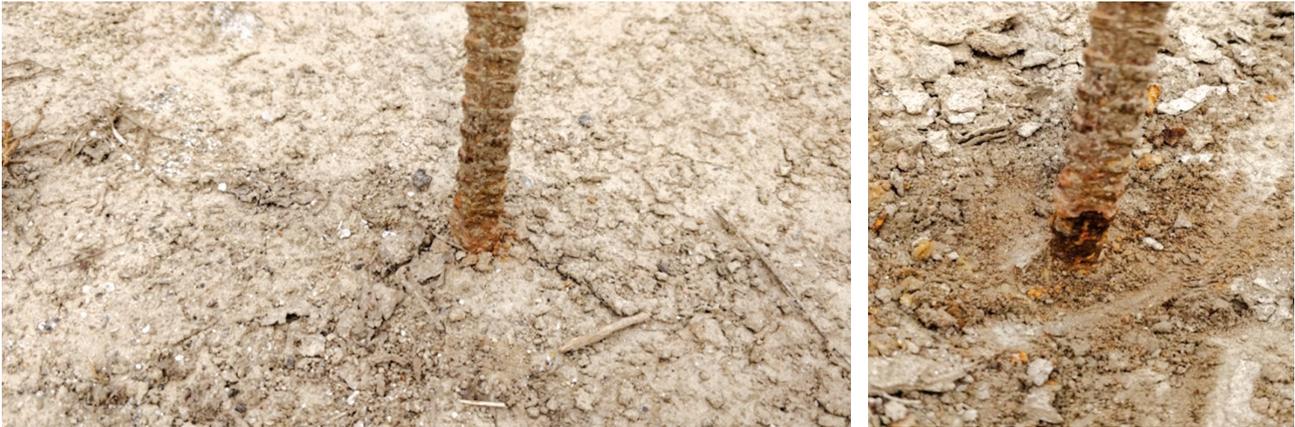
Figure 31: Corrosion of vertical rebar near plinth

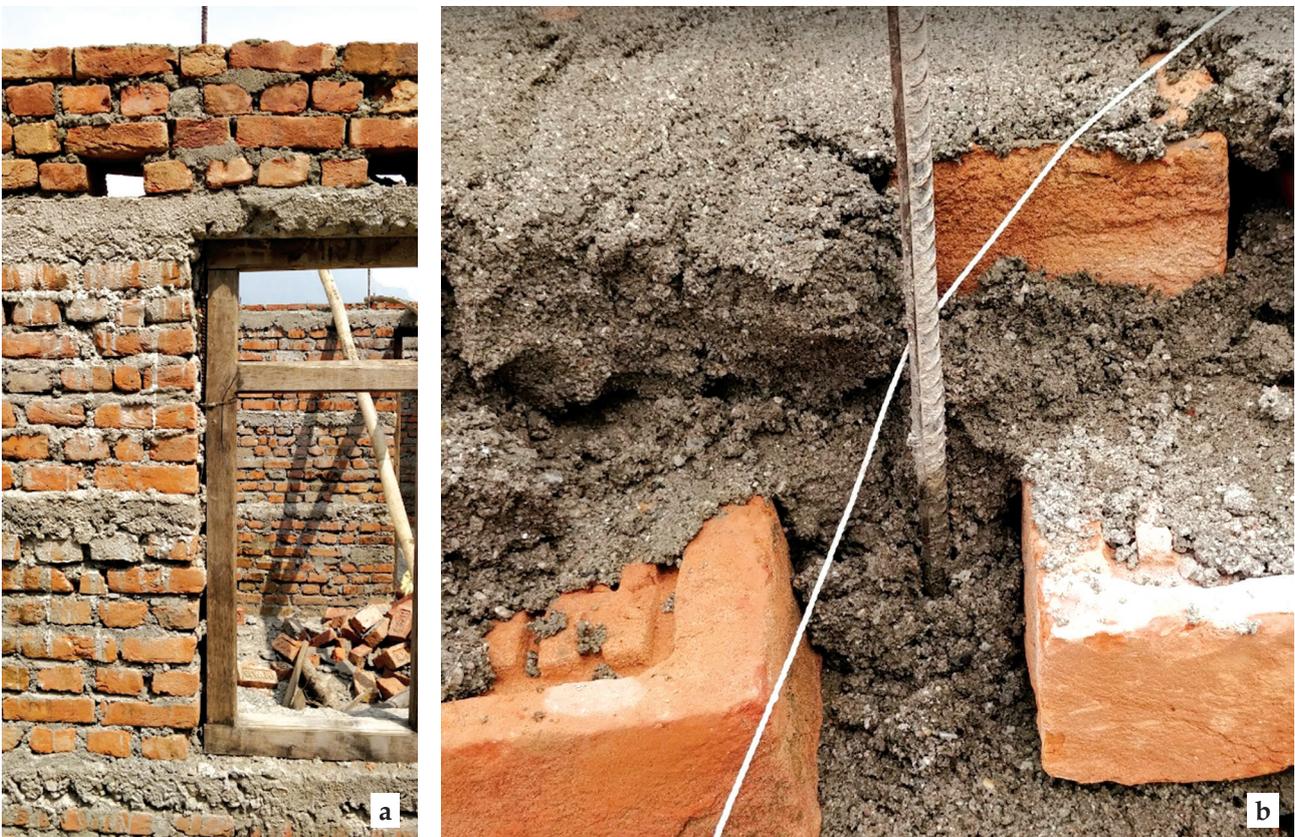
Figure 32: (a) Jamb rebar exposed on window side (b) rebar embedded in concrete wall in mortar

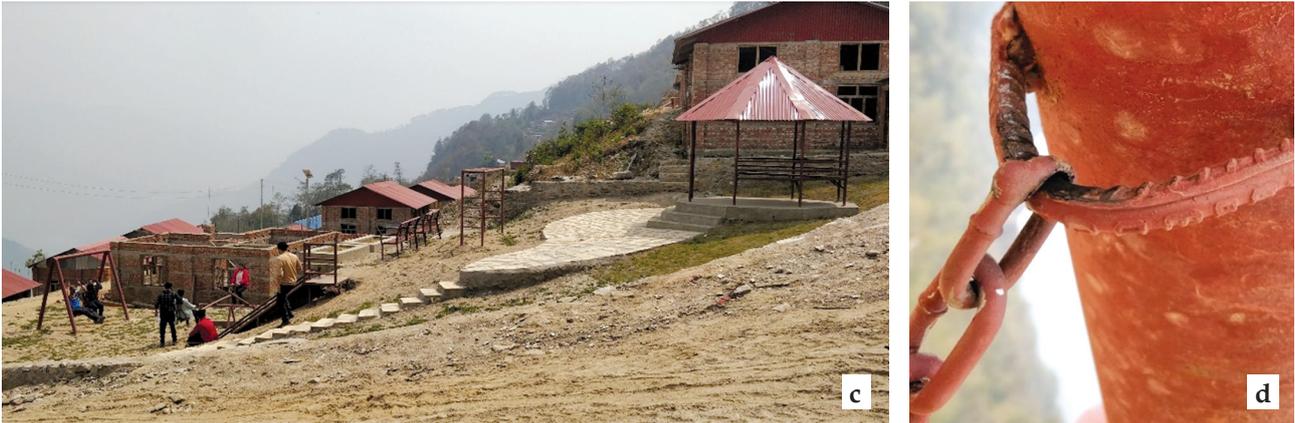
Figure 34: (a) Open parapet, (b) Temporary water collection and distribution system (c) Children's playground, (d) Significant reduction of section of chain due to friction in the swing of playing ground.

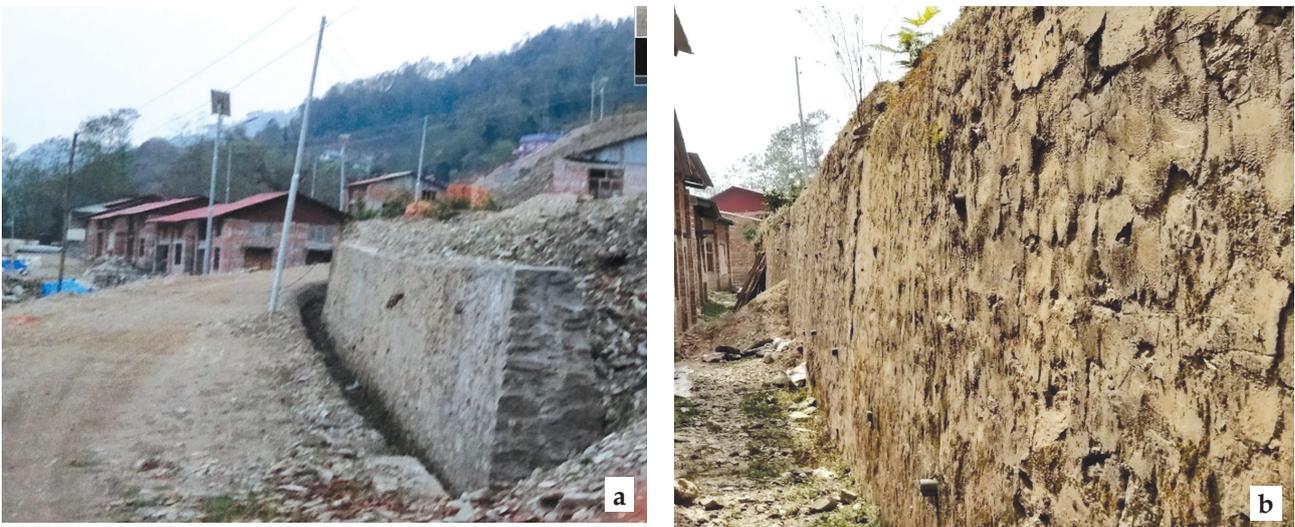
Figure 35: (a) Tilted electric transmission pole (b) Stone masonry retaining wall of poor workmanship

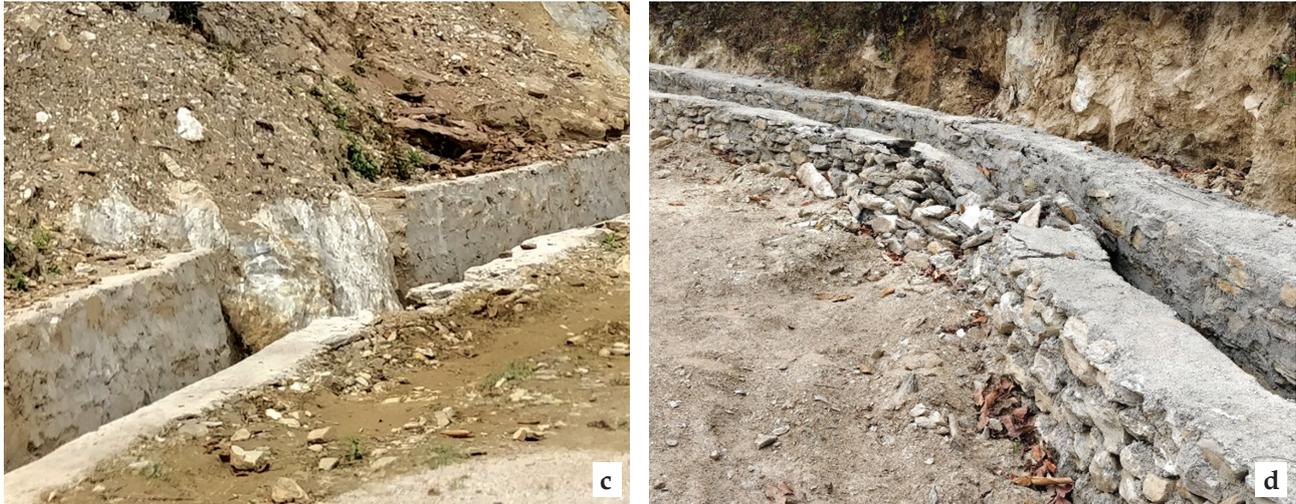
Figure 36: (a) Poor quality mortar in drain that is easily scrapped by shoes (b) the drainage ended in the nearby area without erosion control measures, (c) Damaged drainage and obstruction by stone in early stage of construction, (d) Poor quality of stone masonry work in drainage.
