### Study of Common Construction Practices and Structural Defects in RC Buildings in Darchula District Far-Western Nepal

**Birendra Kumar Bohara**

#### Abstract

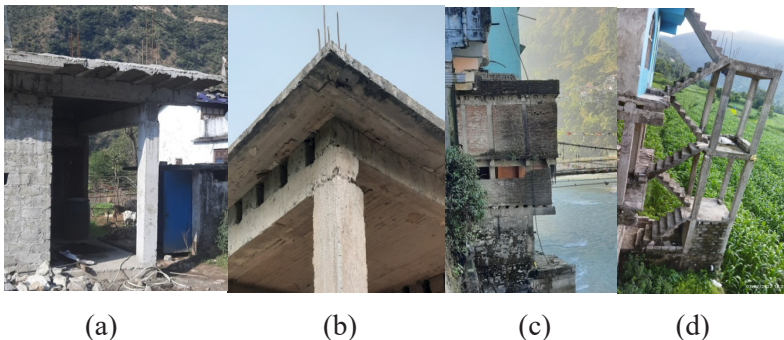
**Figure 4**

In Mahakali municipality, most of the construction of the column-beam joint is not monolithic. Figure 4 shows the construction of one axis beam resting on another axis beam in the columns. It is common in this area. While observing the 467 buildings, 24% of buildings have poor beam-column joints. Due to this, the connection of beams and columns seems to be vulnerable to earthquakes (Varum et al., 2018). The building data also shows that some buildings have small column sections (230mmX230mm) with less than a minimum 0.8% rebar and almost the same beam section that's don't follows the rules of the code. Due to this, there are maximum chances to observe the weak-column strong-beam design. It is also observed that insufficient stirrup spacing near the joint, small diameter of the stirrup, honeycombing structure and weak confinement of RC section in the RC buildings in Mahakali municipality.

(a), (b) Beam-column joints defects and column reinforcements is short for the continuity of the columns in the upper floor (c) Poor beam-column joints (d) Poor joints

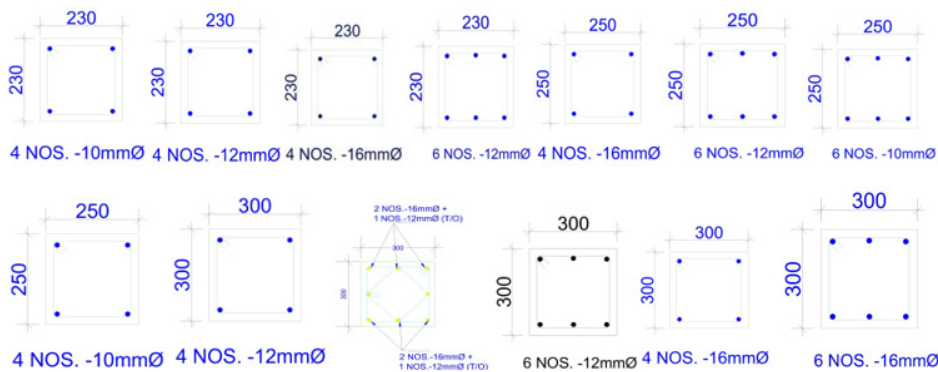
**Figure 5**

The number of main reinforcements in beam and column are undervalued. It is observed that in columns 4-10mm bars are provided. In the Gorkha earthquake, it was observed that the maximum number of buildings, which were collapsed, due to the use of less amount of rebar (Gautam et al., 2015). Since the required number of reinforcements should be, provide. It has been observed that 6 and 8mm diameter bars were used as a stirrup and spacing is 0.15m or even more. Figure 5 shows the different types of column sections used in Mahakali municipality. However, in some governmental buildings, 350 mm X 350mm and 400mm X 400mm size of columns are noticed and also a good amount of reinforcements are provided on it. The spacing of stirrups near the joints and lap splices length are not proper as shown in Figure 6. No proper structural drawings are used while the construction of buildings. Poor construction work and poor concrete quality also observed (see figure 6(d)).

*Detailing of columns used in RC buildings located in Mahakali municipality Darchula*

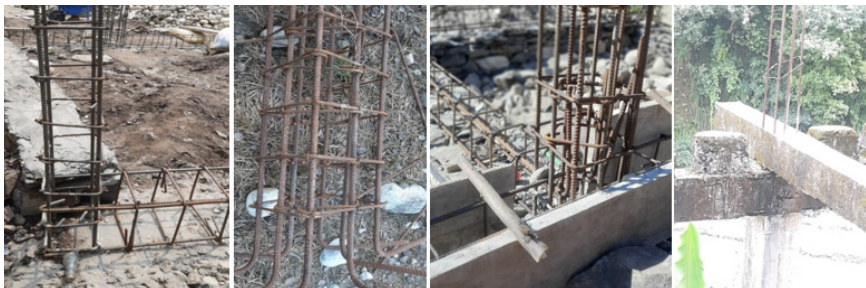
**Figure 6**

(a) No proper anchorage provided in beam-column joints (b) Stirrups spacing near the joints is more (c) No proper cover and spacing of stirrups maintained (d) Poor beam-column joint

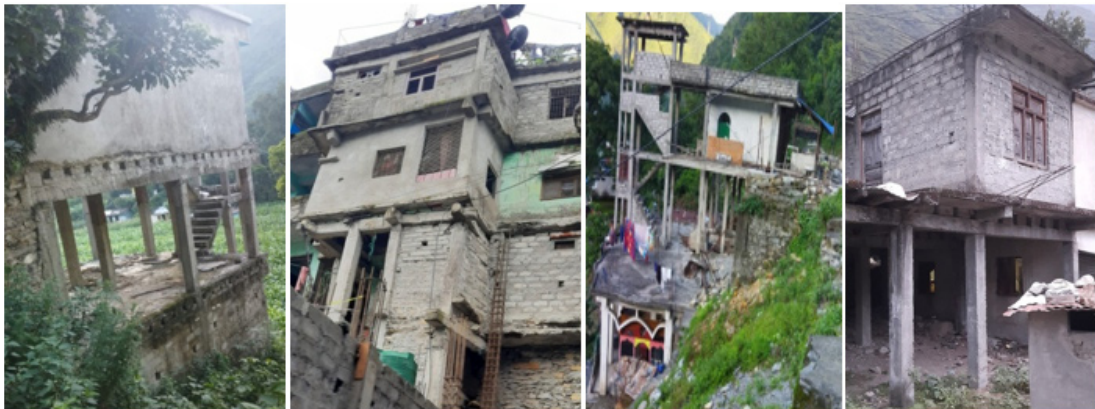
**Figure 7**

While observing the different types of buildings, almost 80 to 90% of private buildings are constructed for commercial purposes and having with shutters. Lower storey is open and upper storey are with infill brick or block masonry walls, some buildings step back buildings which cause the soft storey as shown in [Figure 7](#). It is noticed that almost 11% of buildings are as soft-story buildings. It has been observed that during several earthquakes soft-story failure is one of the common causes of collapse ([Gautam et al., 2015](#)). In the soft-storey buildings, the size of the columns are 230mmX230mm and has a minimum percentage of steel (<0.8%), which further shows the buildings are seismically hazardous.

(a) Softstorey in the mid storey of the buildings (b) Soft storey, floating columns, (c) Softstorey and short column effects (d) Soft storey

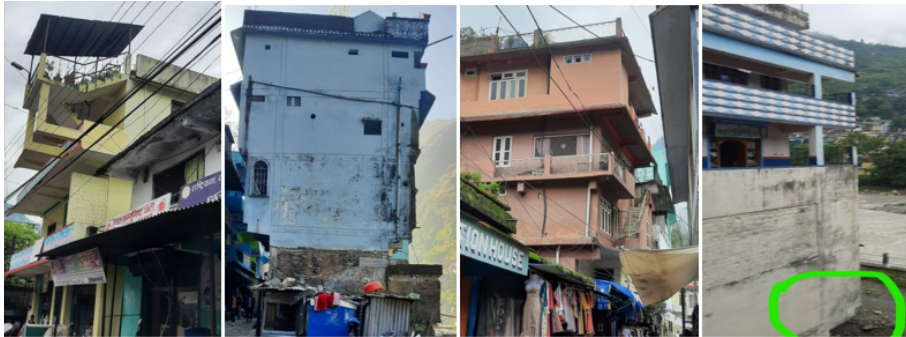
**Figure 8**

It is observed that in the upper stories the loads are increased by constructions of extra area loads which cause floating columns effects and due to the discontinuity of load path during earthquakes, the lateral load is not effectively transferred in beams, columns and ultimately in foundations. Due to the incremented loads in the upper story as shown in [Figure 8](#) overturning moments developed in columns and there is a chance to buckle the columns in the lower storey and damage may be observed. Such types of buildings are designed and the use of code provisions should be properly but in Darchula it is very difficult to see the implementation of laws and codes in buildings.

*(a) load accumulation on the upper floor, (b), (c) and (d) Floating columns*

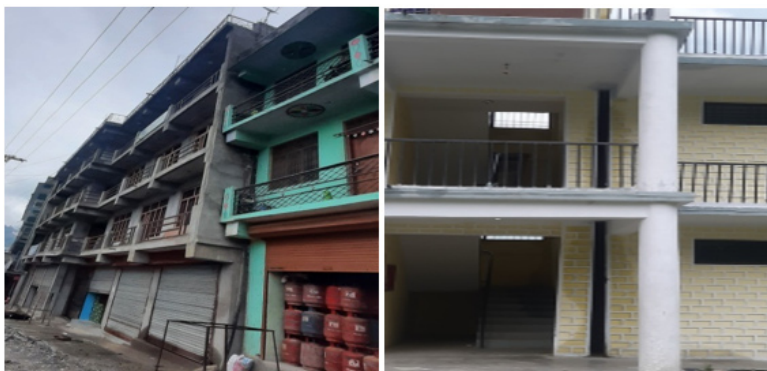
**Figure 9**

Leaving the proper dilatation gaps between structures helps to minimize the pounding effects in buildings during earthquakes. It is observed in the city area, buildings are constructed adjacent to each other without providing seismic gaps (as shown in Figure 9(a)). Different storey heights, weights, workmanship, and ages of the structures cause high load impact on each other and it may cause the failure of structures. Figure 9(b) shows that a seismic gap has been maintained in an L shape building as 15cm but due to lack of supervision, one part of the beam is joined with columns of another part of the building.

*(a) No seismic gaps in each building (b) Gap maintained but the beam of one part of the building is connected with the column of another part of the building*

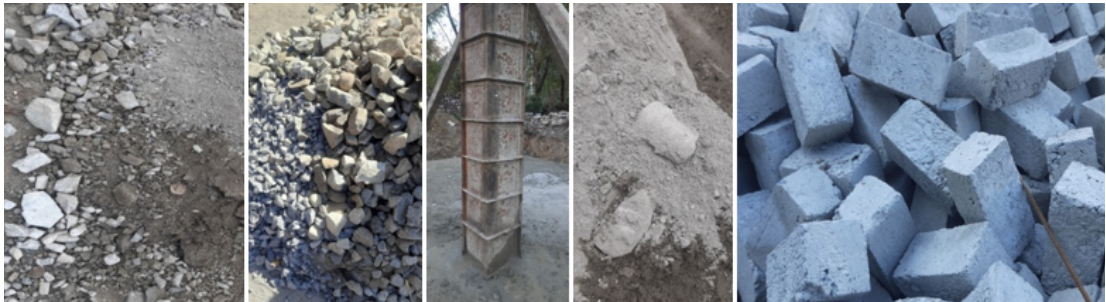
#### Figure 10

It is observed that the size of coarse aggregate is 40mm to 70mm (see in [Figure 10 \(a\),\(b\)](#)) and for this reason, they used more fine aggregates (1:3:4) is noted. Improper mixing of concrete and water cement ratio are observed. Due to poor construction technology in beam, slab and columns, these segregation, honeycombing and bleeding in concrete members are noticed. Due to this, the main reinforcements are visible and even corrosion is common on it. Patching in columns has been observed and to cover it plaster was applied on it. Almost the total height of columns (greater than 1.5m) is cast in a single stage, as shown in [Figure 10 \(c\)](#). The materials used in construction also substandard, cement used in construction sometimes used 3-month-old types of cement as shown in [Figure 10\(d\)](#). Different types of blocks are used and are made by local or house owners so it is very difficult to know their strength, specific gravity weight, and another parameter (see [Figure 10\(e\)](#)). This makes load uncertainty in buildings.

*(a) and (b) Non-uniform aggregate (c) Cements past flow outside from lower portion of formwork (d) Cement lump has been observed in site (e) Unknown specific gravity of the concrete block which is standard material*

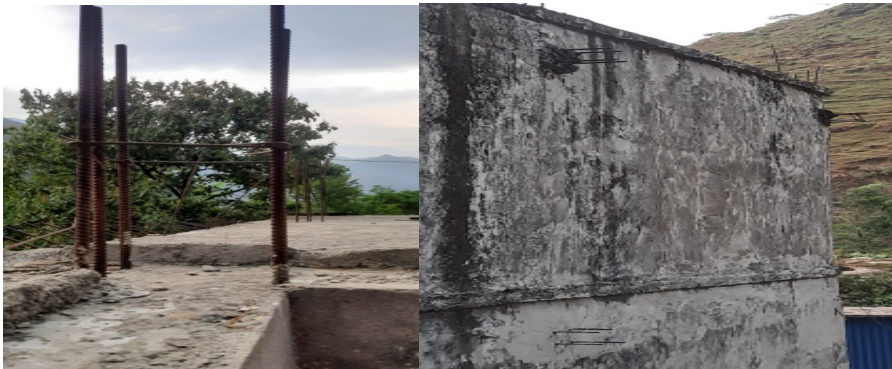
### Figure 11

shows that the first cracks are observed in cold joint locations (Chaulagain et al., 2015). In Darchula it is observed that old buildings and new buildings are jointed, where beams and slabs in the old building are jointed with new beams and slabs, which formed cold joints. It is observed that too short column and beam reinforcements are used for continuity of buildings (old to new construction) as shown in Figure 11.

(a) Too short reinforcements left for continuity of columns (b) Beam rebar is left to make a cold joint in the beam in the future

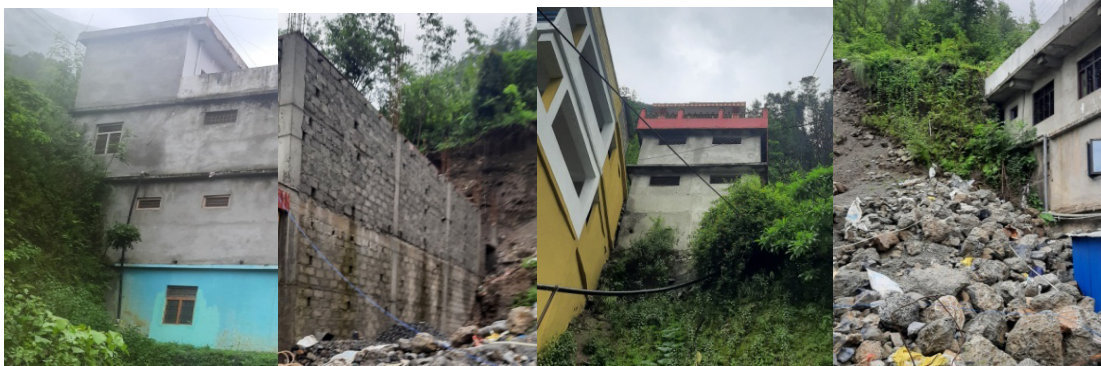
**Figure 12**

In Khalanga bazaar, the slopping side is cut down and stone walls or blocking is used to construct the buildings. During an earthquake, it is a maximum possibility of the collapse of the non-structural walls due to the soil pressure in the wall. Extra lateral pressure is induced in the wall and if the wall is not properly designed, the maximum possibility of failure of the wall. However, it has been observed that in Darchula slopping side of the buildings have been constructed with non-structural walls as shown in Figure 12.

(a), (b) Soil pressure induced in the wall (c) Soil pressure and risk of landslide for buildings (d) Soil pressure in the back-side of buildings

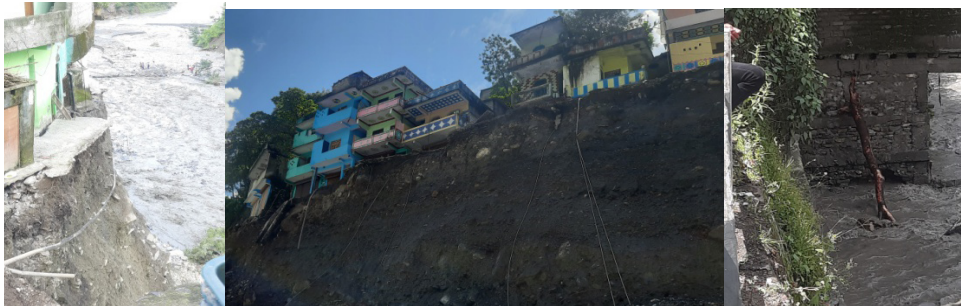
**Figure 13**

Flood may sweep the whole structure when improper urban planning and sustainable design process is used. In Darchula the flood is observed in the Mahakali river (Paudel et al., 2013). In 2013 one of the massive floods was observed and that flood swept 12 government buildings, 156 private buildings, playgrounds, halls etc. even district hospital buildings were partially swept out by the flood. Also recent flood in Darchula 2022, destroyed life, property and land (see Figure 13) so it is very important that understand the flood risk area and hazardous areas. It has been observed that many buildings are constructed near the riverside, and landslide risk area (see Figure 13).

(a) and (b) Buildings collapsed due to the Darchula flood in 2022 (c) Flood hit the wall in buildings
