## Impact of Monsoon Rainfall on Roadside Slopes

Monsoon-induced landslides pose a severe threat to Nepal's hilly and mountainous regions, frequently causing highway disruptions and substantial loss of life and property every year. This study examines a 4 km section of the Dakshinkali-Kulekhani road to assess the effects of monsoon rainfall on roadside slope stability. Field data, including slope geometry, land use, and the presence and condition of erosion control measures (ECM), were recorded before and after the monsoon, alongside photographic documentation at each chainage of the study route. Rainfall data were collected for the study area, and soil samples from failed sections underwent laboratory tests to determine relevant index and engineering properties. Slope stability analysis combined with transient seepage modeling was performed using GeoStudio on key sections with slope failures. Among 188 sections under considerations, 62 experienced significant slope failures, predominantly in areas lacking effective ECM; even where ECM existed, they were often insufficient and showed considerable collapse post-monsoon. Most of the failures occurred on slopes excavated on soft rock

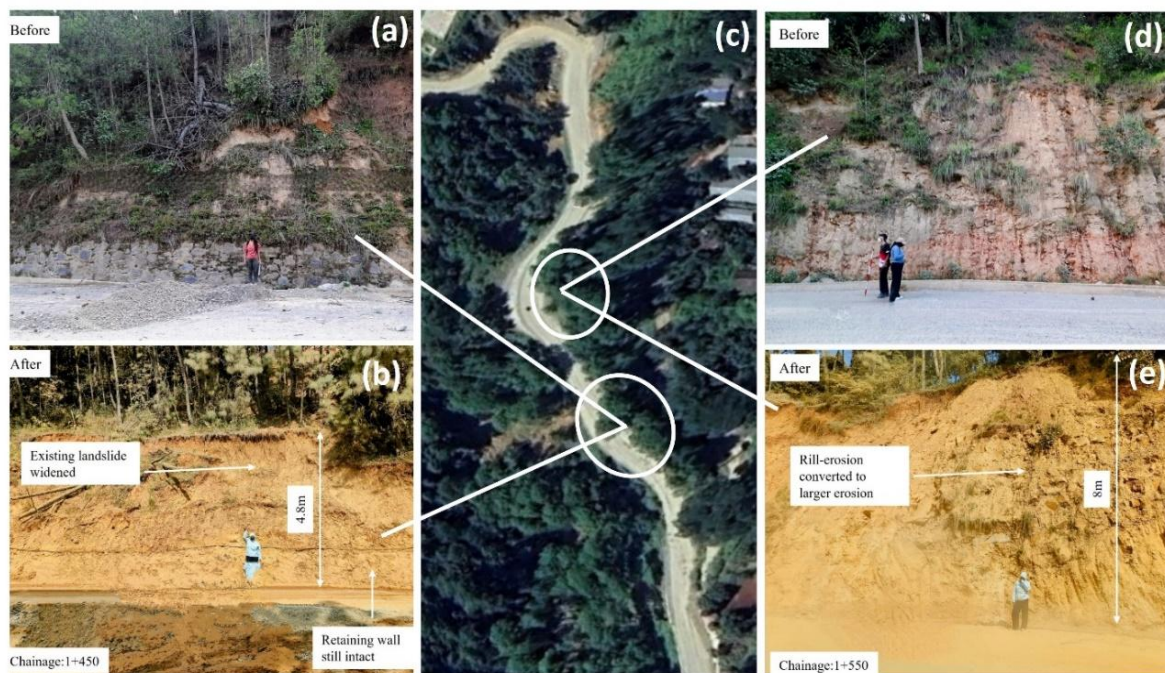
The field observations clearly demonstrated the significant impact of monsoon rainfall on slope stability. Within a relatively short 300 m stretch of the road from chainage 1+450 m to 1+778 m, three uphill slopes and one downhill slope exhibited notable failures as depicted in Figure 5. For example, at chainage 1+450 m (uphill), a shallow-seated planar failure with a crown height of approximately 4.8 m occurred, causing accumulation of landslide debris that blocked side drains and obstructed surface drainage. Similarly, at chainage 1+550 m (uphill), erosion and sliding with a crown height of 8 m were observed, intensified by pre-existing gullies and steep slopes; this erosion extended about 40 m along the road corridor, destroying vegetation and depositing material along the roadside, which reduced carriageway width and clogged drainage. Downhill at chainage 1+752 m, the slope comprising loose road-cut material with no protective measures showed significant post-monsoon damage, including erosion of almost half the road width and persistence of large gullies, indicating high vulnerability to future instability.

*Figure 5: Pictorial comparison of before and after the monsoon at different chainage; (a) Before monsoon picture of chainage 1+450, (b) After monsoon picture of chainage 1+450, (c) Satellite Map of the alignment part, (d) Before monsoon picture of chainage 1+550, and (e) After monsoon picture of chainage 1+550*

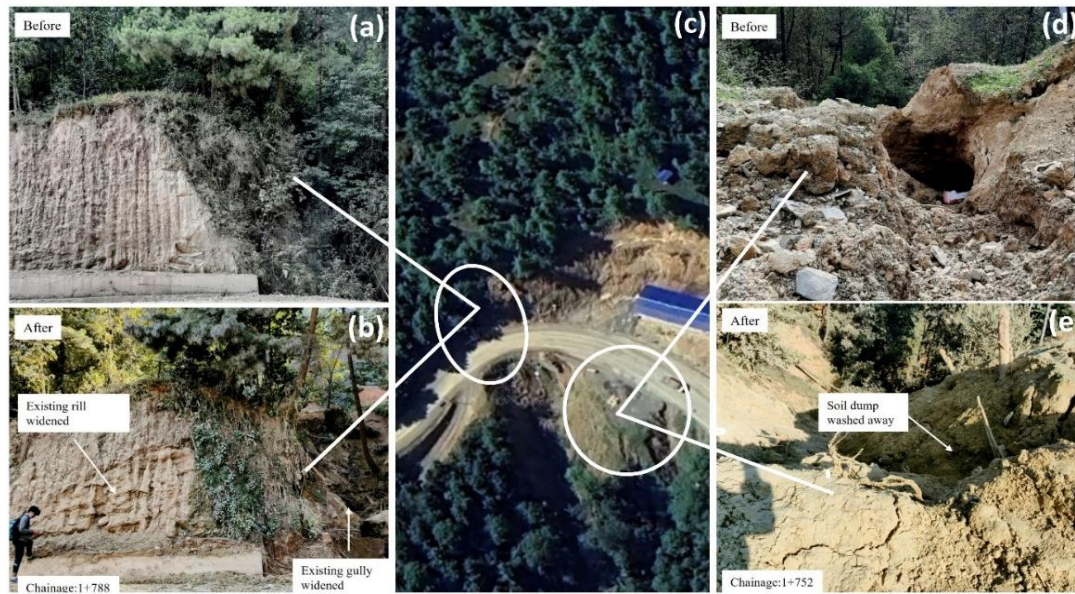
Further observations at chainages 1+777 and 1+788 m revealed that a cross-drainage structure and a natural gully, present before the monsoon, suffered badly after the monsoon as the gully widened and the drainage structure got clogged, reducing runoff discharge capacity. Unprotected soil deposited downhill was washed away, causing partial damage to an adjacent gabion wall. At chainage 2+554 m (downhill), the absence of drainage provisions led to uncontrolled water flow forming gullies up to 0.5 m deep, transporting sediment downslope and damaging agricultural fields and a secondary access road. Additionally, at chainage 2+742 m (uphill), a vertical cut slope about 4.2 m high with small pre-monsoon gullies experienced severe erosion post-monsoon, with large gullies forming along concentrated water paths and side drains clogged by soil deposits. Lastly, at chainage 4+031 m, critical river training structures, including gabion and retaining walls protecting a culvert and road boundary, were destroyed by floodwaters, leaving the culvert foundation exposed and the adjoining roadway extensively damaged, posing serious risks to transportation safety.

Figure 6: Pictorial comparison of before and after the monsoon at different chainage: (a) Before monsoon picture of chainage 1+788, (b) After monsoon picture of chainage 1+788, (c) Satellite Map of the alignment part, (d) Before monsoon picture of chainage 1+752, and (e) After monsoon picture of chainage 1+752

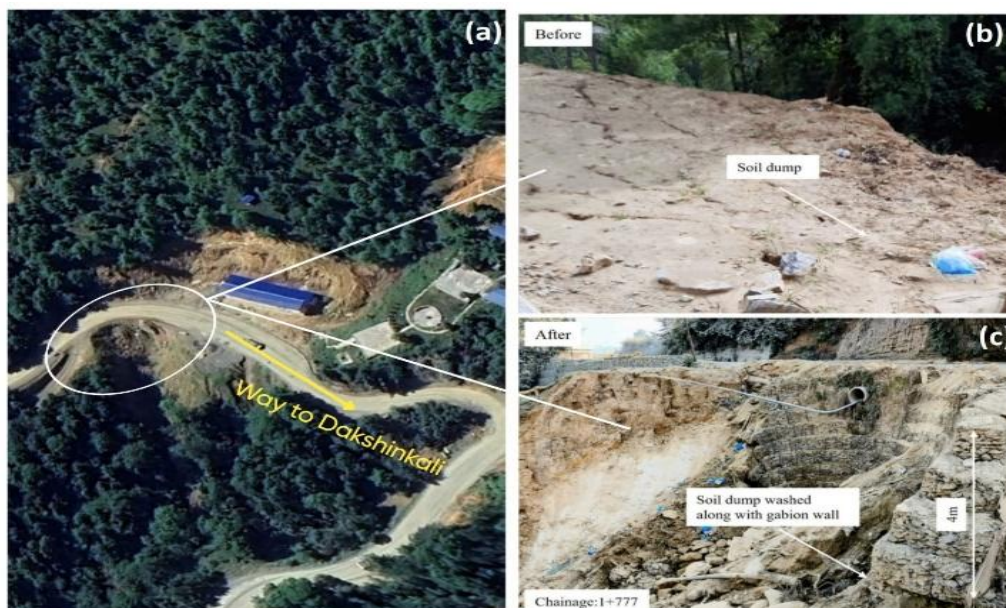
Figure 7: Pictorial comparison of before and after the monsoon at different chainage: (a) Satellite Map of the alignment part, (b) Before monsoon picture of chainage 1+777, and (c) After monsoon picture of chainage 1+777

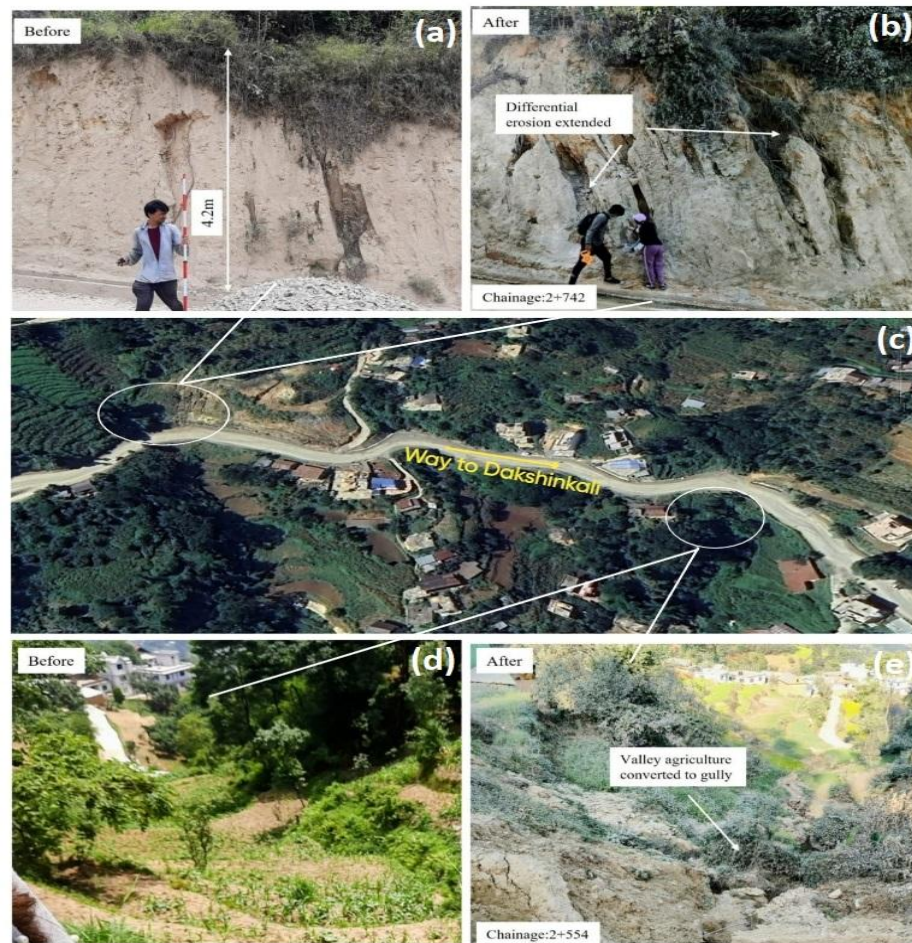
Figure 8: Pictorial comparison of before and after the monsoon at different chainage; (a) Before monsoon picture of chainage 2+742, (b) After monsoon picture of chainage 2+742, (c) Satellite Map of the alignment part, (d) Before monsoon picture of chainage 2+554, and (e) After monsoon picture of chainage 2+554

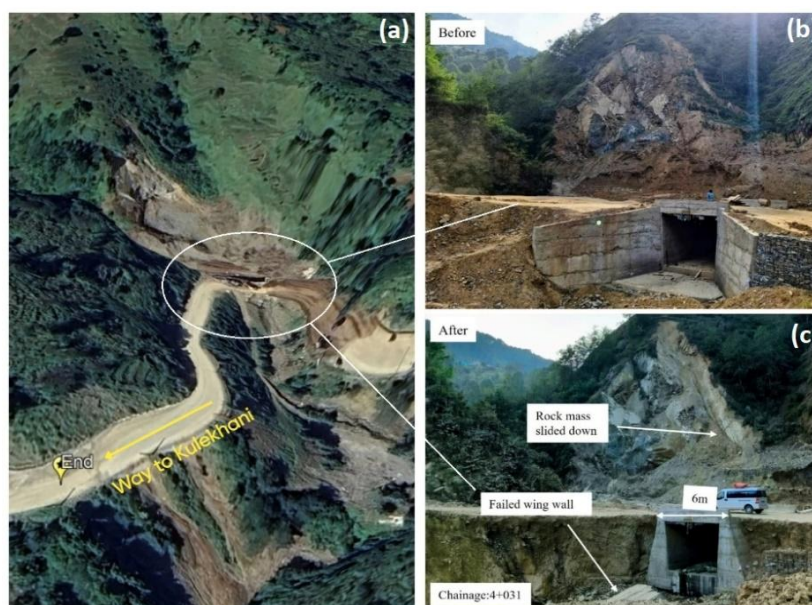
Figure 9: Pictorial comparison of before and after the monsoon at different chainage; (a) Satellite Map of the alignment part, (b) Before monsoon picture of chainage 4+031, and (c) After monsoon picture of chainage 4+031

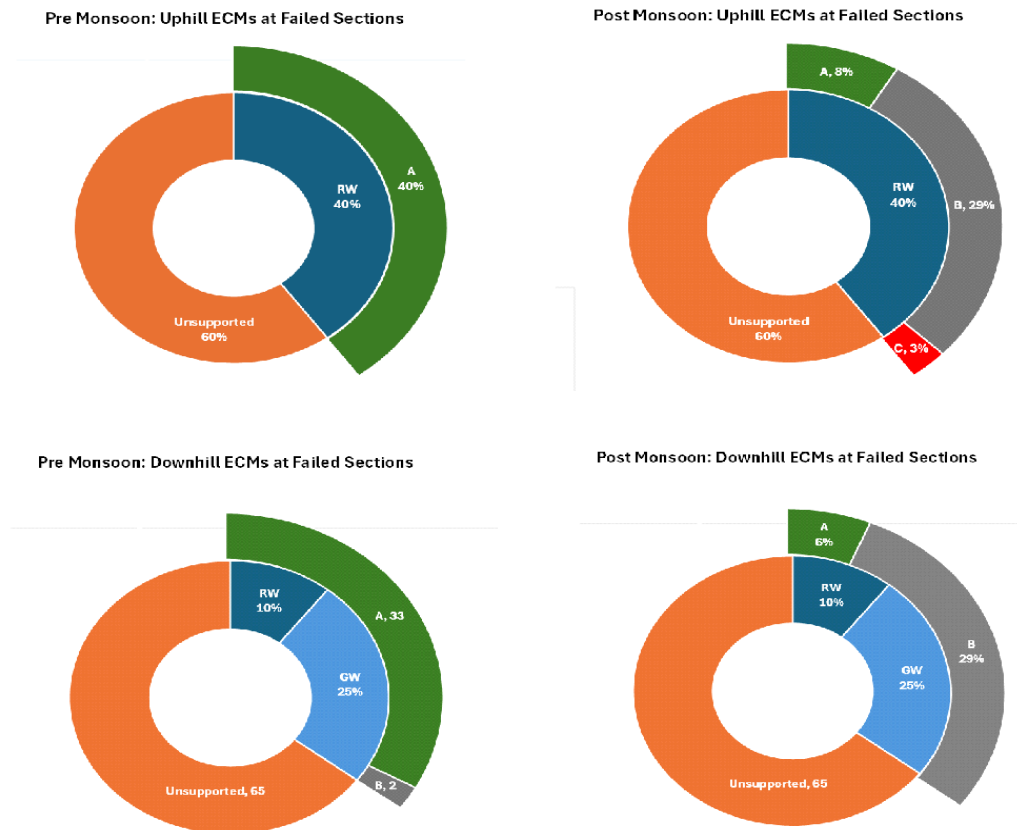
Figure 10: Pre- and Post-Monsoon Comparison of ECM at Failed Sections

Among the 188 chainages/sections studied, 62 sections encountered significant slope failures: 14 on uphill, 26 on downhill and 22 on both sides. Among the slope failure sections, the patterns observed were presented in the Figure 10, suggested that most of the failed sections did not have any erosion ECM. And those which did have ECM in place, the measures were insufficient to prevent slope failures and thus were badly collapsed or distorted post-monsoon.

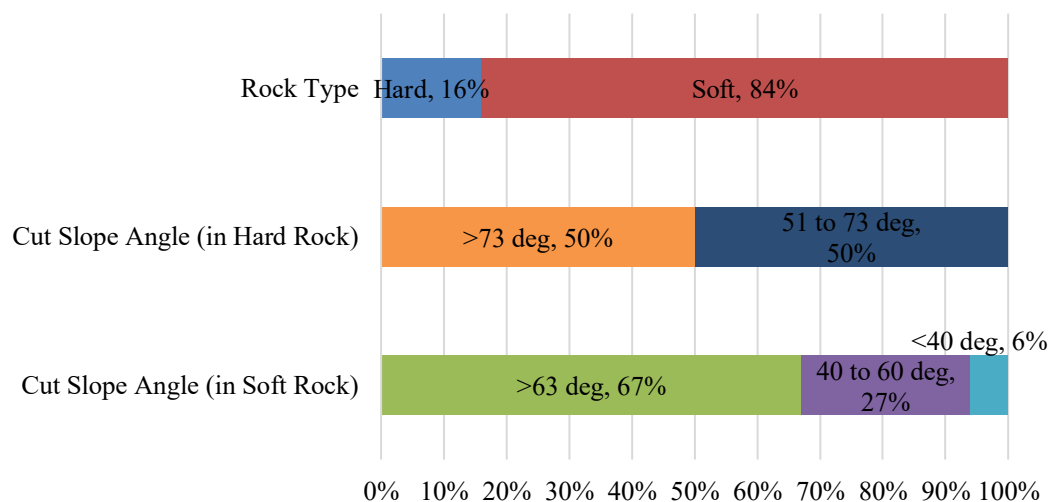
Figure 11: Rock type and Cut slope angle composition at Failed Sections

As per the DoR recommendations (DoR-GoN, 2007), for cut heights up to 15 m, the preliminary cut slope angle for road excavation should be 40 to 63° in soft rock and 51 to 73° in hard rock. But the observed cut slope angles at failed sections were:

This shows that slope failure was more common in areas with soft rocks, and that DoR guidelines were not followed properly during road excavation – excavating roadside slopes at angles greater than that recommended by DoR- and have therefore resulted in slope failures. Moreover, some slopes were indeed cut at a slope angle equal to or less than the DoR recommended angle but still endured landslides, which may also hint towards the insufficiency of the current DoR recommendations and the need for their upgrading.

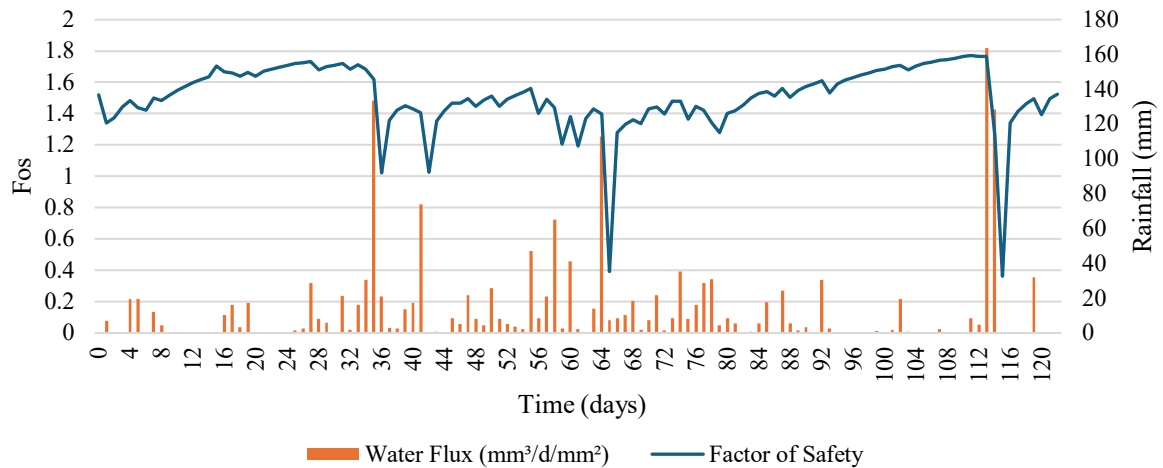
Figure 12: FOS vs Rainfall Vs Time graph for chainage 0+640m

The initial site was a sloped terrace farm uphill, with vertical cuts in the soil at certain points along the chainage and reinforced with a short retaining wall of 3m height. The initial factor of safety for the site was 1.34. Analysis suggested a plane failure, particularly at high risk on days 65 and 115, with the factor of safety dropping to as low as 0.36. Notably, the factor of safety also decreased to 1 as early as days 36 and 42. The actual site showed wedge failure with the retaining walls overtaken by debris, drains filled with soil, and the large mass movement exposed the uphill land and house to the risk of further damage. Failure is attributed to the insufficient design of the retaining wall, coupled with the geometry of the section alongside the classification of the soil on site as loamy sand, which is generally prone to waterlogging, and therefore highly sensitive to rainfall. It is possible that the initial failure originated from the section with the vertical cut, which allowed further mass movement to occur.

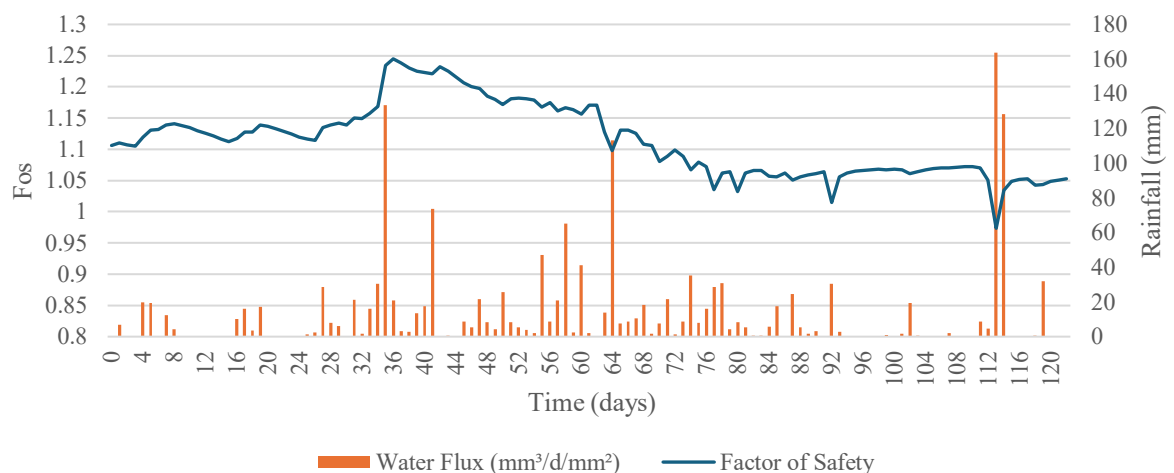
Figure 13: FOS vs Rainfall Vs Time graph for chainage 0+980m

The factor of safety (FoS) at this chainage was also greater than 1 before the monsoon. As rainfall started, FoS started to vary in reaction to the pattern of infiltration and water flux. At moderate early storms, partial saturation raised stability at some point temporarily, a phenomenon due to the increase in matric suction. But sustained infiltration decreased this stabilizing effect. The heavy rains caused pore-water pressures that continued to reduce the FoS. According to the results, limited rainfall does not instantly cause failure, which indicates that the slope could tolerate a certain level of precipitation. However, persistent and heavy rainfall quickly moves FoS downward until slope failure eventually occurs. Overall, the correlation analysis shows that the water flux due to rainfall has a strong negative dependence on slope stability. Infiltration into deeper layers of soil causes sudden decreases in FoS, and long-term seepage will not allow restoring the stability state; the slope remains in a very dangerous position. Consecutive severe storms increase the pace of this degradation process, eventually lowering FoS to life-threatening levels and slope failure.

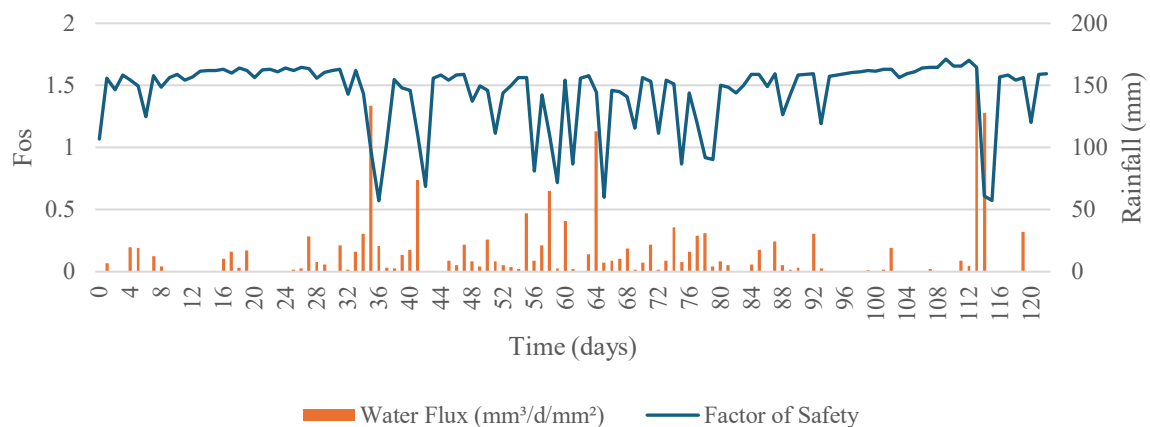
Figure 14: FOS vs Rainfall Vs Time graph for chainage 1+550m

Initially, the site had steep cuts of approximately 70°, 10m in height uphill, with the provision of a retaining wall 4m in height. Soil from the cut slope was deposited downhill. Still, it was not relevant to the slope stability analysis as it covered the existing retaining structure, which kept the road stable. The initial factor of safety was found to be 1.06. Analysis suggested a plane failure with steep drops in factor of safety throughout the monsoon season, which shows very high sensitivity to rainfall conditions. The Factor of safety dropped to less than 1 on several instances, notably days 36, 42, 56, 59, 114, and more. The actual site showed erosion along a large span of 40m with a crown height of about 10m, which corresponds to the analysis results. Multiple large gully erosions were also observed further than 10m. The resulting erosion covered both the drainage measures and retaining walls. Failure is attributed to the heavy rainfall alongside the properties of the site soil, as the analysis suggested a high correlation with rainfall, and evidence of water erosion was clearly present during the site visit.

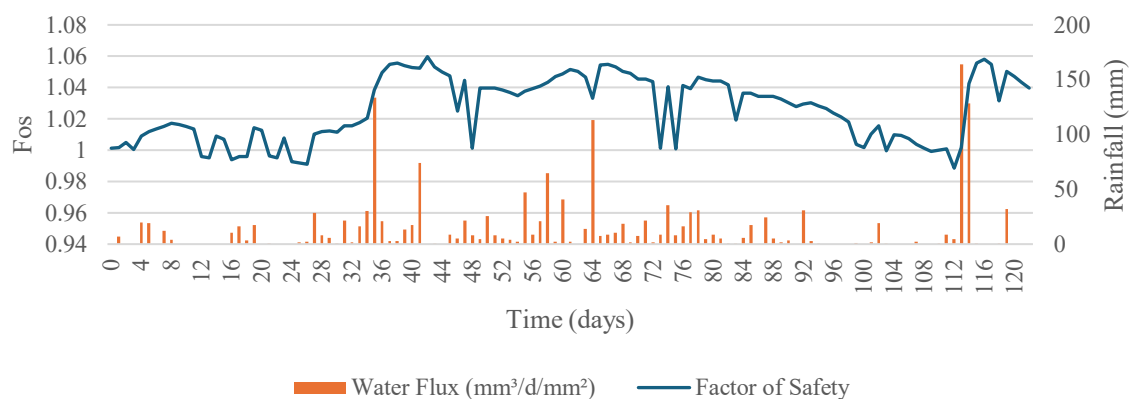
Figure 15: FOS vs Rainfall Vs Time graph for chainage 1+760m

Initially, before the onset of monsoon rainfall, the factor of safety for this chainage was satisfactory, i.e., it was above 1. As soon as the precipitation started, the factor of safety began to decrease. The factor of safety dropped enormously during intense precipitation. The graph of the factor of safety illustrates the high risk of the site as the factor of safety prominently dropped with the slightest precipitation. The analysis brought out the high peaks of infiltration during the storms and the seepage that followed, which sustained the pore-water pressure build-up and delayed the recovery of stability. These results bring attention to the extreme effect of rainfall on the slope, as it is only marginally stable and is highly impacted by aggressive storms. Overall, these results point out the likelihood of the factor of safety dropping below unity and the slope failing due to extreme rainfall events or consecutive rainfalls, in addition to bringing attention to the need for drainage and constant monitoring.

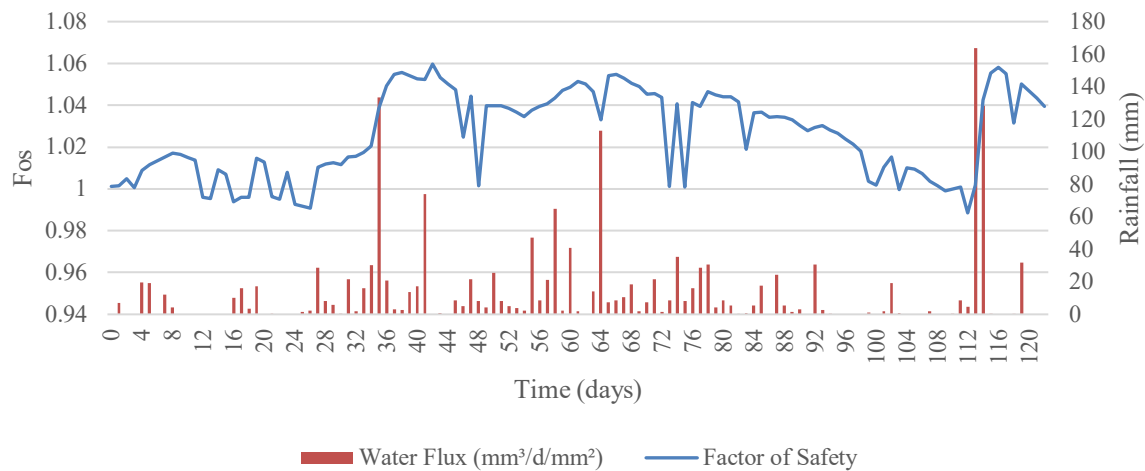
Figure 16: FOS vs Rainfall Vs Time graph for chainage 3+897

Pre-monsoon, the site was a fresh-cut soil slope of height about 7m and 70° angle with no ECMs present uphill except for the side drain. Analysis suggested a plane failure, but also that the section was initially unstable. Back analysis showed the actual properties of the slope to be much greater than the laboratory data for the slope to be initially stable, exceeding the range of values for loamy sand. Some correlation was found between the FoS and rainfall. The actual site showed large erosion on the top layer of the slope, revealing a layer of gravel underneath the soil layer. This suggested that the interlocking action of the gravel layer contributed greatly to the overall stability of the slope, and during rainfall, only the top layer of weak soil was eroded, resulting in plane failure for the soil layer only. Drains were found to be clear, likely cleaned up before the post-monsoon site visit.
