OUT-OF-PLANE DYNAMIC SHOCK TABLE TESTING OF A MOCK-UP UNREINFORCED STONE MASONRY BUILDING

Abstract

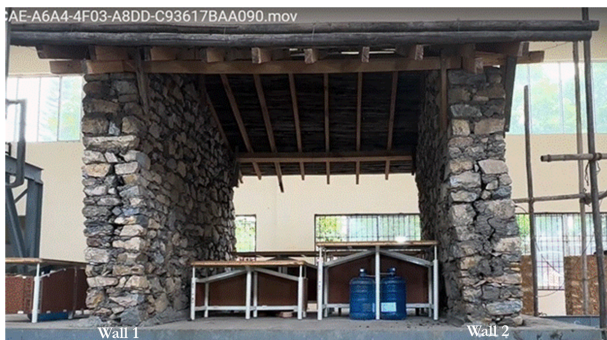
Figure 10. Initial pendulum impact (Shock #7) generates shear in walls and produces vertical crack separating the wall wythes

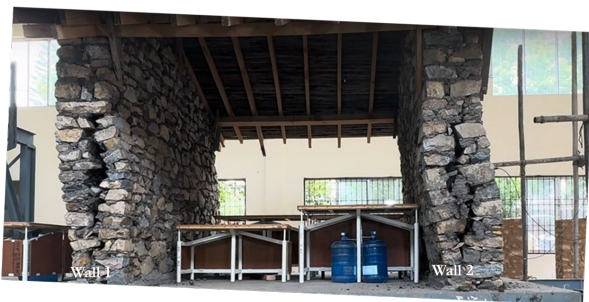
Figure 11. Second pendulum impact (Shock #7) produces additional shear in the walls and further separates wall wythes.

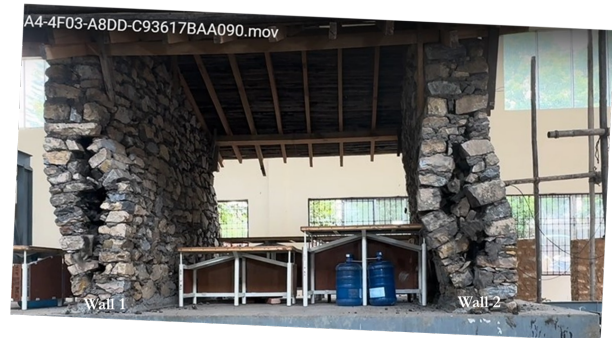
Figure 12. Contact of desks A and B with Wall 2 temporarily stabilizes wall interior wall wythe of wall 2. portion of wall 2 NOT in contact buckles.

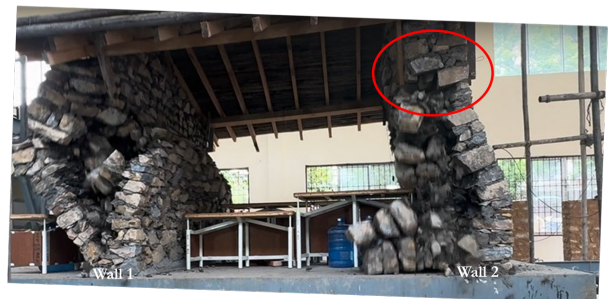
Figure 13. Wall 1 wythes buckle in opposite direction. Wall 1 loses load bearing capacity. Roof begins to fall. Roof-wall connections hold wall 2 together (somewhat).

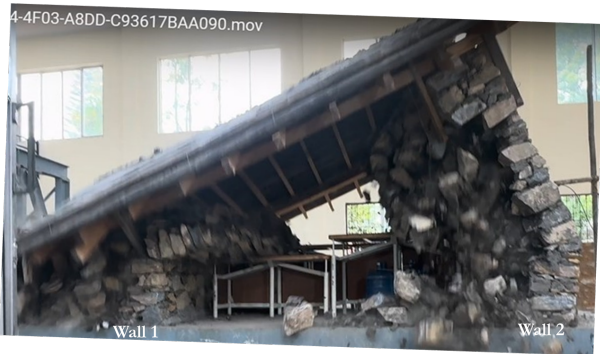
Figure 14. Roof over wall 1 collapses. wall 2 loses load bearing capacity.

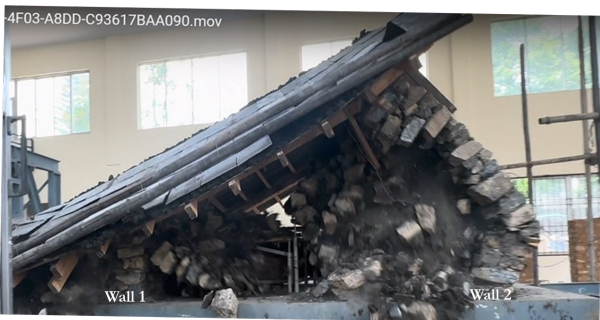
Figure 15. Wall 2 collapses.

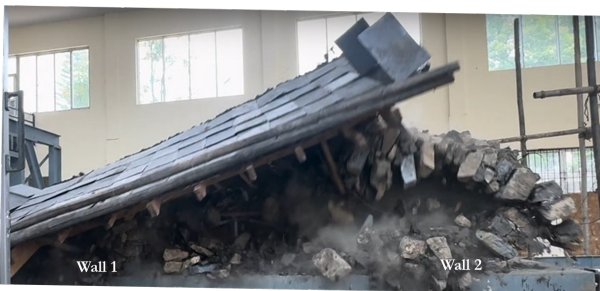
the EQ desks rather than bearing directly on the ground (Figure 16 and Figure 17). These observations highlight that walls constructed with the same materials and details may not collapse in the same manner, and that local crack development, roof-wall interaction, and interior placement of furniture may influence the damage progression and collapse mechanism.

Figure 16. Collapse of wall 2 continues.

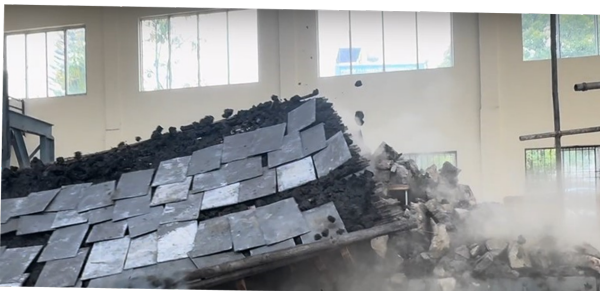
Figure 17. Roof impact splits the roof along the ridge beam and causes slate roofing to fly off.
