## A Case study of Building Damage Pattern in Nepal: Insights from the Nov 3, 2023 Jajarkot Earthquake

A field reconnaissance was carried out from November 6 to 15 in the earthquake-affected regions of Jajarkot and Rukum West, focusing on various municipalities, namely Bheri, Kuse, Chhedagad, Sani Bheri, Chaurjahari, and Musikot. We observed seismic damage on building structures in highly affected areas and other areas impacted by earthquake.

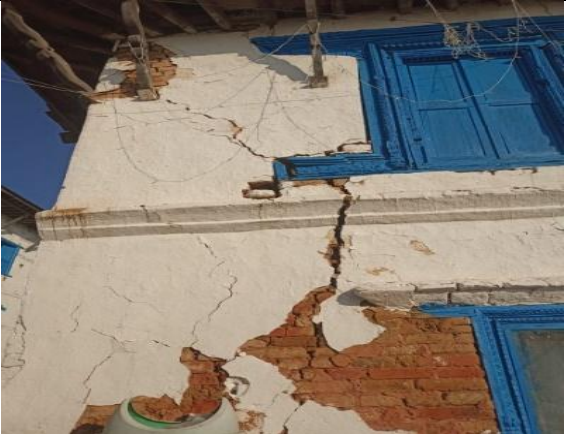
The earthquake has damaged historic palace known as “Jajarkot Durbar” as shown in figures 4, 5, 6 and 7. The bands provided in the palace prevented it from complete collapse. It was built in 1769 AD by the King of Jajarkot Hari Shah. Originally it was seven storey and reduced to

| <p><b>Figure 4:</b> Diagonal crack near sill level</p> | <p><b>Figure 5:</b> Flexural crack</p> |

Those building which are collapsed 90 % of their components will cost severely high if retrofit process is conducted. But for those building with some diagonal cracks may be retrofitted with proper bands of RCC.

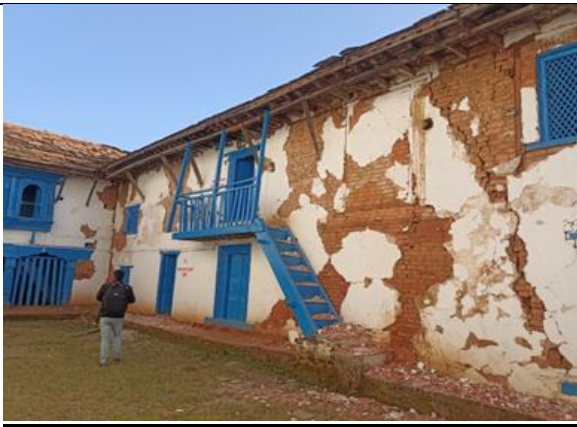
| <p><b>Figure 6:</b> Flexural crack</p> | <p><b>Figure 7:</b> Diagonal crack</p> |
