## Seismic Vulnerability Assessment of Plan Irregularity Reinforced Concrete Framed Building

The study presents the seismic vulnerability assessment of plan irregular reinforced concrete framed building. At PEC, there are a total of 5 blocks among which Block-B, established in 2000 AD was selected for detailed assessment due to its structural irregularities. The assessment started with visual inspection using FEMA guidelines, which revealed undersized members, poor concrete quality, irregular plan layout, torsional irregularity, and visible deterioration. Non-destructive tests (Ultrasonic Pulse Velocity and Rebound Hammer) confirmed good internal concrete integrity but weak surface strength. To understand the building's seismic performance more clearly, a structural model was developed in ETABS v22.5 following NBC 105:2020. The analysis showed that 130 members failed seismic checks, including torsional irregularities, storey drift, and displacement limits. Based on these findings, a hybrid retrofitting plan was proposed combining concrete jacketing for columns and beams, steel jacketing for selected beams, and the addition of reinforced concrete shear walls. Post-retrofitting anal

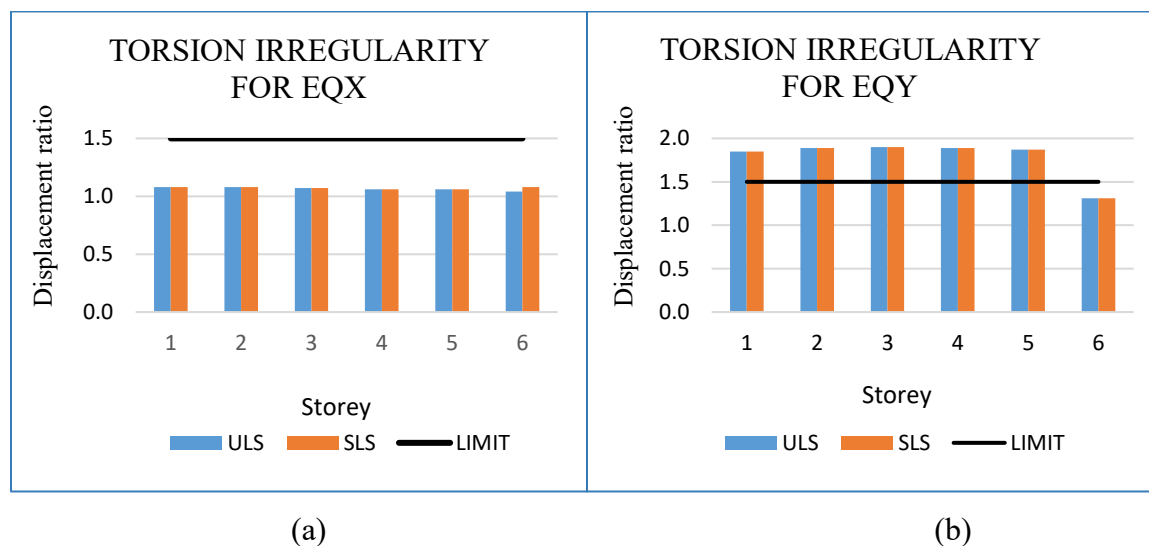
**Figure 3:** Torsion irregularity for ULS and SLS in: (a) X-direction; (b) Y-direction.

As shown in the Figure 3, the building exhibits torsion irregularity in the Y-direction with displacement ratios exceeding 1.5 between storey 1 to 5 under both ULS and SLS. While in the X-direction the displacement ratio remain within the permissible limit, indicating no torsion irregularity.

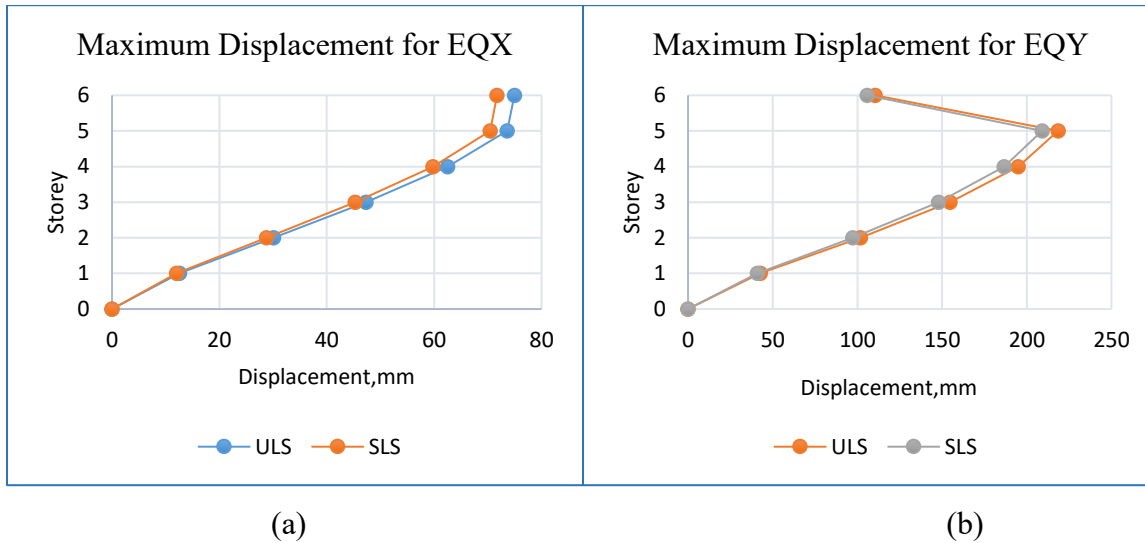
**Figure 4:** Maximum storey displacement for both ULS and SLS in: (a) X-direction; (b) Y-direction

As show in the Figure 4, the maximum displacement in X-direction was 74.96 mm under ULS and 71.72 mm under SLS which are both within the permissible limits of 112.5 mm and 108 mm. In Y-direction, the maximum displacement was 218.49 mm and 209.06 mm exceeding the permissible limits.

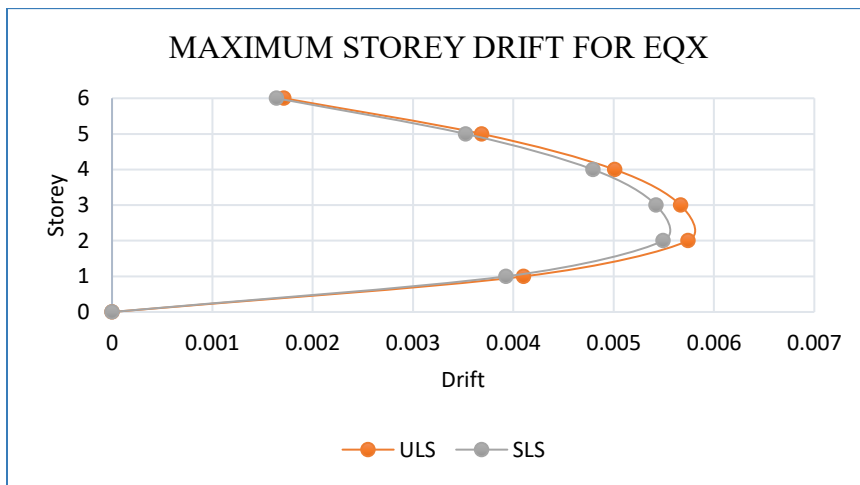
**Figure 5:** Maximum storey drift for both ULS and SLS in X-direction

As shown in the Figure (5-6), the maximum storey drift was 0.00567 under ULS and 0.00549 under SLS in X-direction, both within the permissible limits of 0.00625 and 0.006 respectively. In the Y-direction the maximum drift was 0.0197 under ULS and 0.0188 under SLS both exceeding the permissible limits.

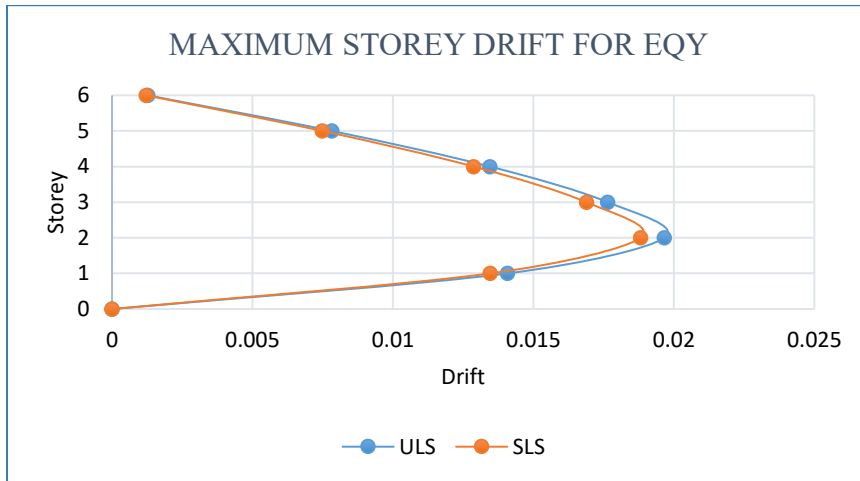
**Figure 6:** Maximum storey drift for both ULS and SLS in Y-direction

Overall analysis confirms that the building fails to meet seismic performance criteria of NBC 105:2020. Structural analysis shows torsional irregularity in the y-direction, excessive storey displacement and drift values exceeding permissible limits. These failures clearly indicate that the building is vulnerable and requires retrofitting measures to enhance safety and ensure code compliance.

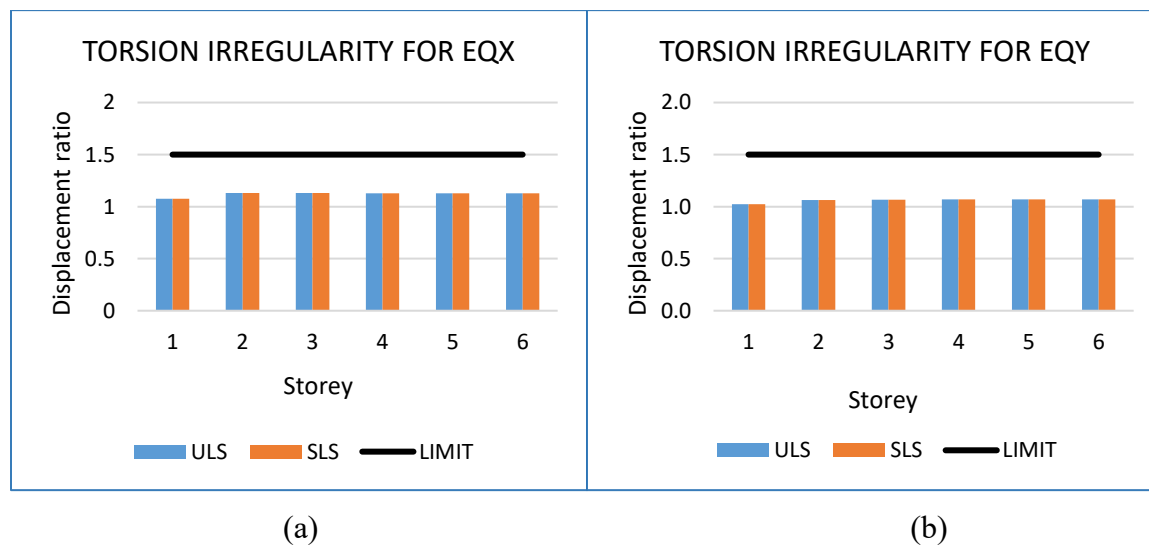
**Figure 10:** Torsion irregularity for ULS and SLS after retrofitting in: (a) X-direction; (b) Y-direction

As shown in the Figure 10, the torsion irregularity in the Y-direction was resolved with ratios below 1.5, while the X-direction remained within the permissible limits.

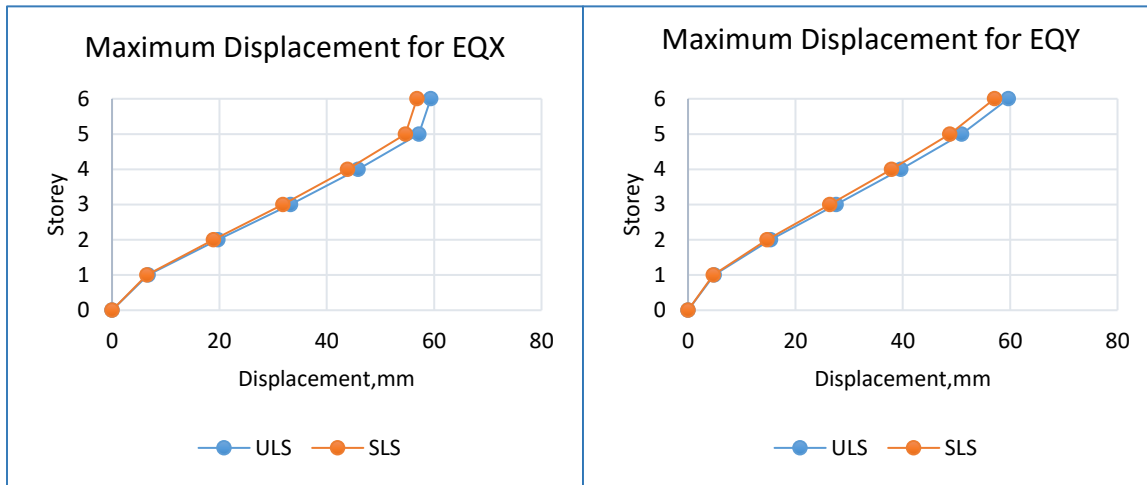
**Figure 11:** Maximum displacement for ULS and SLS after retrofitting in: (a) X-direction; (b) Y-direction

As shown in the Figure 11, the building no longer shows storey displacement in the Y-direction and the X-direction remains within the limits.

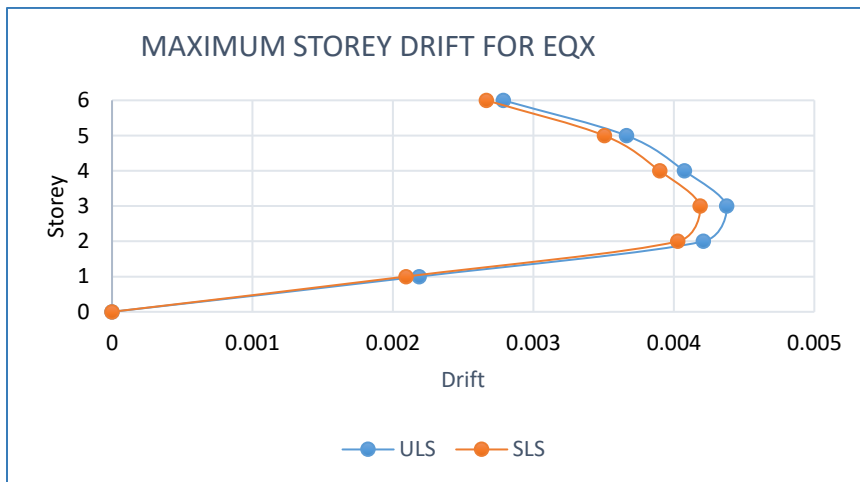
**Figure 12:** Maximum storey drift for ULS and SLS after retrofitting in X-direction

As shown in the Figure (12-13) the building no longer shows storey drift in Y-direction and storey drift in X-direction has also been improved.
