## Soil erosion in the south bank of the Brahmaputra River in and around Hatishal, Jorhat District, Assam, India

Ajit Borkotoky<sup>1</sup> and \*B.P. Duarah<sup>2</sup>

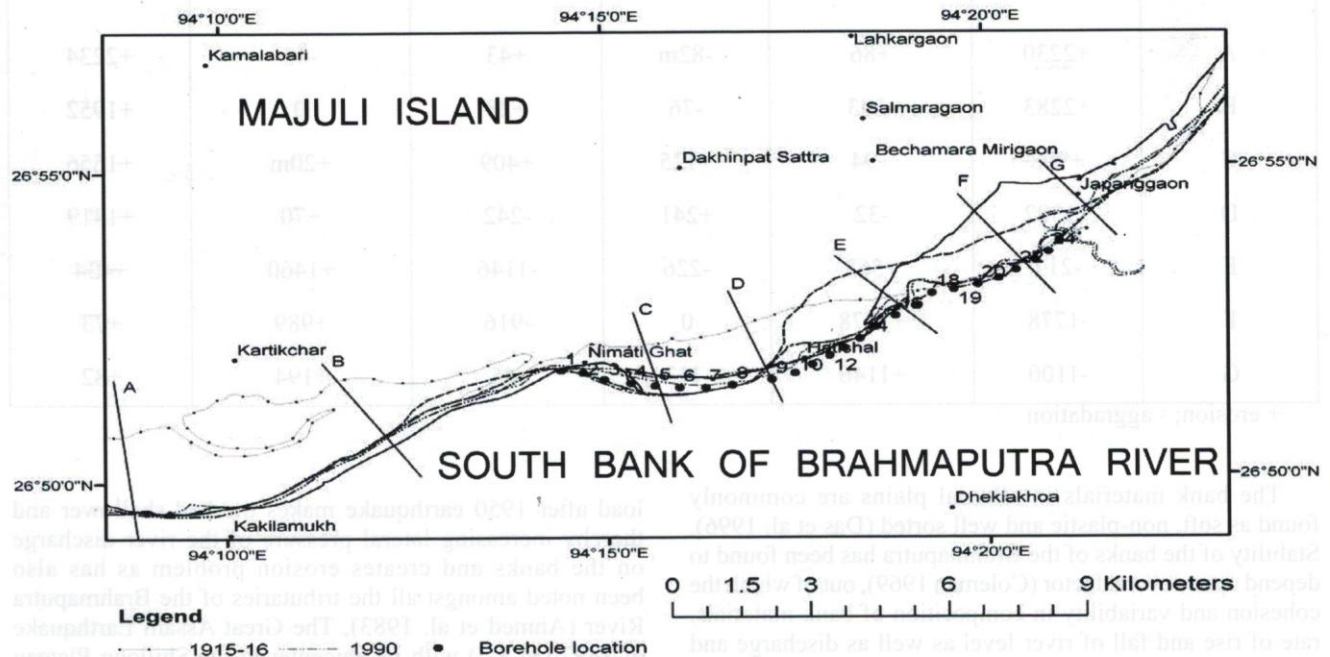
It has been observed that area of section A, B, C and D suffered pronounced erosion during 1915 to 1967-68. During that period E, F and G sections got fill up by the river. The total amount of lateral bank migration during the period 1915 to 2007 ranged from 73 to 2234 meters. It is evident from the Table 1 that there was large variation in amount of area

eroded or fills up in different section during whole periods. It is observed from Table 1 that erosion was predominant in some of the areas while in some other areas deposition was dominant in the same time span. These data reveal that amount of bankline erosion and fill up by the alluvial soil of Brahmaputra River in different sections are not uniform.

Fig. 5: Bankline migration of the south bank of the Brahmaputra along Nimati-Hatishal area. 1, 2, 3,....., 25 are the boreholes where sediments have been collected to investigate their engineering properties.

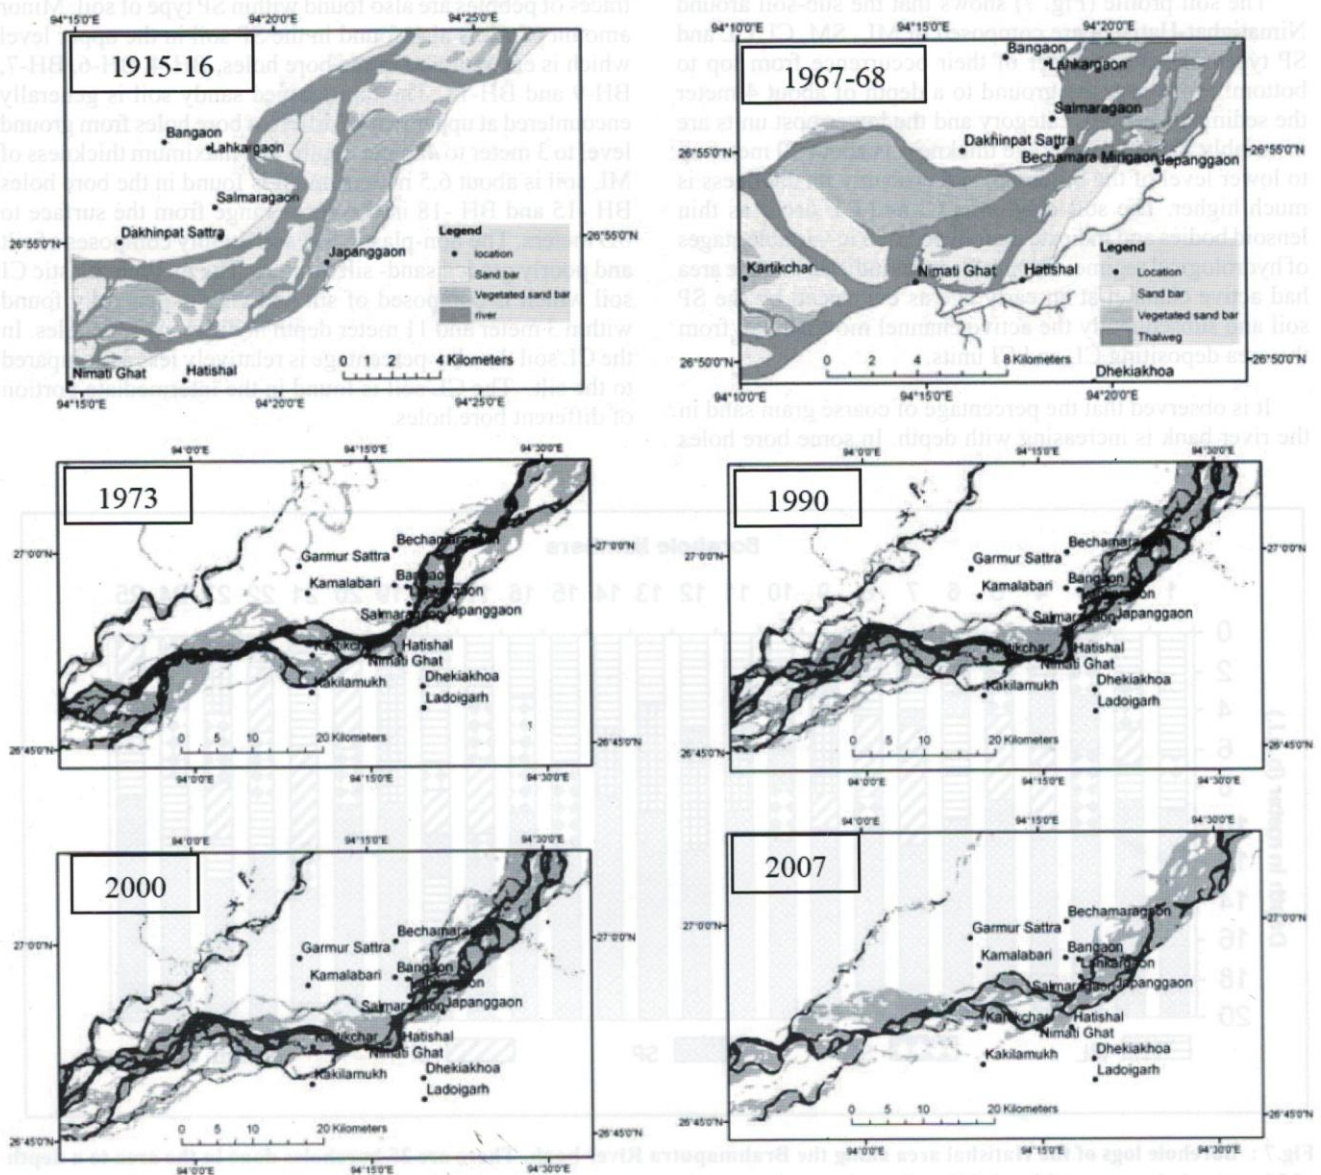
We also compared the thalwegs of the Brahmaputra in the segment for years 1915-16, 1967-68, 1973, 1990, 2000 and 2007 (Fig. 6). In 1915-16, a major channel of the Brahmaputra was flowing about 1.5 km north of Hatishal (east of section D in Fig. 4). In 1967-68, the Brahmaputra was eroding the Hatishal village, thus migrating 1.5 km towards south during a period of 52 years. One of the thalwegs of the Brahmaputra was very well established near Hatishal by 1967-68. By 1973, the thalweg receded from Hatishal area but accelerated erosion took place in Nimatighat at the downstream. Thus aggradations of bank at Hatishal propagated the erosion problem in Nimatighat area by the year 1973. By the year 1990, there is severe erosion between Hatishal and Nimatighat. The main thalwegs which was located towards the north bank during 1973 now entirely shifted to the south bank passing through Hatishal. By the year 2000, the 1990's thalwegs gradually migrated towards Nimatighat and erosion near Hatishal has been halted. By the year 2007, the thalwegs further shifted towards west of Nimatighat and takes a northerly course, thus relieving the south bank erosion in the Nimatighat – Hatishal area.

Fig. 6: Thalweg (dark continuous bands) position of the Brahmaputra in Nimati Ghat-Hatishal area during the years 1915-16, 1967-68, 1973, 1990, 2000 and 2007

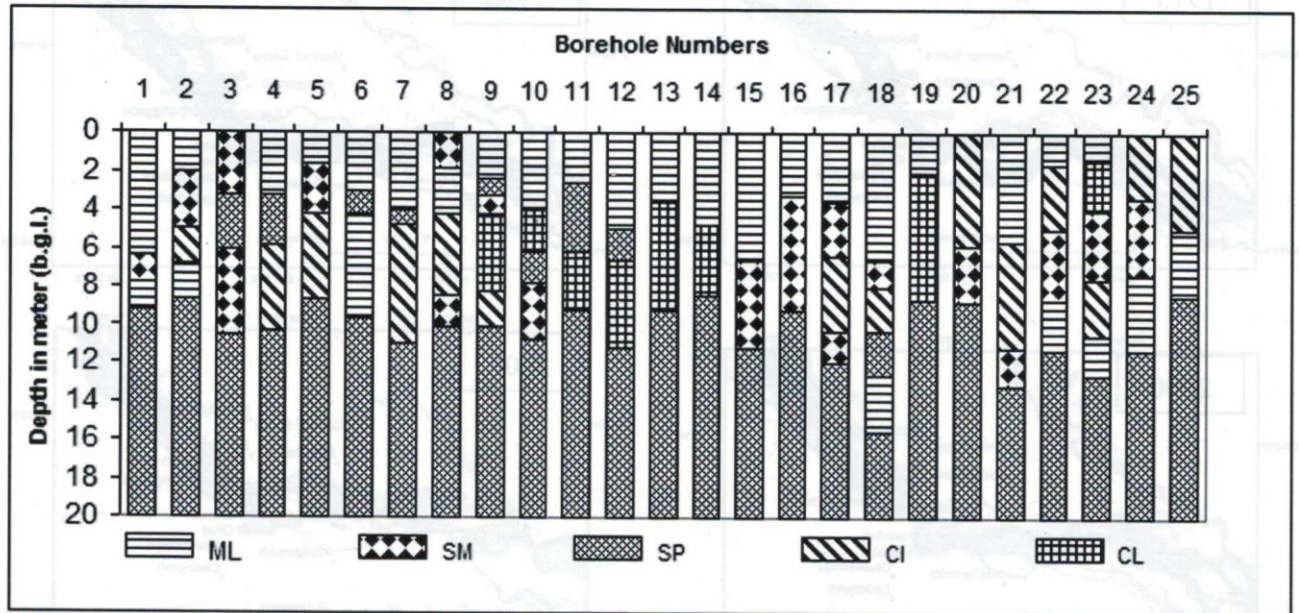
The soil profile (Fig. 7) shows that the sub-soil around Nimatighat-Hatishal are composed of ML, SM, CI, CL and SP types of soils in order of their occurrence from top to bottom. From near the ground to a depth of about 4 meter the sediments are ML category and the lowermost units are invariably SP whose average thickness is about 10 meter up to lower level of the borehole, and probably its thickness is much higher. The soft clay units CI and CL occur as thin lensoid bodies and indicate their deposition in variable stages of hydrological regime. The profiles also indicate that the area had active channel at an early age as evidenced by the SP soil and subsequently the active channel moves away from the area depositing CL and CI units.

It is observed that the percentage of coarse grain sand in the river bank is increasing with depth. In some bore holes

traces of pebbles are also found within SP type of soil. Minor amount of silt is also found in the SP soil in the upper level which is encountered in the bore holes, BH-4, BH-6, BH-7, BH-9 and BH-11. The fine grained sandy soil is generally encountered at upper part of different bore holes from ground level to 3 meter to 4 meter depth. The maximum thickness of ML soil is about 6.5 meters and it is found in the bore holes BH -15 and BH -18 in the depth range from the surface to 6.5 meters. The non-plastic SM soil mainly composes of silt and poorly graded sand- silt mixture. The medium plastic CI soil which is composed of silt and clay is generally found within 3 meter and 11 meter depth in different bore holes. In the CL soil the clay percentage is relatively less as compared to the silt. The CL soil is found in the intermediate portion of different bore holes.

Fig.7 : Borehole logs of the Hatishal area along the Brahmaputra River bank. There are 25 boreholes done in the area to a depth of 20 meter below ground level. ML- silt and very fine sand, clayey fine sands and silt; SM-silty sand, poorly graded sand-silt mixture; SP- poorly graded soil; CI-silty clay of medium plasticity CL-silty clay of low plasticity

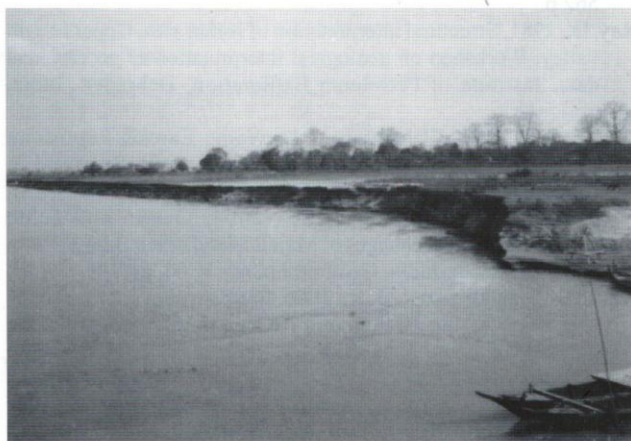
Erosion due to the Brahmaputra around Hatishal of Jorhat district becomes quite vulnerable since 1978 (Figs. 8 and 9). From last few years, the pattern of the river flow has been changing extensively and taking south-ward swing toward the Hatishal-Nimatighat areas hugging the southern bank at an angle of about  $60^\circ$  to  $70^\circ$  causing huge bank erosion. In spite of several short terms protection measures like bamboo and concrete porcupines bank revetments and normal apron were also tried from 1989 to 1992 unsuccessfully in the reach. After the alarming flood situation at Hatishal in the year 1993 a hydraulic model study was carried out by River Research Station of Government of Assam. The model study has recommended constructing 4 numbers of land spurs 2 numbers of bull heads) with 3 numbers of bed bars in 1994. But due to changed river configuration the hydraulic model study has to be repeated in 1995. The later model study suggests constructing 3 numbers of land spurs and 2 numbers of bull heads as long terms bank protection measures. Based on the model study, the anti-erosion project, initially designed to protect Hatishal-Nimatati area in north Jorhat on the south bank of the Brahmaputra River involved the construction of three spurs and two bullheads along with raising and strengthening of 3.14 km stretch of the strategic Bor Ali dyke running from Jhanjimukh to Nimati, when the Nimati-Hatishal project was started in February 1996 it cost was pegged at Rs.317.7 million. The five protective structures, covering a reach of 12km were supposed to protect a total area of 10,800 hectares. Though these protection measures partially successful in case of embankments, occasionally they fails.

Fig. 8: River bank erosion of the Brahmaputra at Hatishal, Jorhat district, Assam

Erosion is a major factor of river instability due to very large amount of silt load coming from the river banks and causing more instability downstream. Total control of flood and erosion is not practicable from economic considerations and hence, flood management is essential. Flood management rationally refers provision of reasonably degree of protection against floods by structural or non-structural measures to minimize the loss of property and life caused by floods.

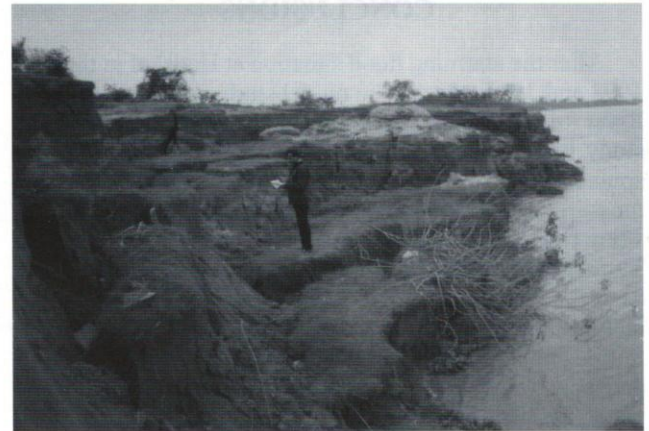
There are main three types of failure observed around the study area. The shear failure (Fig. 6), undercutting and pore water pressure / seepage. The other major cause of shear failure is over steeping of the bank materials as thalweg of the channel hug banks. In localities where bank materials are slightly cohesive, shear failure of the bank results in a related step-like structure leading from the top of the bank to the water edge. Most of the shear planes diminish in the slope as they penetrate into sub-surfaces and as a result the blocks are tilted land-ward by rotation. The second types of failure is that during flood the river banks get saturated and in the time of falling floods the seepage flow starts through the bank due to excessive pore water pressure. The seepage flow increases at the lower stages due to higher water table in the flood plains and lower water levels in the river channel. As in the study area the banks are composed mainly of sand with little amount of clay having low cohesion, the bank gives way and collapses in the river and the collapsed sediments

get washed away. This type of failure is a sub aqueous type's failure.

Fig. 9: Shear failure in the Brahmaputra River bank at Hatishal
