Natural hazards and environmental geological assessment of the Pokhara Valley, Western Nepal

Krishna P. Kaphle

Department of Mines and Geology, Lainchaur, Kathmandu, Nepal
(E-mail: kkaphle@infoclub.com.np)

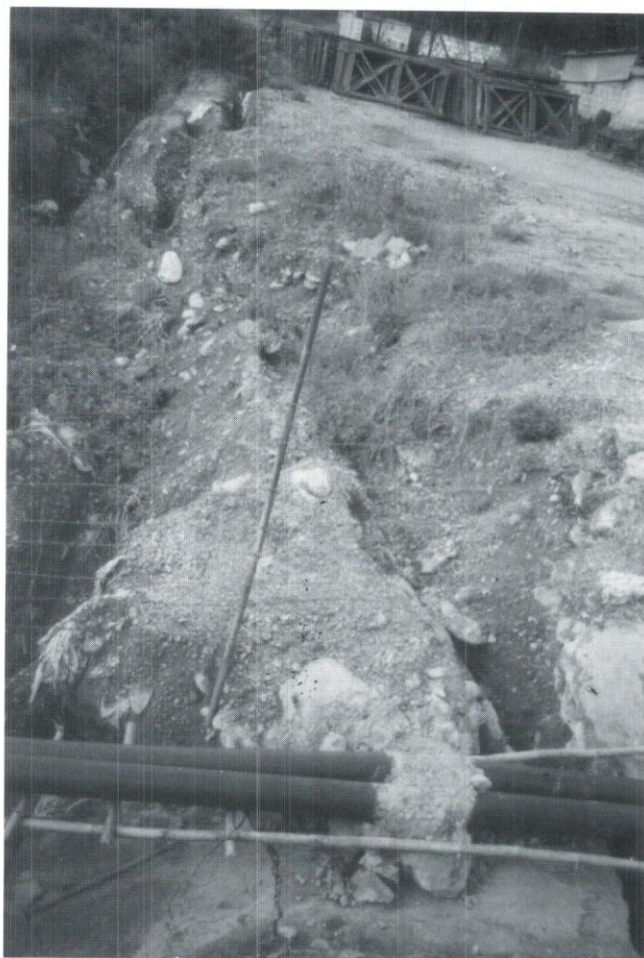
and gully erosion are delineated in the map and shown by standard symbols of red line works. Various protective measures like bioengineering works, construction of check dams, maintenance of internal and surface drainage, removal of unstable materials, reduction of slope angle are very much helpful to overcome these problems. Application of all these items in Phewa lake, Begnas lake and Rupa lake catchment areas are recommended to control landslide and soil erosion problems. The areas prone to block fall (mainly on the banks of Seti gorge) are outlined with recommendation for the mitigation measures. Collapse of Prithivi Highway Bridge over Seti River in 1991 is due to bank scouring and sinkhole development that caused block fall. Development of a 70 cm wide crack in April 1998 to 4.2 m wide in April 2000 of over 150 m long on the left bank (upstream as well as downstream) of the newly constructed Highway Bridge site and collapse of some part of it (by September 2001). Fig. 3 clearly indicates that the process of bank cutting and hydraulic action particularly during monsoon causing block falls and continues are in operation. Such processes are adversely affecting the foundation of the newly constructed highway bridge and may cause early damage (before expected time).

Fig. 3: Riverbank cutting and block fall by the side of Seti River at highway bridge site.

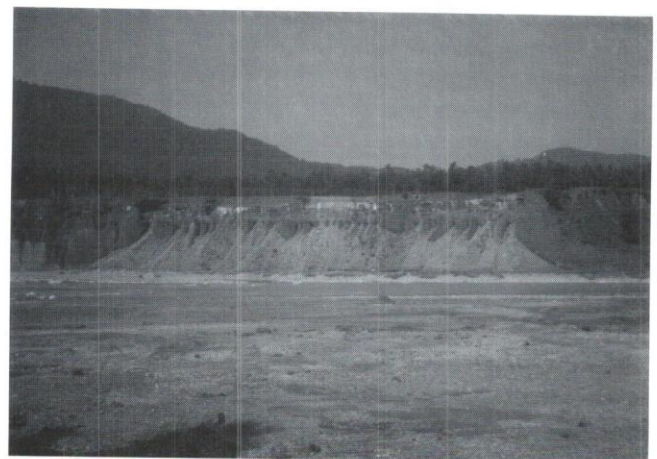
Fig. 4: Riverbank cutting and haphazard exploitation of gravel from Seti River Bed.

Uncontrolled mining of sand, gravel, boulder in river beds increases vulnerability to river bank cutting, blockfall and flooding and quarry operation on the hill slopes created slope instabilities resulting soil erosion and landslides.

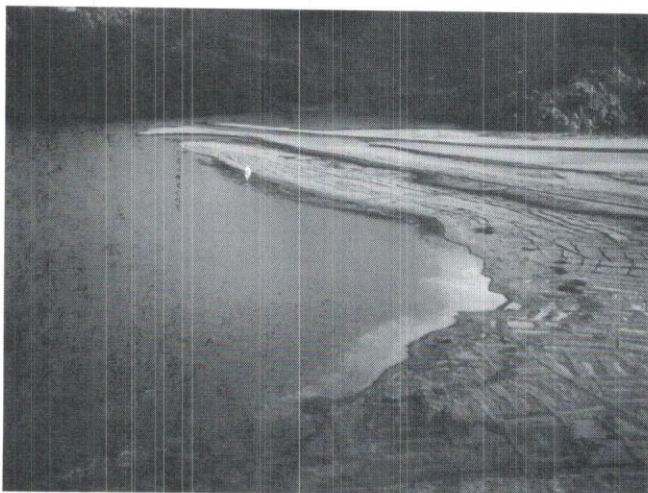
Soil erosion and landslides in the hill slopes have contributed huge mass of sediment causing siltation problem in Phewa, Begnas and Rupa lakes. As a result the size of Phewa lake has reduced considerably (Fig. 5). The problem of eutrophism in these lakes is mainly caused due to fecal contamination and chemical fertilizer used in the cultivated fields in the catchment areas. As a result, the lake water is highly polluted and very rich in coliform bacteria.

Fig. 5: Siltation in Phewa Lake and its size reduction.
