# Landslides and debris flows of 19-21 July 1993 in the Agra Khola watershed of Central Nepal

P. B. Thapa and M. R. Dhital

Central Department of Geology, Tribhuvan University, Kirtipur, Kathmandu, Nepal

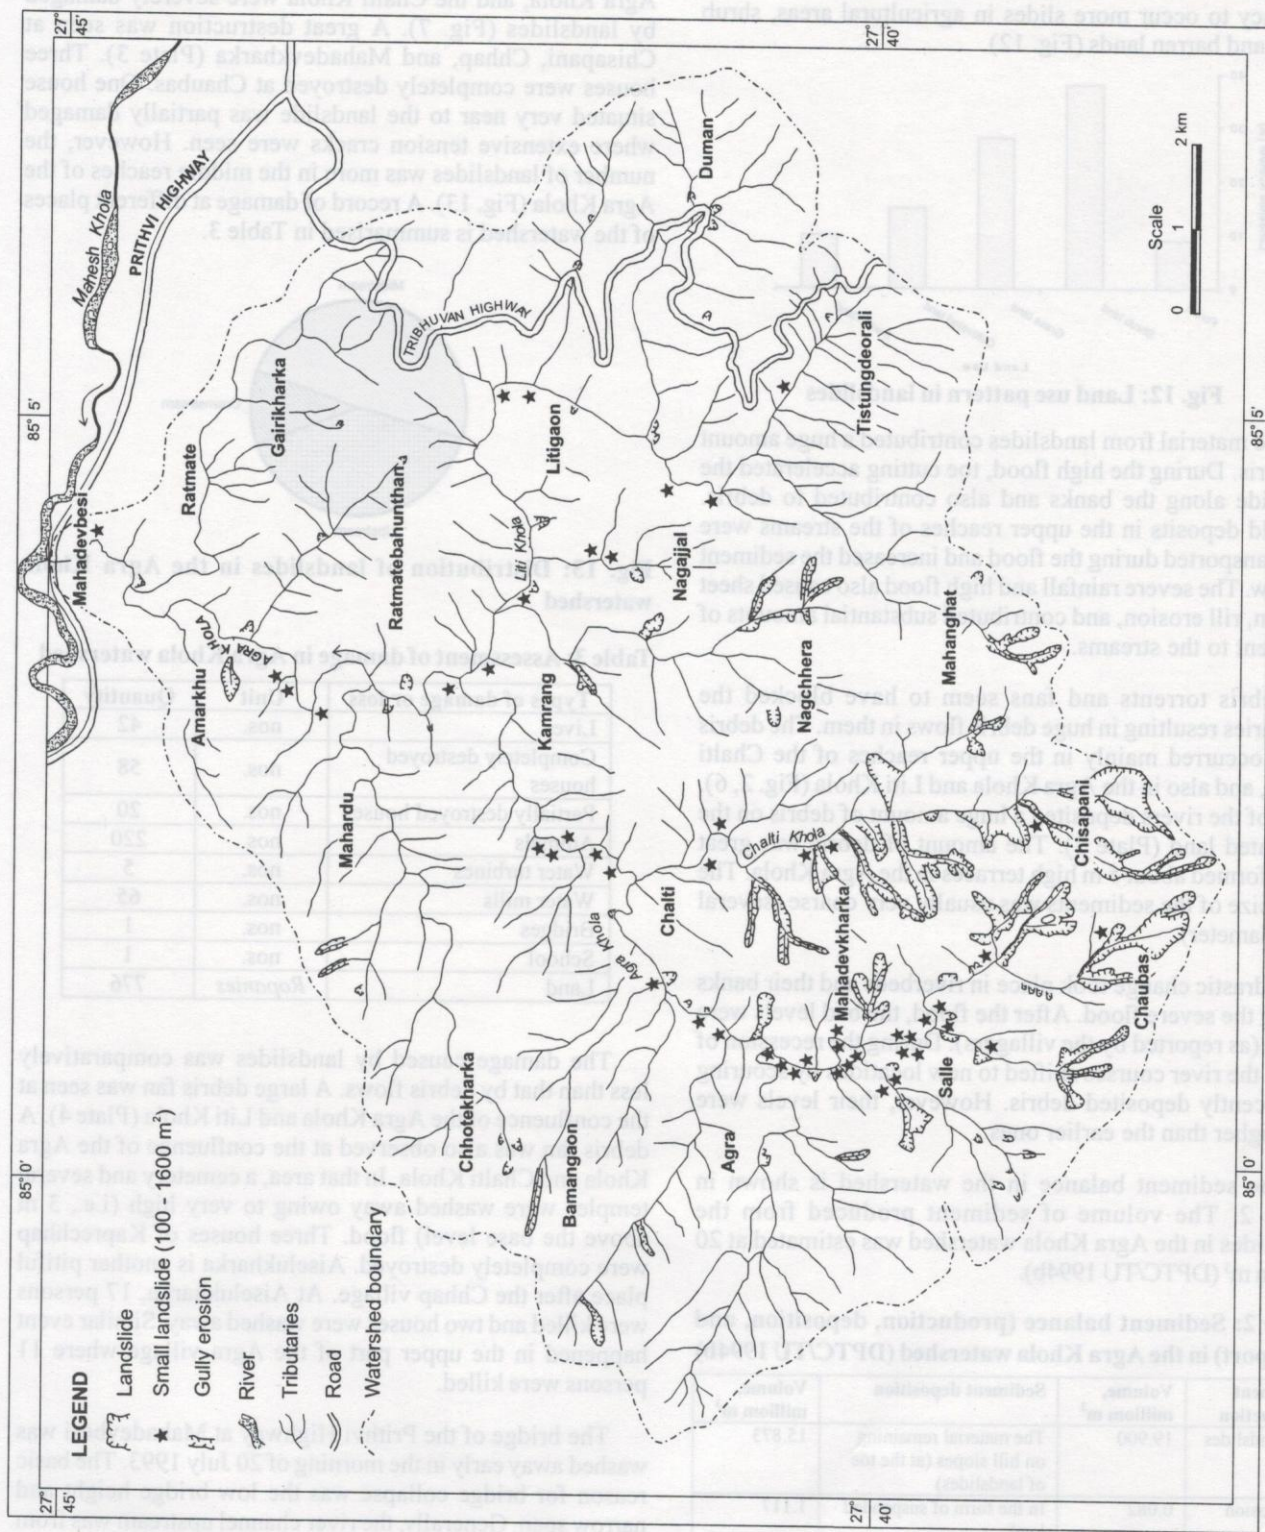
Fig. 7: Landslide inventory map of the Agra Khola watershed, Central Nepal, Lesser Himalaya

The rainstorm of 19-21 July 1993 triggered off numerous rock and soil slides in the Agra Khola watershed (Fig. 7). The mass movements triggered by the event were debris flow, debris slide, debris fall, deep rotational slide, soil slide, wedge failure, and plane rockslide. Complex mass movements (a combination of two or more types) predominate in the area (Fig. 8).

The highest population (based on number of slides as well as area occupied by them) of landslides occurred in the Kulikhani Formation (Fig 9) and on slopes of 25°-45° (Fig. 10). The occurrence of large landslides in the Kulikhani Formation is due to the presence of highly fractured and weathered rock with daylighting foliation plane. The major landslides were at Chisapani, Chaubas, Dandabas, and Chhap (Fig. 7).

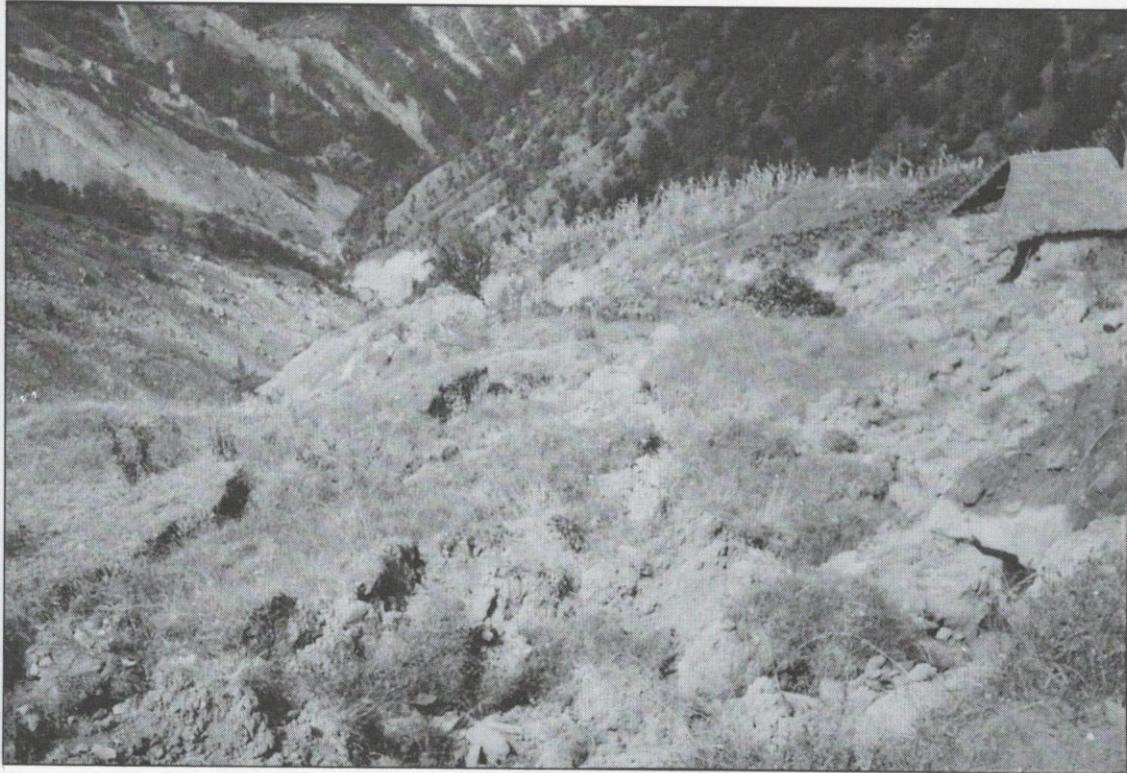
The large, deep-seated rockslides were common on the north-facing dip slopes. On the other hand, shallow slides were observed on granite, counter dip slopes, and thin soil slopes (Fig. 11). Debris and soil slides occurred on slopes that were either deeply weathered or covered by colluvial and/or residual soils with depths ranging from 1 to 6 m. There were many tension cracks at the proximity of the crown of the slides, especially at the upper part and on the left bank of the Chalti Khola, where cracks were 5-30 cm deep in average (some cracks were wider than 60 cm and deeper than 1 m). Similarly, extensive tension cracks were observed near the crown of landslides situated on the upper portion at Chisapani and Chaubas (Plate 1).

**Plate 1:** Extensive tension cracks observed near the crown of landslide at Chaubas. View towards north.

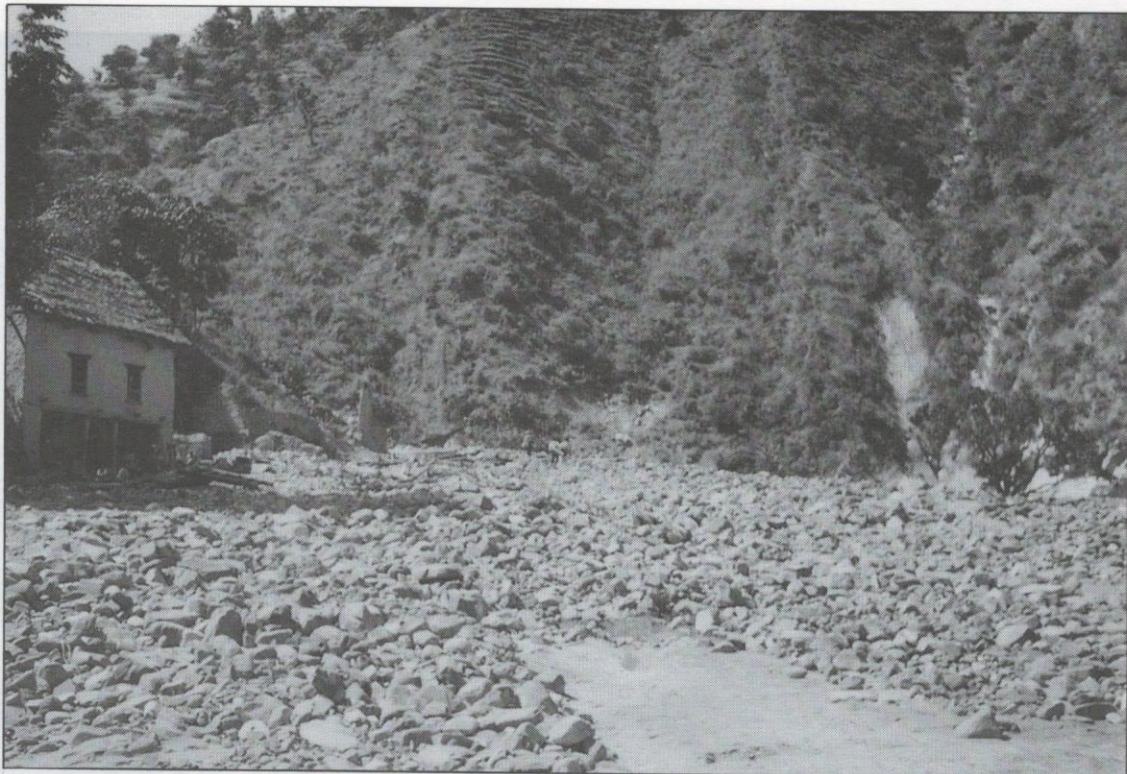
**Plate 2:** Debris deposited along the course of the Agra Khola, northwest of Kaprechhap, where three houses were destroyed. At this place, cultivated land was also washed away. View towards southwest.

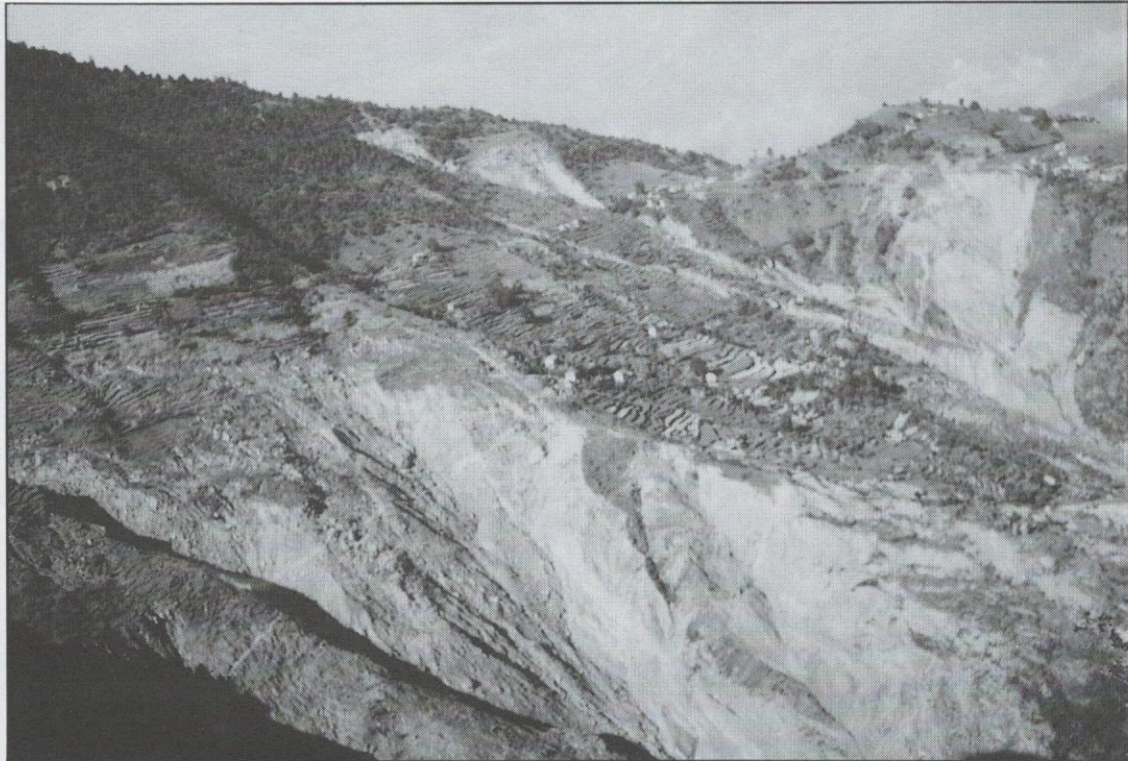
During the disaster, the upper and middle reaches of the Agra Khola, and the Chalti Khola were severely damaged by landslides (Fig. 7). A great destruction was seen at Chisapani, Chhap, and Mahadevkharka (Plate 3). Three houses were completely destroyed at Chaubas. One house situated very near to the landslide was partially damaged where extensive tension cracks were seen. However, the number of landslides was more in the middle reaches of the Agra Khola (Fig. 13). A record of damage at different places of the watershed is summarised in Table 3.

*View towards southwest. Village area is creeping.*

**Plate 3:** Vulnerable position of the village of Chisapani, situated between two large landslides. The entire village area is creeping. View towards southwest.

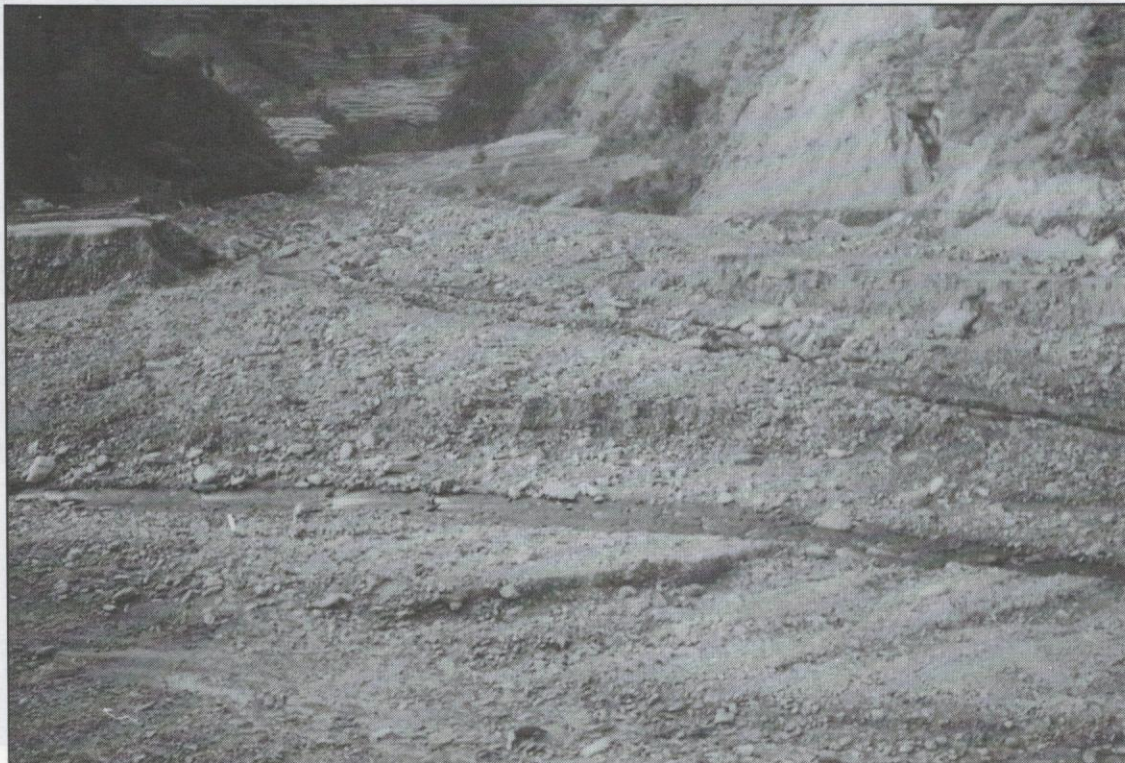
The damage caused by landslides was comparatively less than that by debris flows. A large debris fan was seen at the confluence of the Agra Khola and Liti Khola (Plate 4). A debris fan was also observed at the confluence of the Agra Khola and Chalti Khola. In that area, a cemetery and several temples were washed away owing to very high (i.e., 3 m above the base level) flood. Three houses of Kaprechhap were completely destroyed. Aiselukharka is another pitiful place after the Chhap village. At Aiselukharka, 17 persons were killed and two houses were washed away. Similar event happened in the upper part of the Agra village where 11 persons were killed.

**Plate 4:** A large debris fan at the confluence of the Liti Khola and the Agra Khola. View towards southwest.

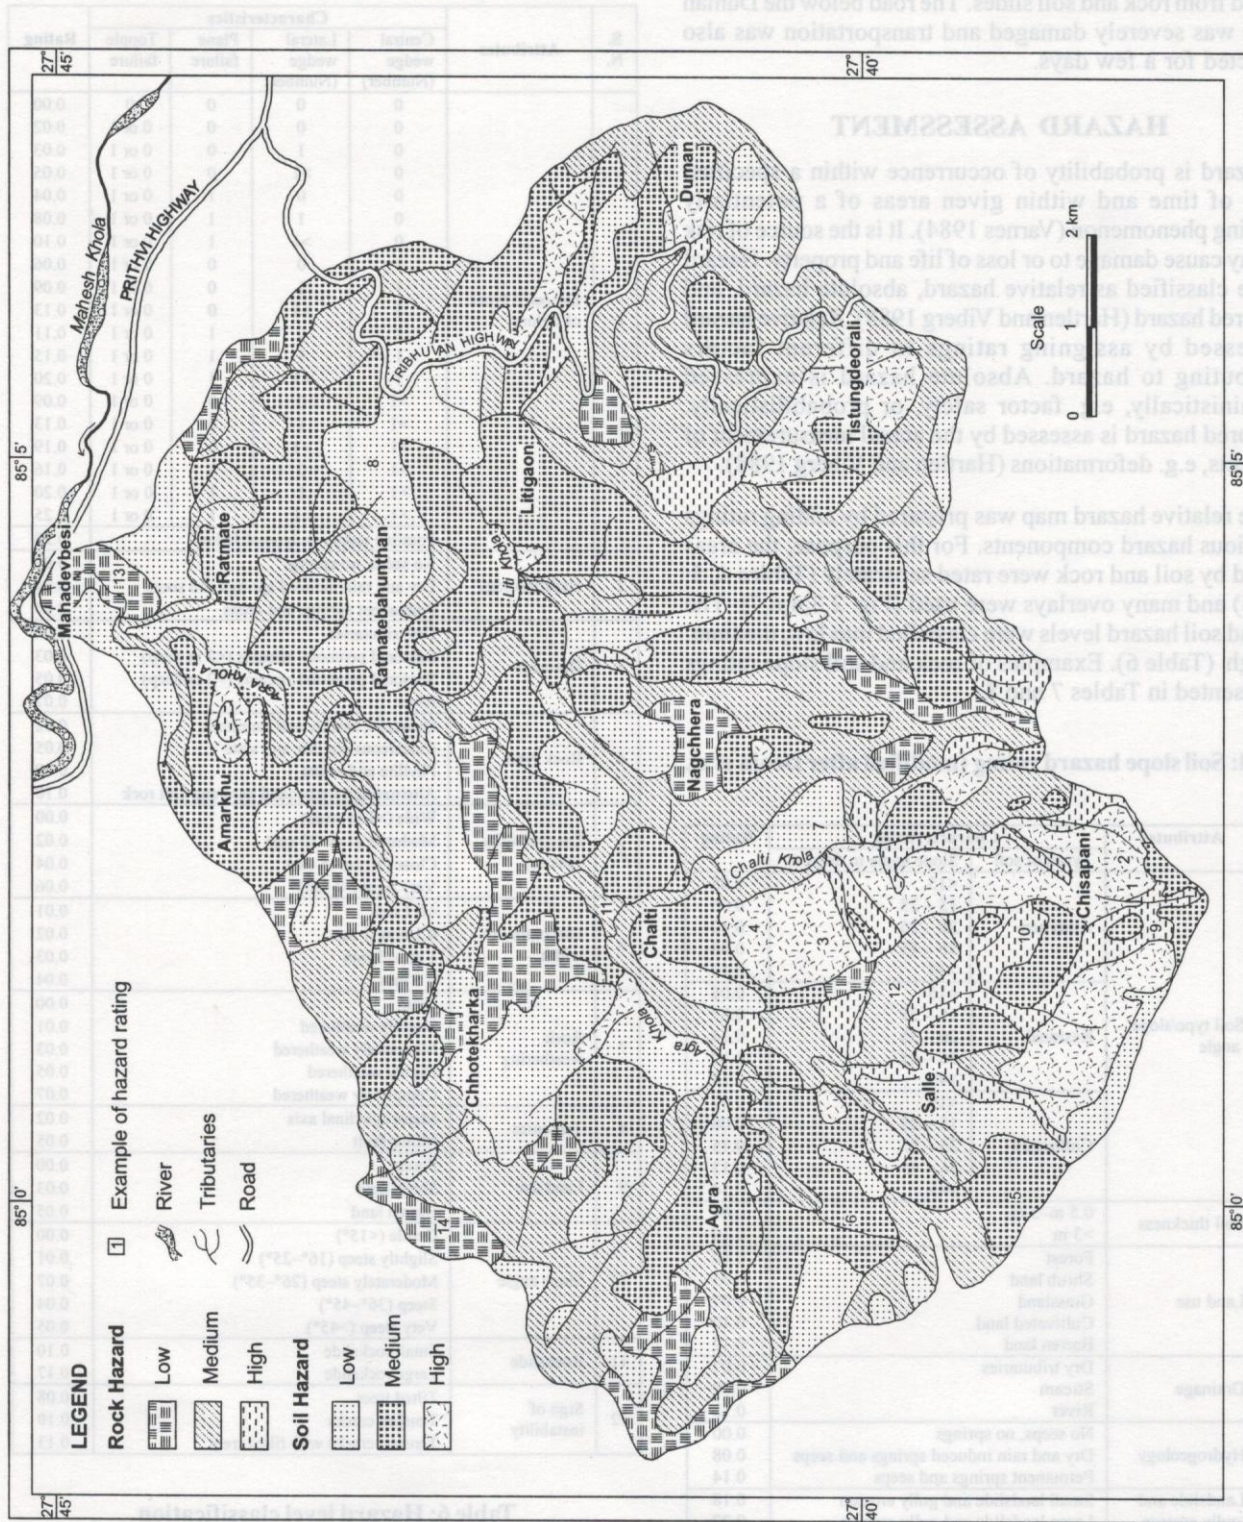
Fig. 14: Hazard map of the Agra Khola watershed, Central Nepal, Lesser Himalaya

The relative hazard map was prepared by adding ratings for various hazard components. For this purpose, the areas covered by soil and rock were rated separately (Tables 4, 5; Fig. 14) and many overlays were used (Fig. 2,3,4,6,7). The rock and soil hazard levels were classified into low, medium, and high (Table 6). Examples of rock and soil slope ratings are presented in Tables 7 and 8.

Various types of hazard and their categories are shown in Fig. 14. High hazard areas are confined in the vicinity of Chisapani, Chaubas, Salle, Tistungdeorali, Duman, and Amarkhu. The upper reaches, especially after the confluence of the Agra Khola and the Chalti Khola are highly hazardous. Medium and low hazard areas are found in the middle reaches and northern part of the watershed (at Agra, Chhotekharka, Nagchhera, Litigaon, Ratmate, and Ratmatebahunthan) with some high hazard zones in between.

considered to be safe, the medium hazard zones can be made stable with some mitigation measures, but the high hazard zones are not suitable for construction and agricultural use.
