Unusual cause for pacemaker threshold elevation

CASE REPORT

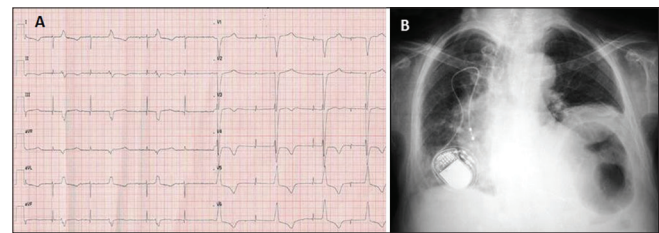
A 75-year-old female patient admitted to our pacemaker outpatient clinic for regular control. She had complaint of abdominal distension and dyspnea especially when she lay back at night. Her VDD pacemaker (Vitatron Saphir 3 VDD) was first implanted nine years ago and she underwent battery replacement (Medtronic Enpulse E2VDD01) 2 years ago. According to the records, lead amplitude was 2.5 mV and pacing threshold was 0.9 mV and impedance was 800 ohms at that time, so operator left the lead in current place. Patient's pacemaker interrogation showed end of life alert (less than one month). This finding was unexpected for such a short period after implantation. A threshold test was applied and result was 2.7 mV. Current pacing amplitude was 2.5 mV. Patient's prior interrogation results were in normal range, lead impedance was 740 ohm, pacing threshold was 1.1 mV. Current lead impedance was 1980 ohms. Surface electrocardiogram revealed capture failure (Figure 1A). A chest plain film demonstrated a partial white-out of left lung without extrapulmonary air (Figure 1B). After surgery consultation, surgical repair of para-esophageal hernia was recommended.¹ Patient rejected surgical therapy. Later, battery was replaced and a new lead implanted to a location with better threshold and impedance values (Figure 2).

Figure 1: (A) Patient's surface electrocardiogram. Pacing spikes are not related with QRS complex, typical for loss of capture. (B) Patient's anteroposterior telecardiogram. Notice the colon segments filling thorax

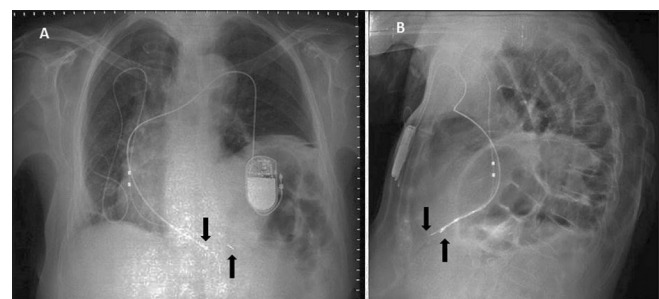
Figure 2: After reimplantation telecardiograms. (A) Anteroposterior and (B) lateral views, arrows show true positioning of the new pacing electrode

infarction) and lead dislodgement.² In our case, it seems that herniated segment provided an external push to the ventricle and caused displacement and insufficient contact of the lead tip. True apical position is easily noticed on the chest x-ray after the procedure (Figure 2).
