Bank erosion and lateral instability hazard status of Kodku Khola, southeast Kathmandu, central Nepal

*Sudarshon Sapkota and Naresh Kazi Tamrakar

Central Department of Geology, Tribhuvan University, Kirtipur, Kathmandu, Nepal

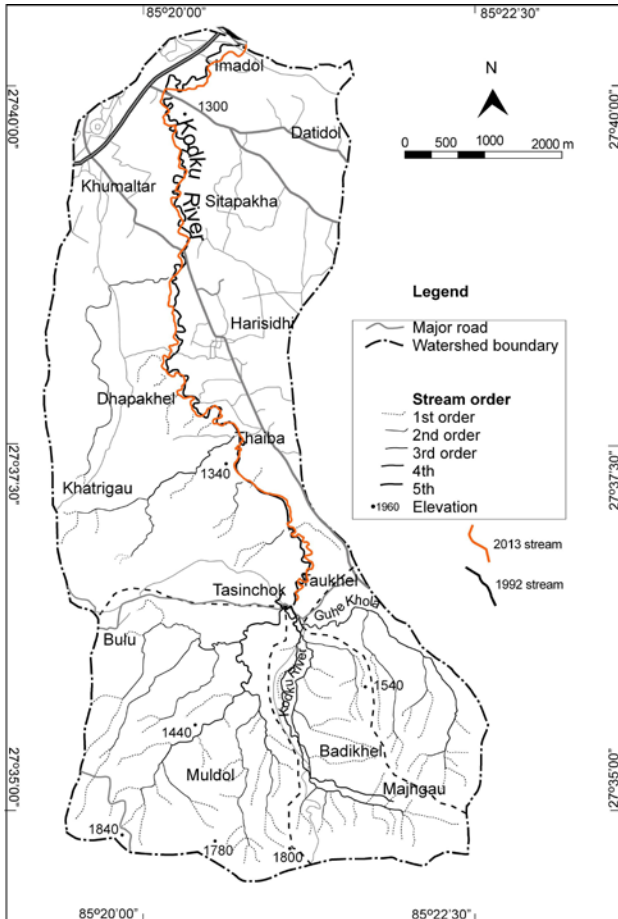
Fig. 3: Comparison of streams of two episodes: 1992 and 2013.

River itself shows dynamic nature by shifting its channel in space and time. The shifting of channel can however be aggravated by effects of natural and human activities. The channel shifting of the Kodku Khola was determined by comparing the topographic map of 1999 and satellite image of 2013 of the Kodku watershed (Fig. 3). The river channel is more shifted in Imadol and Khumaltar.

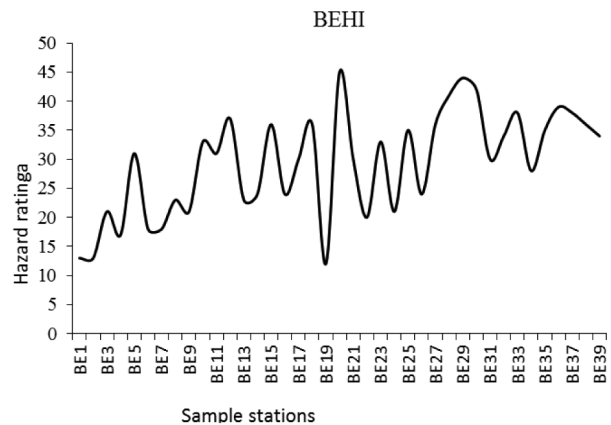
Fig. 4: Bank erosion hazard status of the Kodku Khola.

The result of BEHI is indicated in Table 2 and Fig. 4. The result shows that Erosion potentiality of the Kodku Khola banks fall on low to very high hazard level. The Harisidhi (BE26, BE27, and BE28) and Thaiba (BE20) areas exhibit very high potential of stream erosion. More than half of the sample stations exhibit the high to very high hazard level. The hazard level increases towards downstream region.

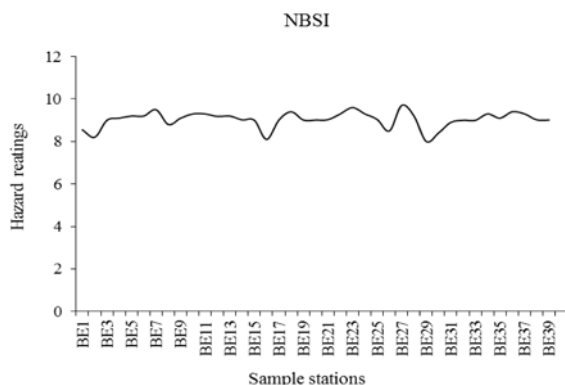
Fig. 5: NBSI hazard status of the Kodku Khola.

The banks of the Kodku Khola are subject to very high to extreme near bank stresses (Table 3 and Fig. 5). Sample stations around the Majhgau areas (BE1, BE2, and BE3), Thapagau (BE7), Jharuwarasi (BE16) and Harishidhi areas are subject to very high hazard level and the remaining sample stations fall on extreme hazard level.

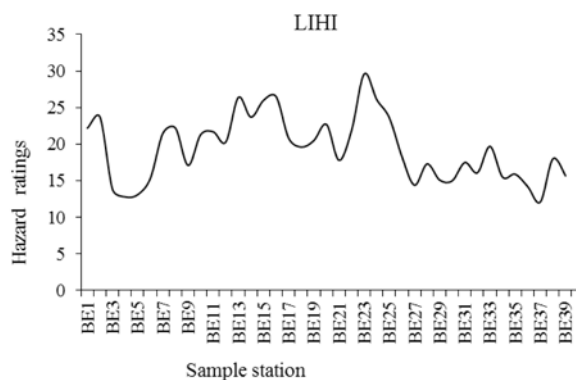
Fig. 6: LIHI hazard status of the Kodku Khola.

The result (Table 4 and Fig. 6) shows that lateral instability condition of the banks of the Kodku Khola fall on low to moderate hazard levels. Moderate LIHI is due to high

values of almost all the Planform parameters. Sinuosity (K), meander width ratio (MWR) and meander length ratio (MLR) of the river largely influence the value of LIHI, and hence its fluctuation. The result shows that the area of Badikhel and the downstream sites from the Harishidhi to the Manahara River Bridge fall on low lateral instability hazard index level. The low values of LIHI are due to the extreme channelisation and human encroachment of the river. The channelisation directly affects the K, MWR and MLR of the river. Such planform parameters are frequently altered due to many anthropogenic disturbances and discharge variation of the river.

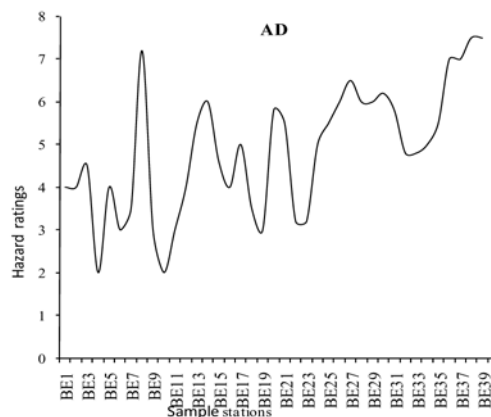
Fig. 7: Anthropogenic disturbance (AD) status of the Kodku Khola.

At the Majhgau area, banks of the Kodku Khola have been less disturbed by human activities whereas natural factors moderately affect stability condition of river banks (Fig. 7 and Table 5). Some areas of the Thaiba and Harishidi belong to very high hazard levels. The sample stations located downstream from the Harishidhi to the Gwarko areas are highly disturbed by human activities. River has extremely lost its natural status by extreme channelization and pollutions in these areas. The Taukhel, Jharuwarasi, Dasghare and Imadol areas fall on high hazard levels. The sample station downstream from the Thapa Gau to Dashgare areas are seriously affected by the anthropogenic disturbances such as unplanned cultivation, disposal of sewage and livestock.

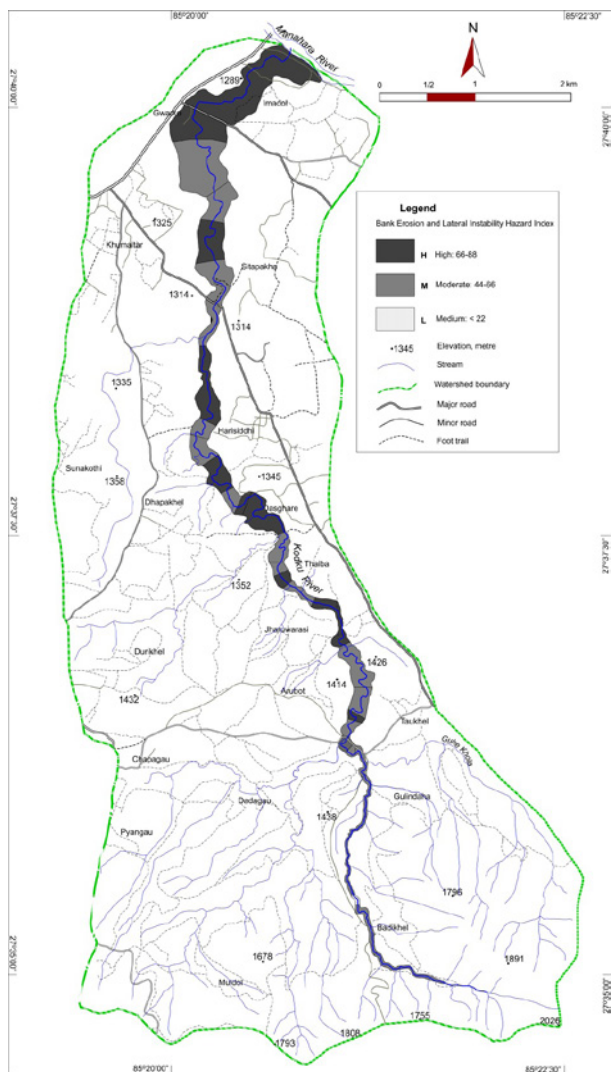
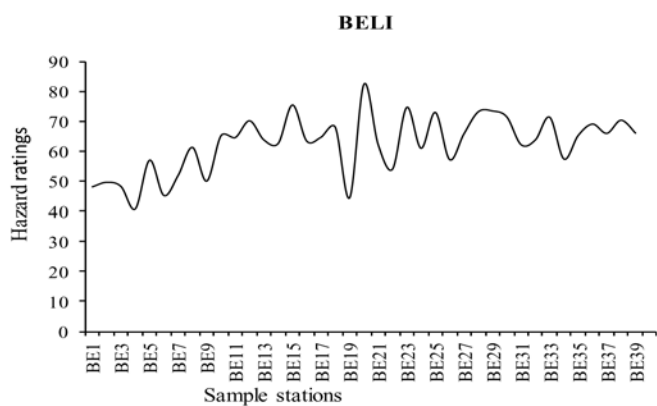
Fig. 8: BELI hazard status of the Kodku Khola.

Above mentioned four major parameters namely BEHI, NBSI, LIHI, AD were combined to prepare the BELI hazard map (Fig. 8) of the Kodku Khola. This shows that the river has moderate to high hazard level except in one sample station (BE4) near Badikhel. The stream bank with high hazard are

observed near Taukhel (BE12, BE15), Gorge (BE18), Thaiba (BE20), Dashghare (BE23), Harishidhi (BE25, BE28, BE29, BE30) and downstream from Los Angel School (BE33, BE36, BE37, BE38, BE39). The remains out stations indicate the stream banks are moderately hazardous (Table 6, Figs. 8 and 9).

The Kodku Khola falls in a moderate to high level of BELI hazard. The hazard level is found higher while moving from the upstream (Badikhel) to the downstream. BELI hazard level is moderate in the Majhgau, Badikhel and Taukhel areas. From Arubot to Los Angel School, the hazard levels fall in moderate to high level. The river has more hazardous in the Thaiba, Harishidi and Gwarko areas. BEHI and AD plays great roles for increasing the BELI hazard levels in the Kodku Khola. Minimising the hazard level of the Kodku Khola is very essential for the peoples, infrastructures around river corridors and to keep the river's natural beauty. Minimising the human disturbance such as by prohibiting channelisation, encroachments, direct sewage input and mining are best way to minimise the hazard levels in the Kodku Khola. To reduce stream bank erodibility, riparian vegetation buffer zones with suitable bioengineering measures should be established soon.
