## **Engineering geological study of the Kali Gandaki 'A' hydroelectric project area, western Nepal Lesser Himalaya**

**K. N. Kafle**  
*Nepal Electricity Authority*  
*Kathmandu, Nepal*

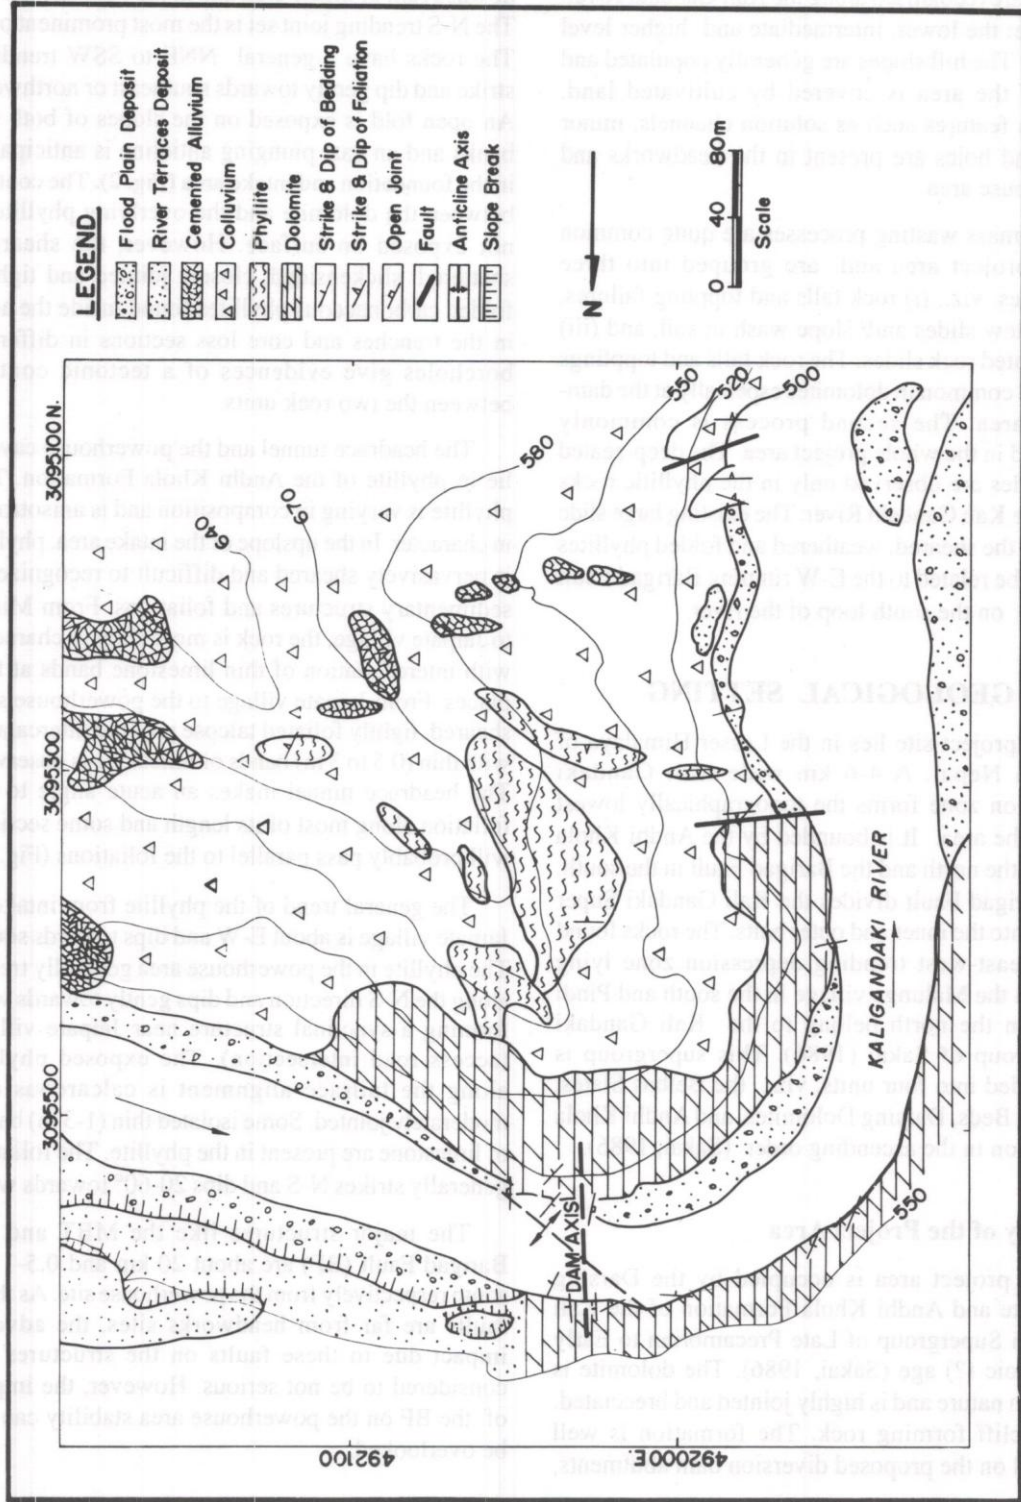
Fig. 2: Geological map of the headworks of the Kali Gandaki 'A' Project.

The project area is occupied by the Darsing Dolomite and Andhi Khola Formation of the Kali Gandaki Supergroup of Late Precambrian to Early Palaeozoic (?) age (Sakai, 1986). The dolomite is cherty in nature and is highly jointed and brecciated. It is a cliff forming rock. The formation is well exposed on the proposed diversion dam abutments,

downstream of intake area and in the desanding area. The N-S trending joint set is the most prominent one. The rocks have a general NNE to SSW trending strike and dip gently towards southeast or northwest. An open fold is exposed on the slopes of both the banks and an east plunging anticline is anticipated in the foundation and intake area (Fig. 2). The contact between the dolomite and the overlying phyllite is not exposed on surface. However, the sheared, shattered, slickensided, closely jointed and tightly folded carbonaceous phyllites found inside the adit, in the trenches and core loss sections in different boreholes give evidences of a tectonic contact between the two rock units.

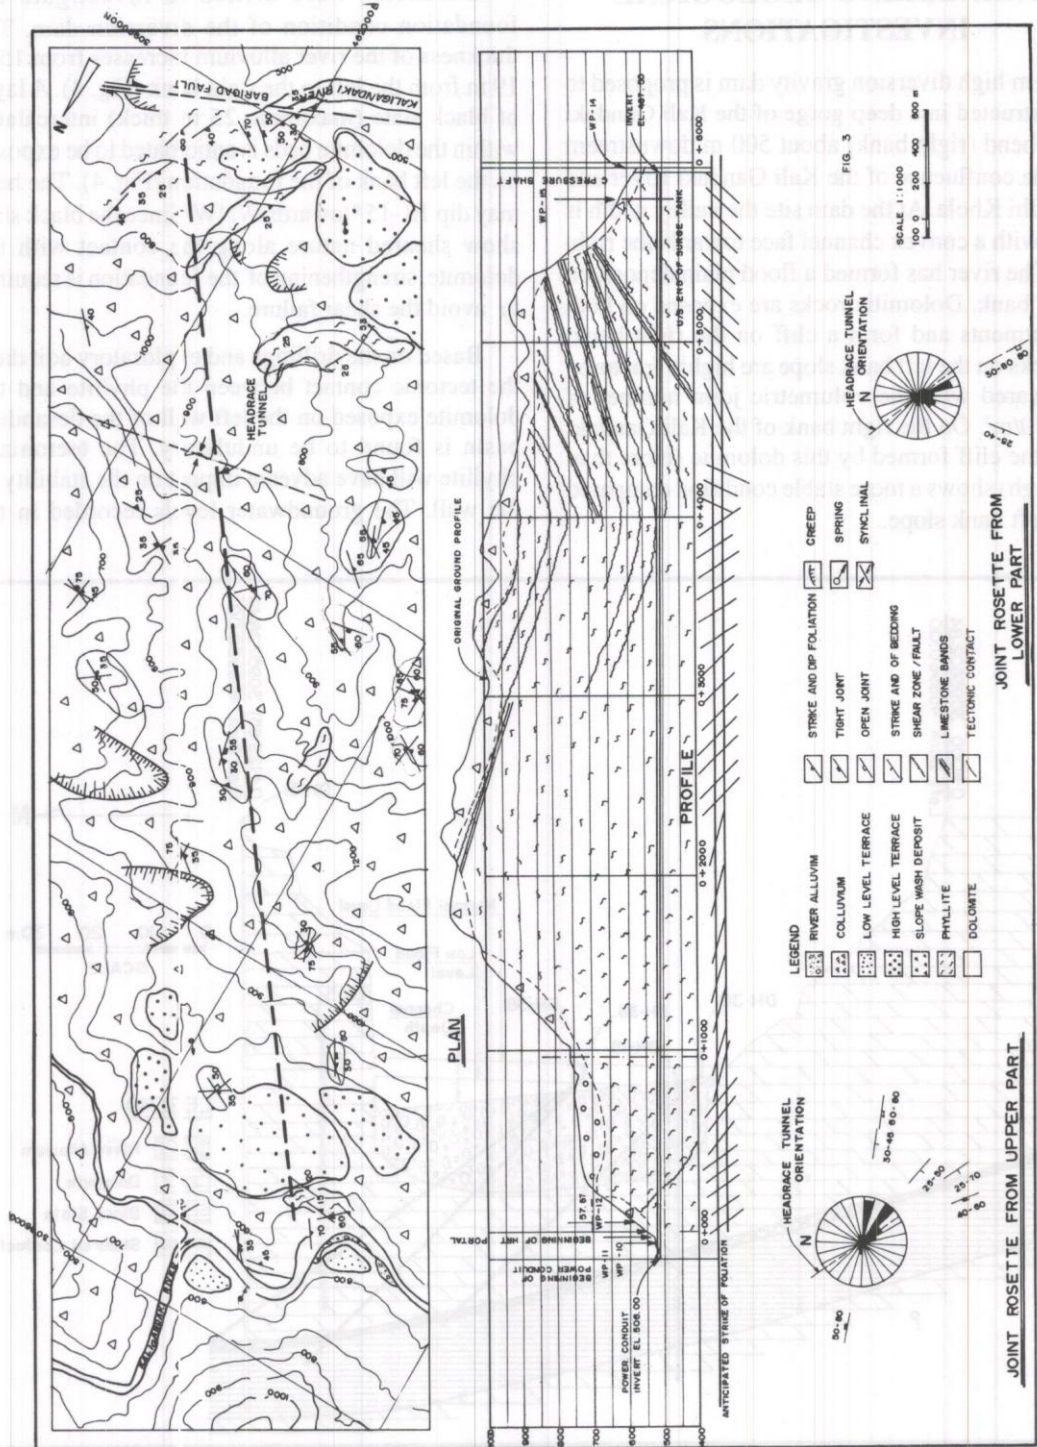
Fig. 3: Geological plan and profile along the headrace tunnel.

The headrace tunnel and the powerhouse cavern lie in phyllite of the Andhi Khola Formation. The phyllite is varying in composition and is anisotropic in character. In the upslope of the intake area, phyllite is pervasively sheared and difficult to recognize its sedimentary structures and foliations. From Mirmi to Jaipate village, the rock is more slaty in character with intercalation of thin limestone bands at few places. From Jaipate village to the powerhouse site, sheared, tightly foliated talcose phyllite intercalated with thin (0.5 to 3 m) bands of limestone is observed. The headrace tunnel makes an acute angle to the foliation along most of its length and some sections will probably pass parallel to the foliations (Fig. 3).

The phyllite in headrace tunnel is characterised by variable composition and rock strength. The rocks vary from weak chlorite and talc rich schist, fissile carbonaceous slate, calcareous shale to strong, massive sections with apparent high content of silica and calcareous materials. The headrace tunnel cuts the rocks making an acute angle with the foliation along most of the length, and runs parallel to the foliation in some sections. In general, the tunnelling condition along most part of the tunnel is not favourable considering the orientation of the foliations in the rock. In such cases, both shear and buckling failure may occur. The perennial springs along the tunnel alignment may add inflow of groundwater into the tunnel.

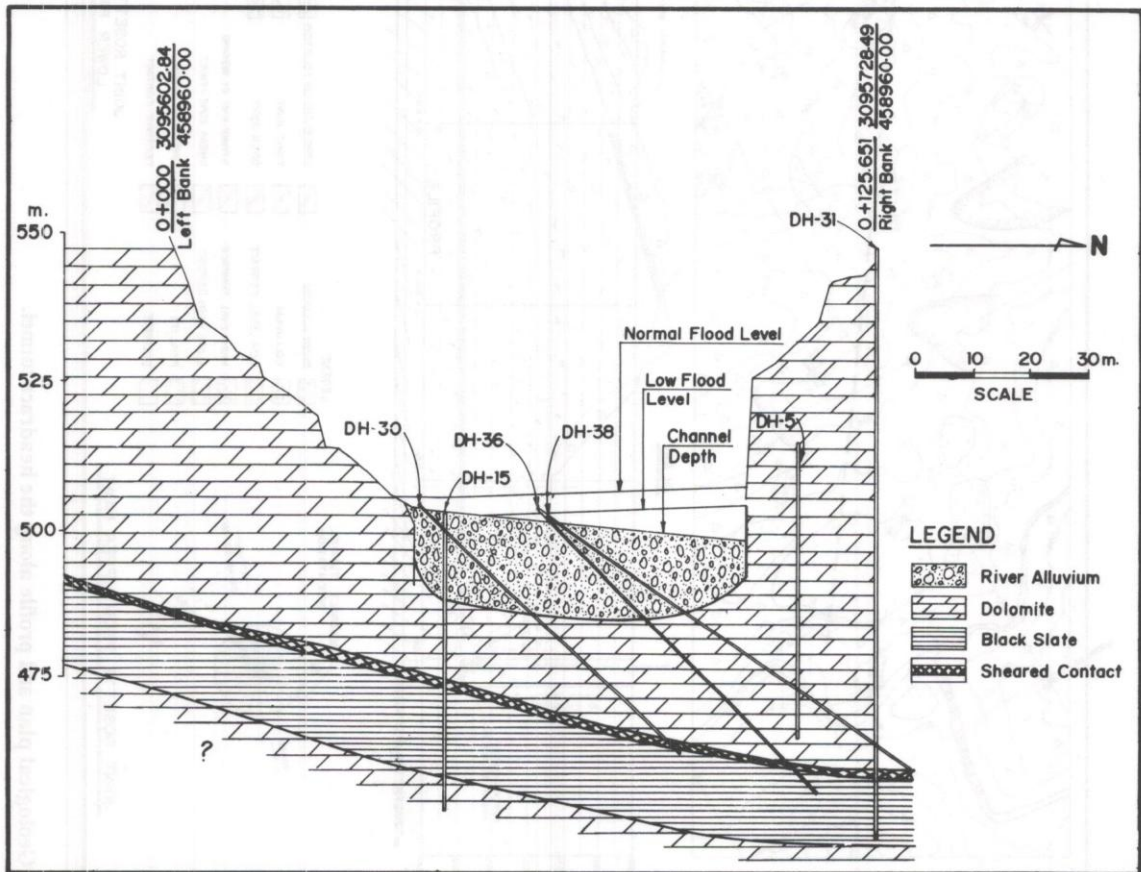
Fig. 4: Geological section along the dam axis.

Boreholes were drilled to investigate the foundation condition of the diversion dam. The thickness of the river alluvium increases from 15 to 19 m from the left to the right bank (Fig. 4). A layer of black slate (maximum 25 m thick) intercalated within the dolomite beds is anticipated to be exposed on the left bank of the foundation (Fig. 4). The beds may dip  $10-15^\circ$  towards WNW. Since the black slate show sheared nature along the contact with the dolomite, strengthening of the foundation is required to avoid the shear failure.
