# Alluvial mining and its impact on deterioration of physical health of Malekhu Khola, Central Nepal

\*Jharana Khanal

*Central Department of Geology, Tribhuvan University, Kathmandu, Nepal*

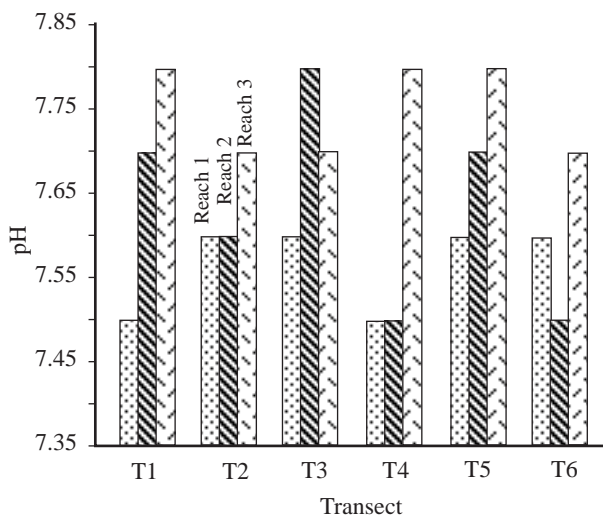
Fig. 3 pH value of the Malekhu Khola

The pH measures the alkalinity presence in the water. The river water was alkaline although it varied from transect to transect. The average pH in the Malekhu Khola during study conducted was 7.6 where Reach 3 has got highest value of pH. The value steadily increases towards the downstream portion (Fig. 3). Calcium carbonate (CaCO<sub>3</sub>) and other bicarbonates can combine with both hydrogen or hydroxyl ions to neutralize pH, thus the alkalinity of a stream or other body of water is increased by carbonate-rich soils (carbonates and bicarbonates) such as limestone, dolomite etc. So the growing value of pH towards downstream shows the signal of presence of high carbonate content in the water.

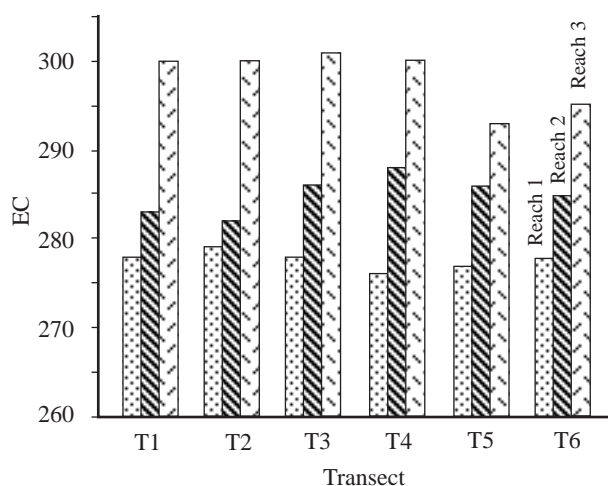
Fig. 4 EC value of the Malekhu Khola

there is a problem of riverbed extraction. In addition, the study area receive excessive amount of organic matter compared to the upper reaches. Increasing of EC values gradually towards downstream or towards the mining site is an indication of river contamination as related to the previous reaches (Fig. 4).

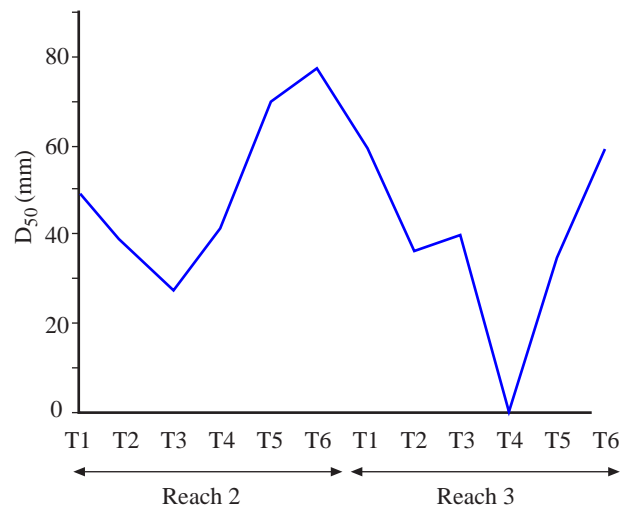
Fig. 5 Graph showing fluctuation of  $D_{50}$  in different transect

to 64 mm for the Malekhu Khola. Hence, the Malekhu Khola is called a gravel bed stream. But there are abnormal values in some transects, 5th and 6th transects of reach 2 have the value of  $D_{50}$  greater than 64 mm that means these transects have boulder to cobble sized sediments rest over the river banks and channels which are difficult to transport for crusher plant. The fourth transect of Reach 2 have  $D_{50}$  value 0.25 which belongs to the medium sand particles, settled in the bottom after the extraction of gravel (Fig. 5). The high instability of data in a same reach within 500 m noticeably proves that the extraction of river sediments is going unsystematically.

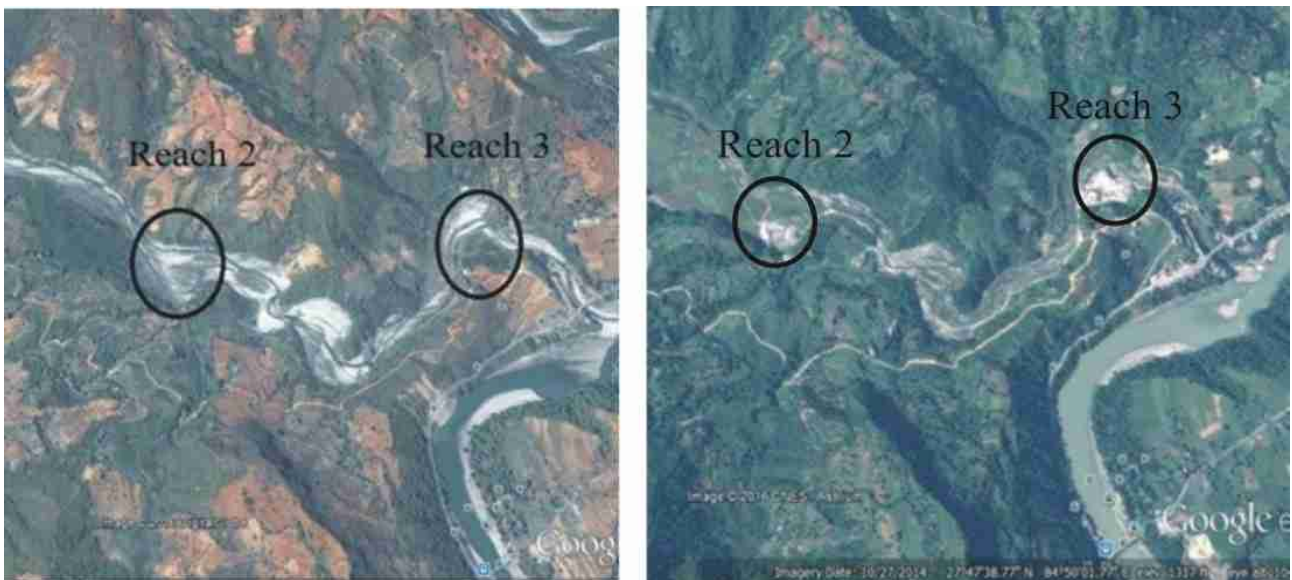
Fig. 6 Satellite image of year 2002 (left) and 2014 (right) of the Malekhu Khola

Study of satellite image clearly shows the evidence of change in river morphology throughout the certain time span. The satellite image from 2002, before the establishment of processing plant verifies that there is a vibrant bifurcated river channel at Reach 3 of the Malekhu Khola (Fig. 6). The accumulation of river sediments is naturally stratified. The channel was not blocked by the river sediments whereas in the image of 2014 the bifurcated river channel is almost collapsed, sediments are erratically disperses. Bigger sediments themselves are hindering the path of river which finally leads the alteration of channel.

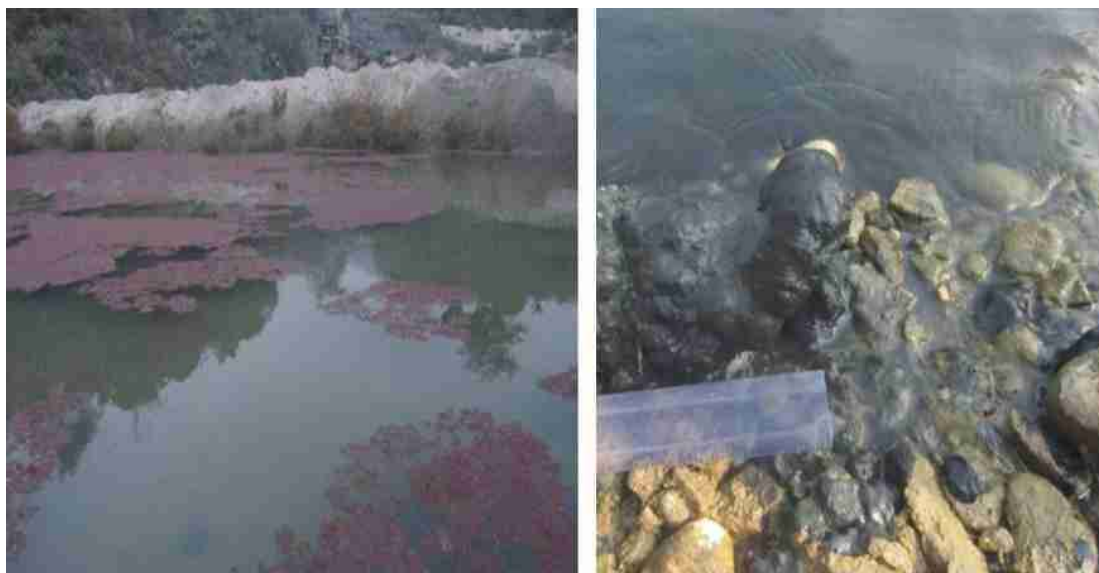
Fig. 7 Contaminated pool and organic matter around Reach 3

The removal of soil, extraction of sand from in-stream bed and flood plain are highly adopted in the study area where oversized materials are accumulated in the stream channel as well as in the bank side. These oversized unfed material in the channel and bar blocks the flow of water and finally leads the alteration of channel. The extraction of sediments below the depth of  $D_{max}$  in reach 2 and 3 are very common which further makes the pool. The contaminated pool with silt, clay, organic matter and mycrophytes are clearly observed in reach 3 (Fig. 7).
