Morpho-hydraulic parameters and existing stability condition of Nakhu River, southern Kathmandu, Central Nepal

Binod Maharjan and *Naresh Kazi Tamrakar

Central Department of Geology, Tribhuvan University, Kathmandu, Nepal

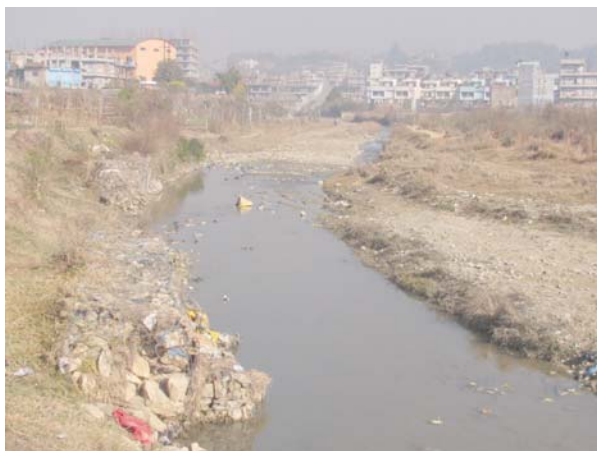
Fig. 5 Downstream view of the segment 1 at Nakhu

Segment 1 is less entrenched (>1.4) with high W/D ratio (30.19) and low sinuosity ($K = 1.17$) with bed material of gravel and silt/clay mixture with little sand. Point bars, point bars with a few mid channel bars and side bars characterize the deposition pattern of this stream. Riparian vegetation along the river corridor is poor, and constitutes mainly shrub and grass, and minorly few trees (Fig.

5). Most of the reaches of the corridor are accompanied by cultivated and built-up areas. The river segment has been affected by clearing of the riparian vegetation, bank encroachment, extremely high effluent discharge from settlement areas, and encroachment of river banks for extending roads.

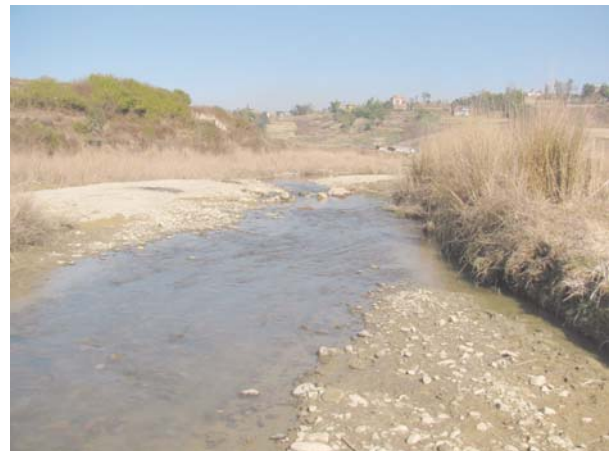
Fig. 6 Downstream view of the segment 2 at Bhainsepati

Segment 2 has a broad valley with terraces associated with well defined flood plains. Segment 2 is slightly entrenched ($ER=4.0$) with well defined

meandering channel ($K=1.52$), high W/D ratio (39.94), and low gradient (<0.02 m/m). The bed material comprises fine sand with gravel. Deposition pattern in the stream is characterized by abundant channel bars and point bars. Riparian vegetation is represented by grass, shrubs. Distribution of tree is only in certain part in patchy and discontinuous pattern (Fig. 6). The banks exhibit erosional scarps. Seasonal channel shifting is remarkable. Building of gabion walls, cultivation of banks, grazing, bank encroachment and riparian vegetation clearing are major problems.

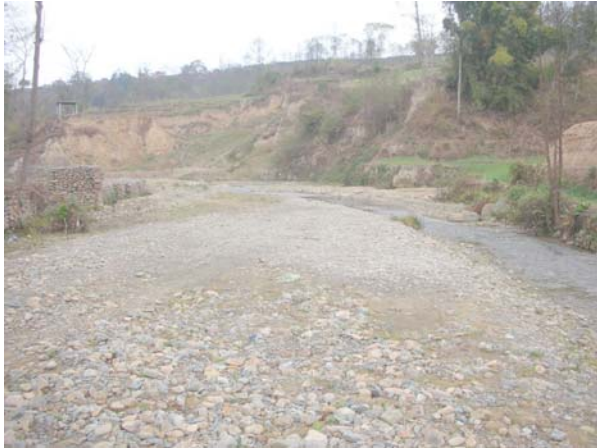
Fig. 7 Downstream view of the segment 3 of the Nakhu River at Chapagaon area

Segment 3 and 4 are slightly entrenched with W/D ratio greater than 12 (Table 2). These are well defined meandering channel with low sinuosity generally less than 1.5 (K of segment 3=1.19 and K of segment 4=1.25) with very gentle slopes. Both segments have broad valleys with terraces in association with flood plains. The bed materials are composed of fine gravel. Abundant point bars and mid-channel bars constitute depositional channel elements. Riparian vegetation is represented by grasses, shrubs, and linear to patchy isolated trees (Fig. 7 and 8). Segment 3 has few trees in a discontinuous pattern in few parts of the segment with wide flood plains. The banks exhibit erosional scarps and a few landslides. Segment 4 exhibits better condition than others. Seasonal channel shifting is quite remarkable in segment 3. Excavation of gravel from channels, cultivation on the banks

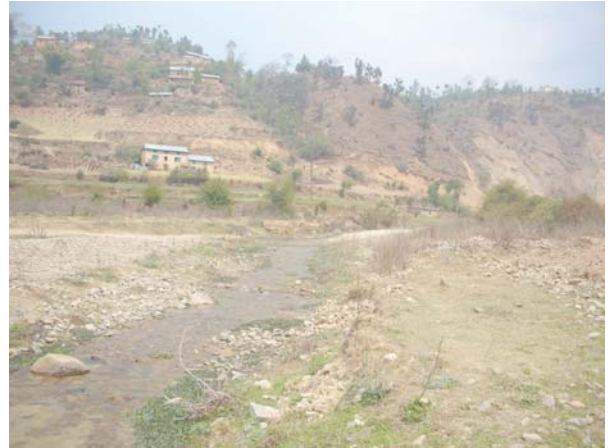
Fig. 8 Downstream view of the segment 4 of the Nakhu River at Nallu area

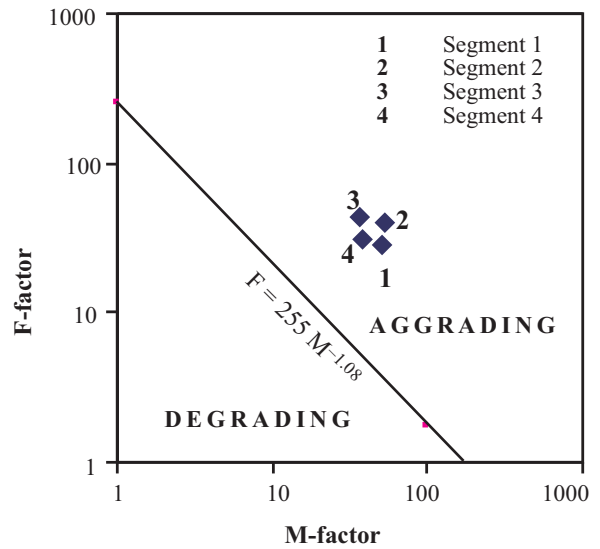
Fig. 10 F versus M-factor diagram showing aggrading/degrading potential of the Nakhu River segments

Fig. 10 shows the F versus M relationship. The plots of all the four segments of the Nakhu River lie on the aggrading field of this diagram.
