Overview of June 2013 Flood and Landslides with focus on Darchula Disaster

Er. Prakash Paudel, Er. Shital Babu Regmee, and Surya Nath Upadhyay

This paper analyses the events surrounding the 17-18 June catastrophic flood causing wide spread damages in Darchula District Head Quarter. Both the countries need to work honestly for mutual benefit especially for minimising the effects of any disasters in the future.

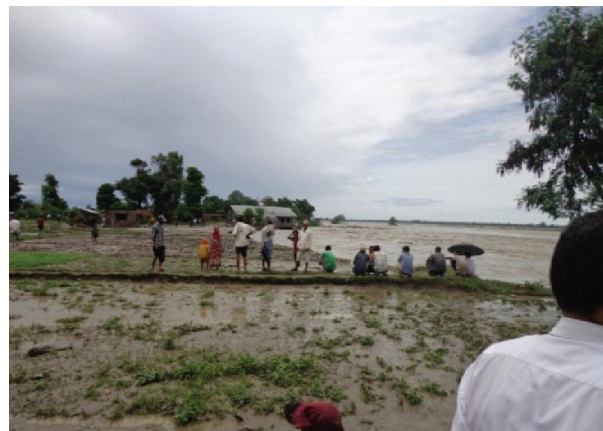
Figure 3. Village building collapsed in Kanchanpur

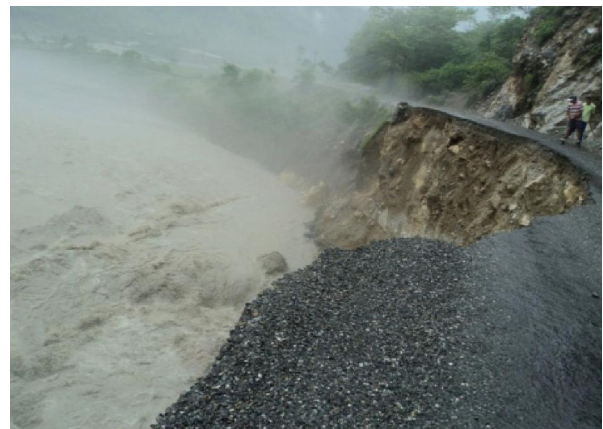
Figure 4.Devastation of Darchula HQ

Mid June of 2013 saw unprecedented rainfall in Uttarakhand state of India and Far-western region of Nepal. The cloud outburst was due to simultaneous activation of monsoon arms from eastern and south western direction. Broad advancement and confluence of the monsoon winds is shown in Figure 2. Due to the flood generated by the rainfall, heavy loss of land and property in Darchula and Kanchanpur districts by Mahakali River were experienced. Also, the normal cases of bank cutting and inundations were reported in Narayani and Tinau rivers, besides events of inundation and bank cutting information came from some central and eastern parts of Nepal (Fig 3 and Fig 4). Huge losses of land and houses were caused by the floods of Karnali River in Bardia district.

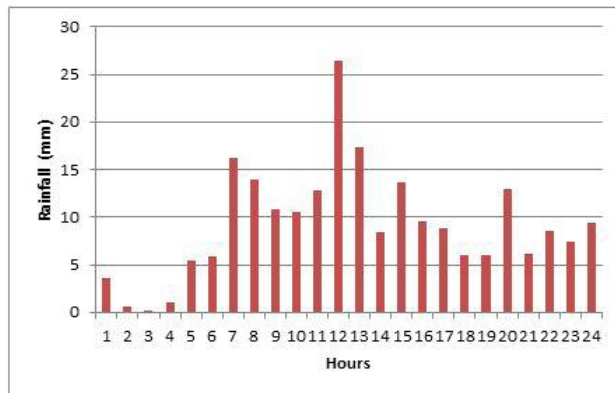
Figure 5.Rainfall in Dipayal, Nepal (June 17, 2003)

The rainfall with hourly distribution in Dipayal station in Nepal is shown in figure 5. There was recorded daily rainfall of 80.4 mm in June 16 and 221.8 mm in June 17 at this station. Similarly, rainfall pattern in these areas of Nepal and India are depicted in the figures 6 and 7. All the records show that the rainfall far exceeded the normal and was main reason for the unprecedented flood in the region.

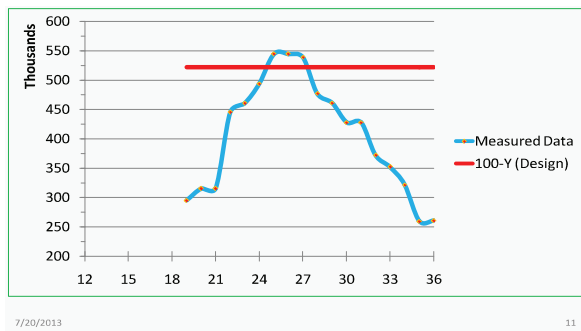
Figure 8. Flood Measurement (CUSECS) Hydrograph in Mahakali (River Discharge From Jun-17-Noon to Jun-18-Noon)

It is clear from above that the flood at 0100-0200 hrs on June 18 has exceeded all the past records as well as the design discharges of Banbasa and Tanakpur Barrages.

It is reported that effective rainfall in the western Nepal started from June 17 and further increased on June 18. Table 2 shows the daily precipitation of Dipayal for consecutive 4 days (as per graph presented by ICIMOD after DHM). The measured flood records (PEP, FO-7) of Mahakali in Sarda barrage for Jun (17-18) are shown in the following hydrograph (Fig. 8).

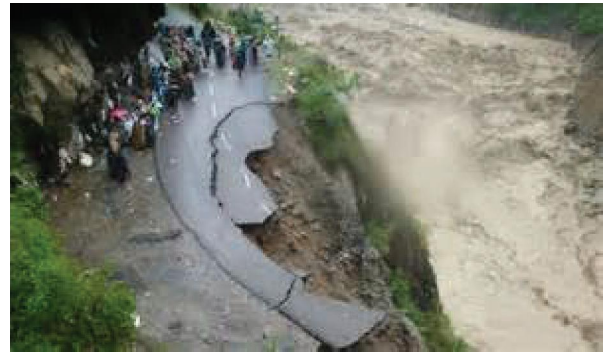
Figure 9. Road to Gaurikund collapsed

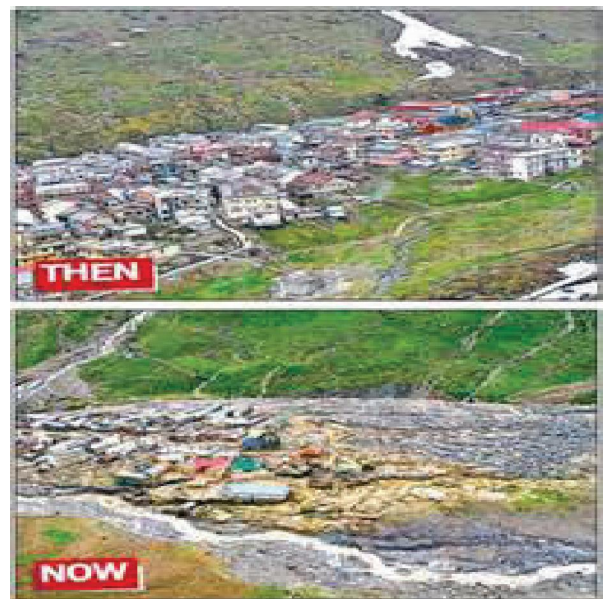
Figure 10. Kedarnath city washed away

- The river upstream of Kedarnath Temple was flooded along with heavy debris flow.
- More channels were formed while entering the Kedarnath area and the debris loaded flood rolled over the houses around the Kedarnath Shrine.
- Most of the houses in the Kedarnath area were swept away, others were left damaged.
- Steep slope of river to Rambara and Gaurikund caused heavy losses in the area with debris deposition.

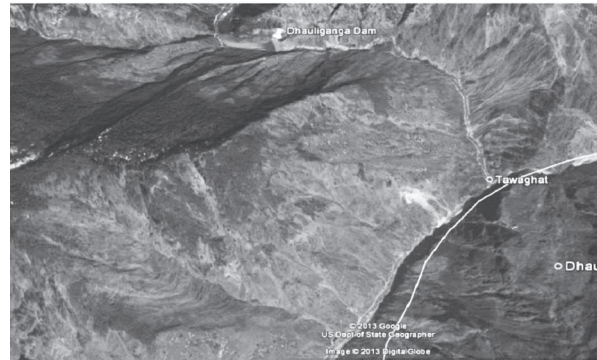
Figure 12. Dhauli Ganga meets mahakali d/s of site

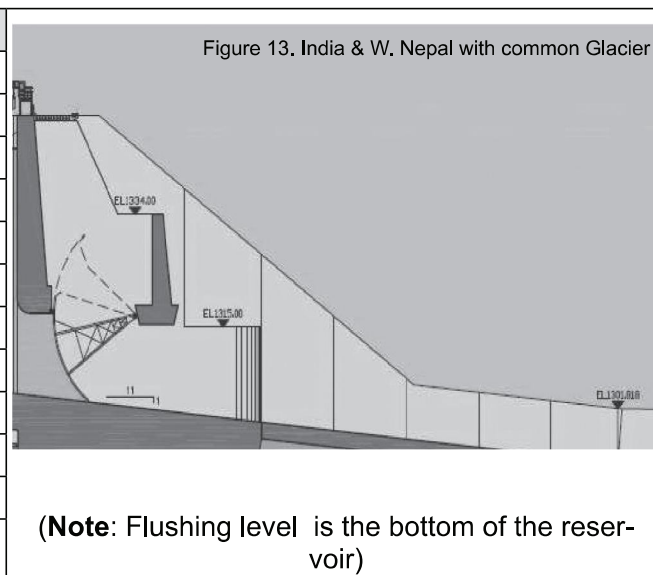
- Crest of Sluices are 46.5 m. below Pond Level and 28.0 m. below the power operating level
- Spillway has full capacity to discharge the design flood (3,210 Cu. m./sec) of the river
- The sluice gates are opened when the reservoir is having sediment or excess water

Item	Dimension
Catchment Area	1360 sq.km
Design Flood Discharge	3210 cum/s
Total Power (4x70)	280 MW
Dam Height	56 m
Total Reservoir Capacity	6.20 M.cum
Active Reservoir Capacity	1.54 M.cum
Reservoir Pond Level	1348.50 m
Power Canal FSL	1345.00 m
Min. Operating Level	1330.00 m
Sluice Crest Level	1302.00 m
Sluice Opening (3x6x10)	180 sq. m
Sluice Capacity	3210 cum/s

Figure 11. Under sluice Spillway Section

Dhauliganga is a tributary of Mahakali River. It is a glacier fed river. Dhauliganga dam is constructed to divert and regulate water for the power generation of 280 MW. The project brochure explains the provision of the sluice spillway and power intake as follows: “The gated spillway and power intake structures are located adjacent to the dam and are designed to minimize the inflow of sediments into the pressure waterways, whilst allowing their efficient flushing from the reservoir during periods of flood.” The spillway section and general dimensions are shown below.

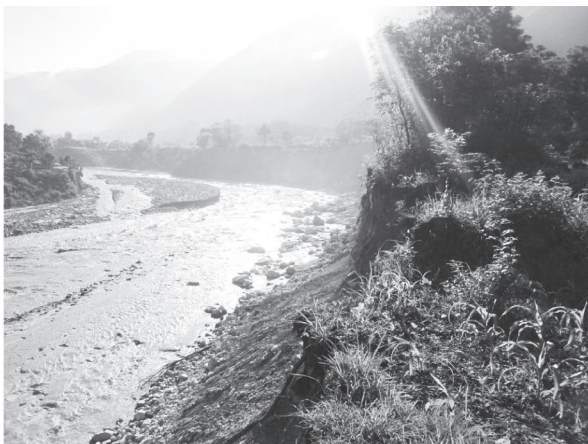
Figure 14. Deposition in India, Scouring in Nepal

- In Dhauliganga Dam, power channel was closed and sluices were fully opened on the day to flush out the sediment (both incoming and collected earlier).
- The Dhauliganga operation combined with swelling of main Mahakali River in Tawaghat has created unusual flood which ultimately triggered disaster in Darchula Khalanga area.
- Embankment protection work on other side in Indiawas robust and, sowas intact after the event while in Nepalese side it was scattered and weak and easily eroded and washed away.

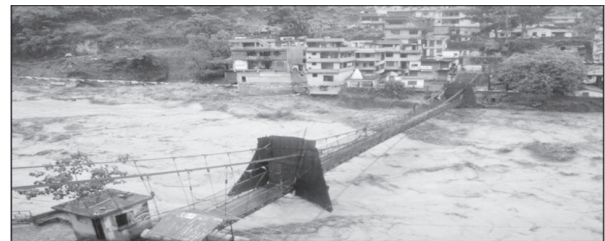
Figure 16. Nepal- India suspension bridge over Mahakali

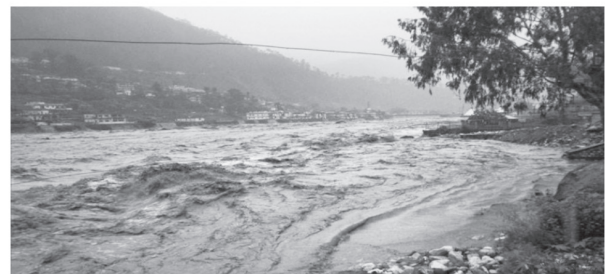
Figure 17. River Mahakali in fury

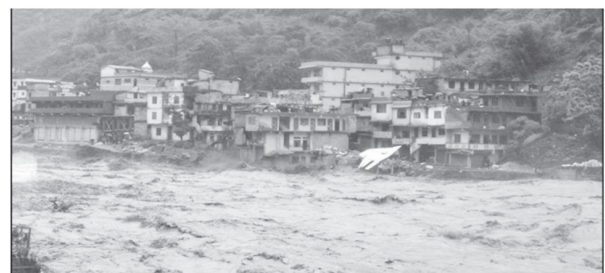
Figure 19. Attack by the flood on settlement
