## CASE REPORT

### AN UNUSUAL CASE OF BURIED BROKEN EXODONTIA INSTRUMENT IN INFERIOR ALVEOLAR CANAL

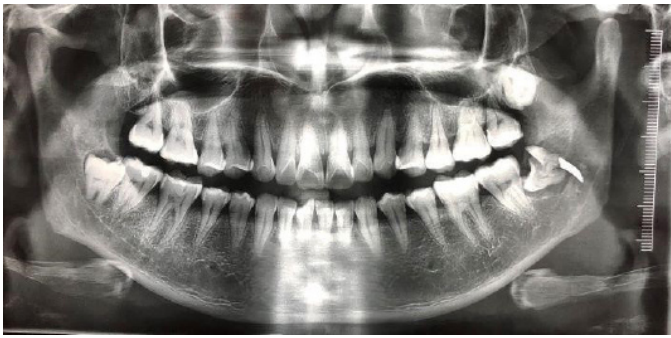
**Figure 1: Preoperative OPG showing splitted 38 with radiolucency surrounding it and radiopaque mass of approximately 1.5 cm below root apex and obliteration of inferior alveolar canal**

A 38 years old male patient was referred to Department of Oral and Maxillofacial Surgery, UCMS College of Dental Surgery, Bhairahawa, Nepal by a dental surgeon working in remote area with chief complain of paresthesia over left side of chin and lower lip area since 1 month. On past dental history, patient had been attempted for surgical extraction of left lower third molar for an hour but was not completed. On examination, inflamed gingival tissue were noticed around 38. There was no pus discharge present. Mouth opening was adequate and bilateral occlusion were intact. On palpation, tenderness over left angle of the region was present. Patient was advised for Orthopantomogram (OPG). OPG revealed fractured 38 with radiolucency surrounding it. In addition, approximately 1.5 cm radiopaque mass with pointed end was present at the apex of 38 with obliteration of inferior alveolar canal as shown in Figure 1.

After clinico-radiological correlation we came to a final diagnosis of fractured 38 with broken instruments inside IAN canal. Patient was informed about the condition according to Code of Ethics set by Nepal Medical Council and planned for extraction of teeth along with retrieval of broken instrument under local anesthesia. Under strict aseptic condition, 2% lignocaine HCL (1:200000 adrenaline) was administered and Ward's incision was given. Full thickness mucoperiosteal flap was raised and distobuccal bone guttering was done with the help of rotary instruments as shown in Figure 2.

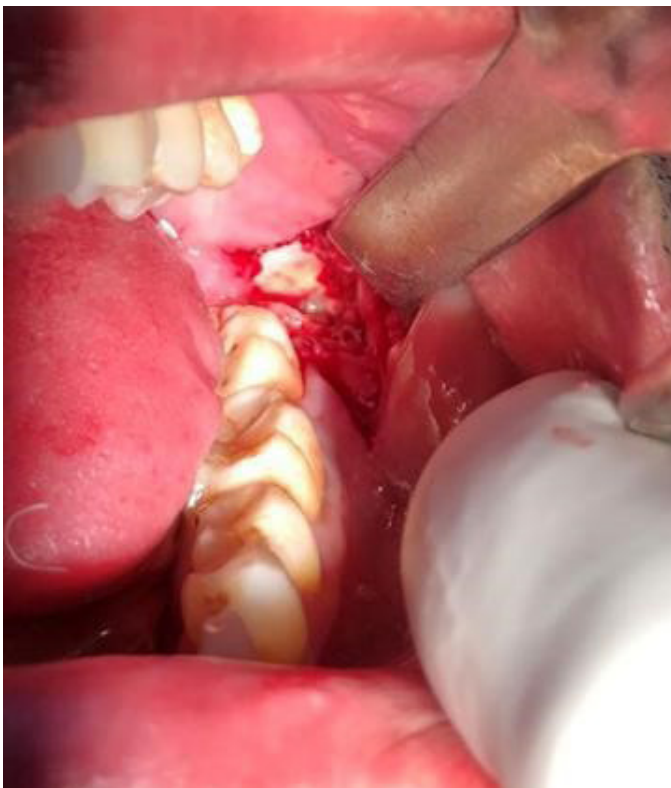
**Figure 2: Intraoperative clinical photograph showing fractured 38 with abundant of granulation tissue inside socket.**

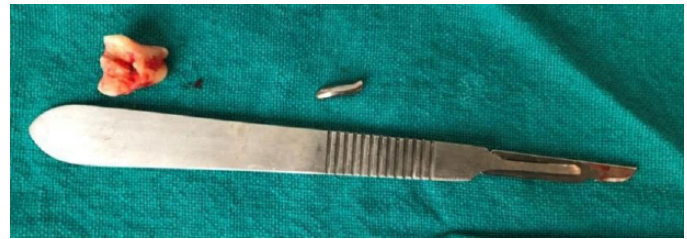
**Figure 3: Postoperative clinical photograph showing extracted 38 and removal of broken exodontia instrument piece from inferior alveolar canal**

Extraction of the offending tooth was done accordingly. Socket was irrigated thoroughly with normal saline and was explored. Finally, broken instrument tip was retrieved with the help of curved hemostat from distal root socket as shown in Figure 3.

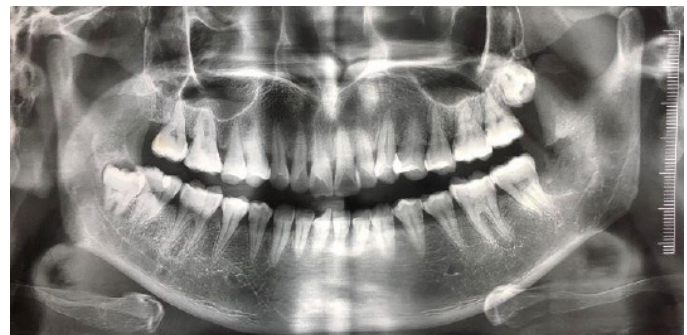
**Figure 4: Post-operative OPG revealing empty 38 socket and absence of instrument tip**

Then, socket was irrigated and closed primarily. Post-operative OPG was done to confirm complete retrieval of instrument as shown in Figure 4.
