Geohazard assessment along the road alignment using remote sensing and GIS: Case study of Taplejung-Olangchunggola-Nangma road section, Taplejung district, east Nepal

Dinesh Pathak

Department of Geology, Tri-Chandra Campus
Tribhuvan University, Kathmandu, Nepal
(Email: dpathaktu@gmail.com)

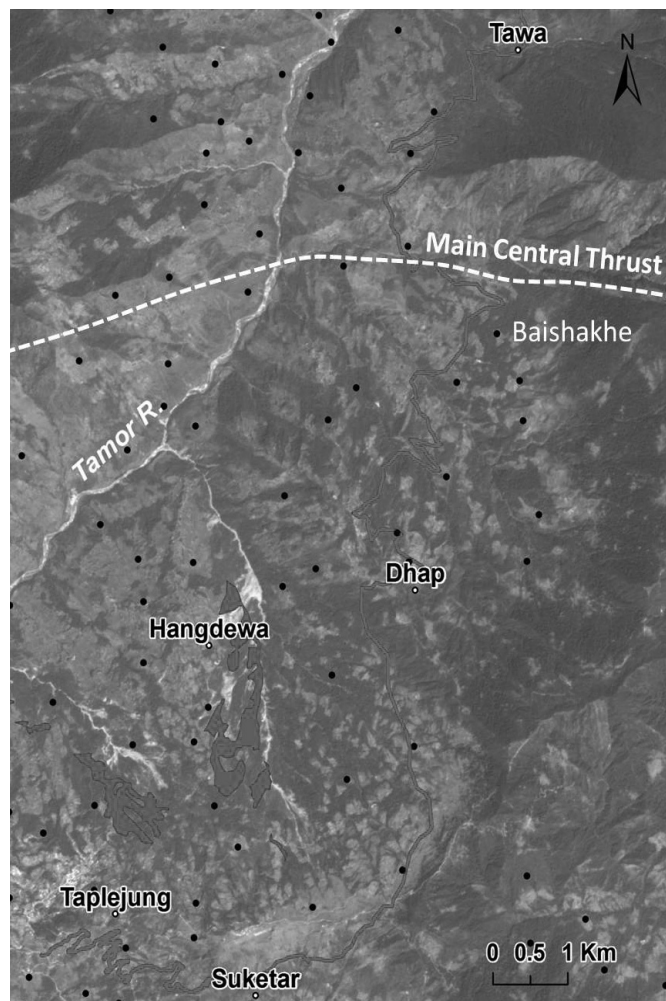
Fig. 6: The road stretch between Taplejung and Tawa village. The Hangdewa and Herewa landslides are the major slides in the west of alignment. The main central thrust (MCT) separating Higher Himalaya in the north and Lesser Himalaya in the south passes through north of Baisakhe village.

This road stretch extends from the Taplejung to Tawa village basically covers both the lesser Himalayan region as well as higher Himalayan region. The area between Taplejung in the south and Baisakhe village in the north falls within the Lesser Himalayan region and is characterized by the presence of phyllite and quartzite with some gneisses belonging to Ulleri Formation (Fig. 6). This area is rather critical that has many landslides, the most important being the Hangdewa landslide and Herewa landslides

(west of Hangdewa landslide). However, these slides zones lies at the western catchment and the road stretch passes through the eastern slope, through the Suketar airport. Because of the relatively better alignment of the road that runs along the ridge area avoiding the major landslide zone, this road stretch is considered to be safe from major geological disaster.

The road crosses the major geological structure, named Main Central Thrust (MCT), north of the Baisakhe village. MCT separates the lesser Himalaya in the south and higher Himalaya in the north. At this section, unstable hill slope is expected around the MCT zone.

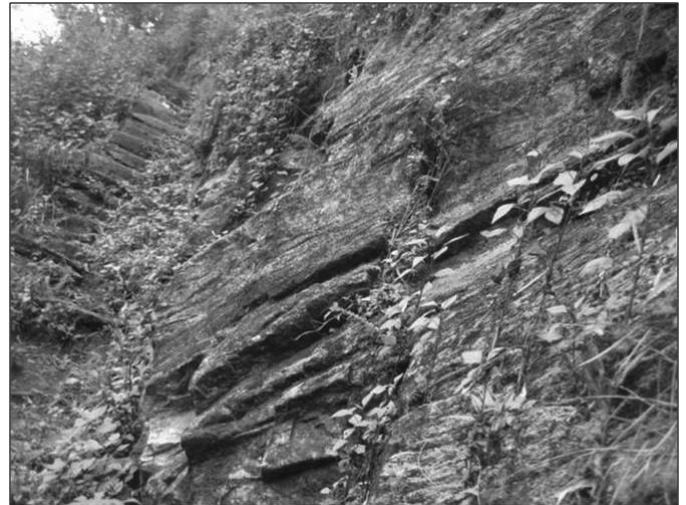
Fig 8a: Rock exposure around Tansee village.

The rocks around the Tansee village are light to dark grey, parallel to continuous, highly jointed, medium grained gneiss. The rocks generally dip toward NE with a dip amount of 60° - 70° (Fig. 8a). The orientation of the rock discontinuities shows that there is mild possibility of plane failure and wedge failure (Fig. 8b). The area between Tansee and Nublung village is represented by light grey, thin to thick bedded, parallel and continuous, highly jointed and slightly weathered gneiss (Fig. 9a). The attitude of rocks is $135^{\circ}/30^{\circ}$ NW. Widely spaced joints were observed on the rocks. The stereographic plot of the discontinuities indicates that there is moderate possibility of plane failure as well as wedge failure (Fig. 9b). The road section between Nublung village in the south and Tartong village in the north passes through some critical locations (Fig. 7). Light to dark grey, highly jointed, moderate

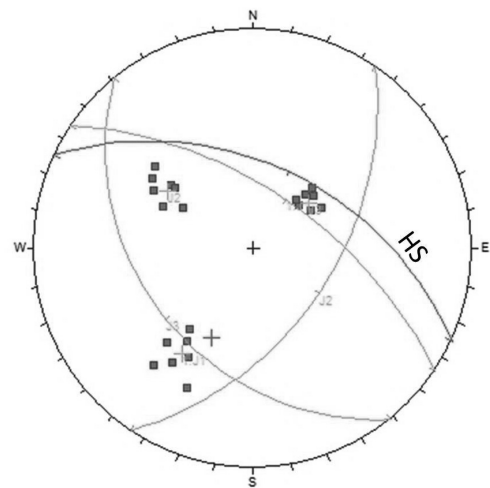
Fig. 8b: Stereo-plot of discontinuities measured around Tansee village.

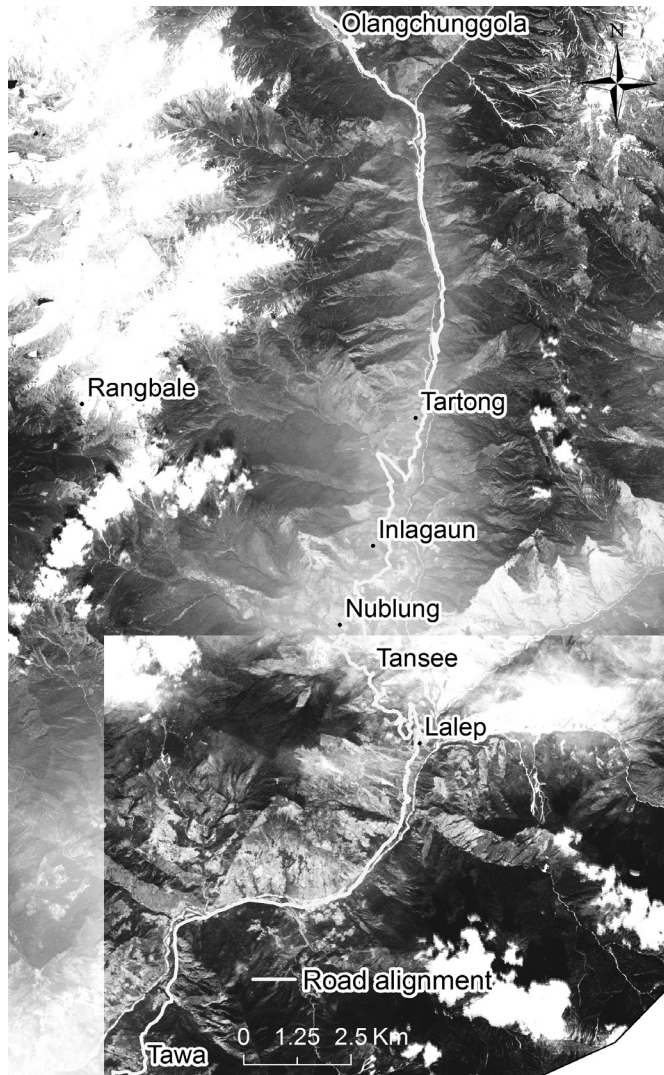
Fig. 7: Road section between Tawa and Olangchunggola village.

The road stretch between Tawa and Lalep is rather stable and no major geological hazard has been noticed except at some steeper terrain, in which the problem may arise during the road construction even though it is stable at present (Fig. 7).

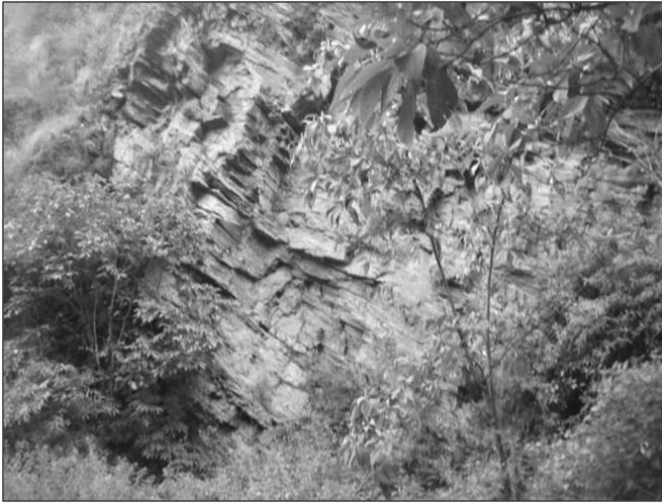
Fig. 9a: Rock exposure between Tansee and Nublung village.

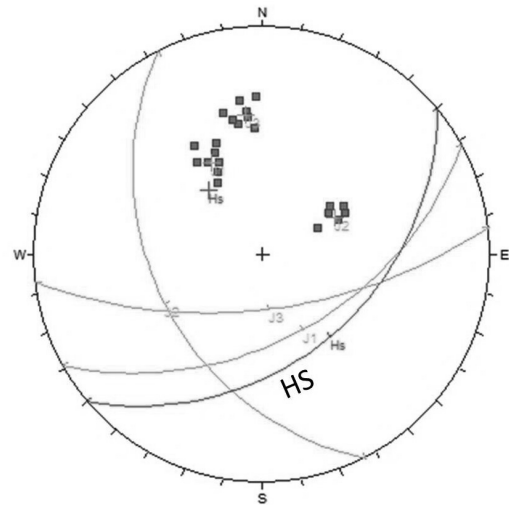
Fig. 9b: Stereo-plot of discontinuities measured between Tansee and Nublung village.

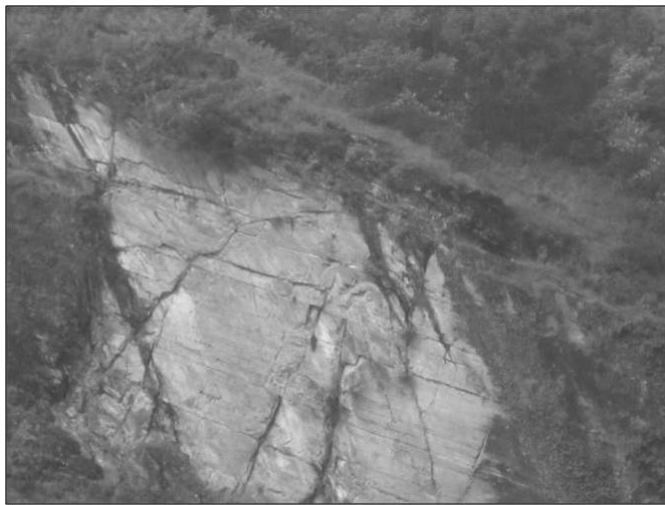
Fig. 10a: Rock cliff observed around Inlagaun.

to highly weathered gneiss was observed along this road section (Fig. 10a). The general attitude of the rock is $155^{\circ}/55^{\circ}$ NE. The stereographic projection of the discontinuities measured on rock shows the wedge failure condition (Fig. 10b).

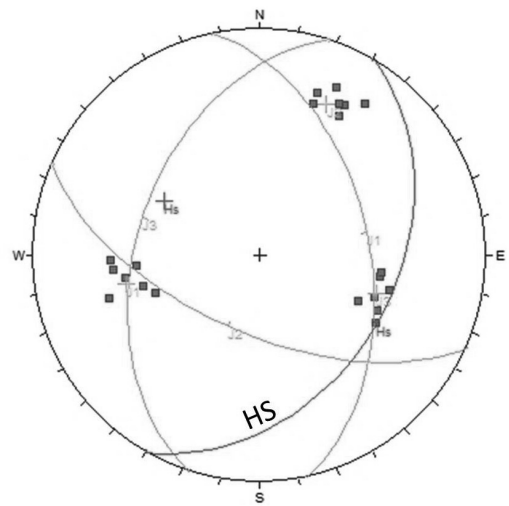
Fig. 10b: Stereo-plot of rock discontinuities measured around Inlagaun.

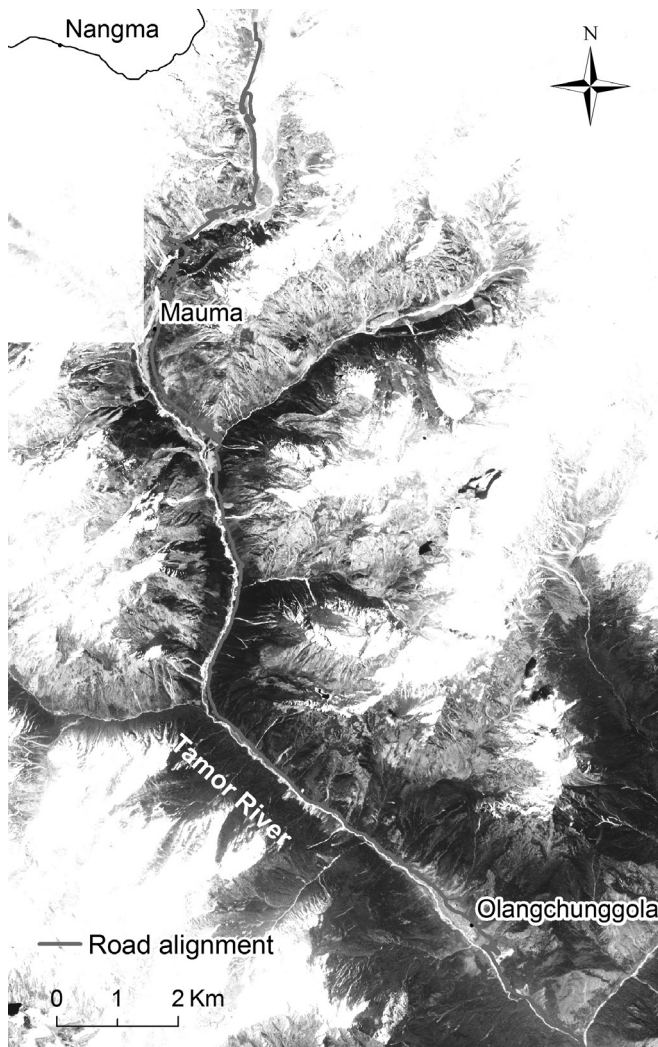
Fig. 11: Olangchunggola-Nangma road section.

The Olangchunggola-Nangma village stretch of the road traverses typical terrain that has different climatic condition than the southern road stretch (Fig. 11).

This area mostly experiences the snow fall and hence the rocks are affected by frost action leading to physical disintegration. There are many landslides along the road alignment that is oriented in north-west direction from Olangchunggola village (Fig. 12). The active landslide is clearly visible on the satellite image near the Olangchunggola village and further northwards along the road alignment.

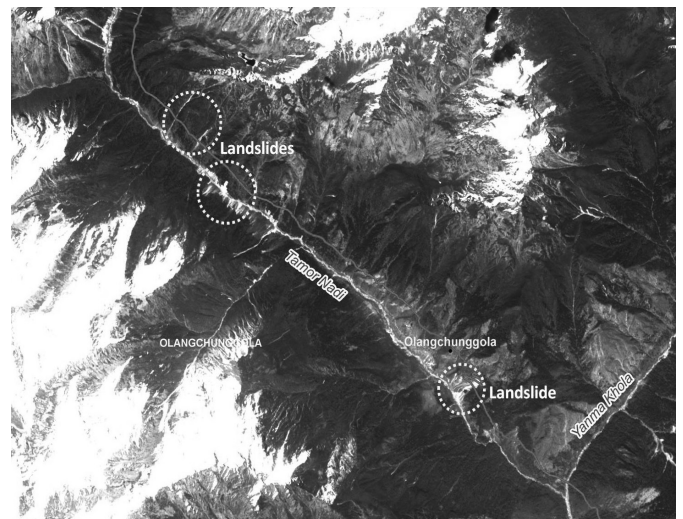
Fig. 12: Landslides around Olangchunggola and northwards along the road alignment observed on satellite image.

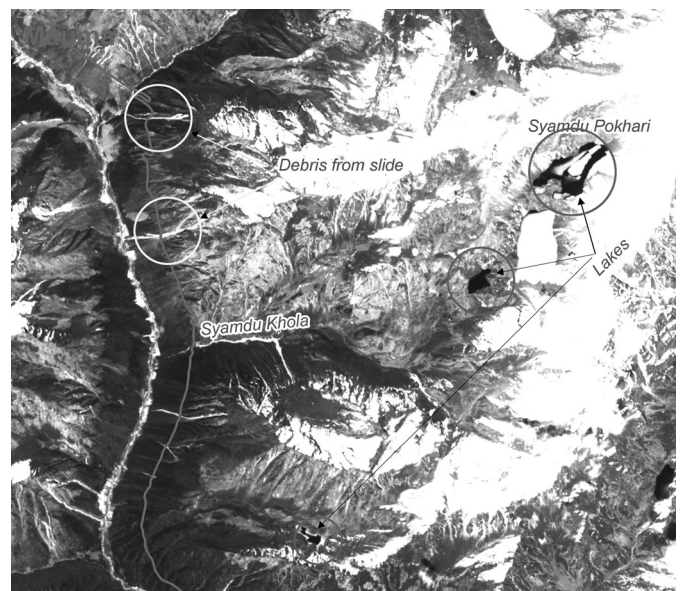
Fig. 13: Hazard condition, north of the Olangchunggola.

Further north of the Olangchunggola, towards the Mauma village, when the road is aligned approximately in north south direction, the hazard condition is rather complex. In addition to the presence of landslides and debris transported from the gullies, there is potentiality of the damages to be occurred due to bursting of the glacier lakes at the higher elevation at the eastern part of the Tamor catchment (Fig. 13).
