# Temporal change detection of Kahphuche glacial lake Kaski District, Nepal

## ABSTRACT

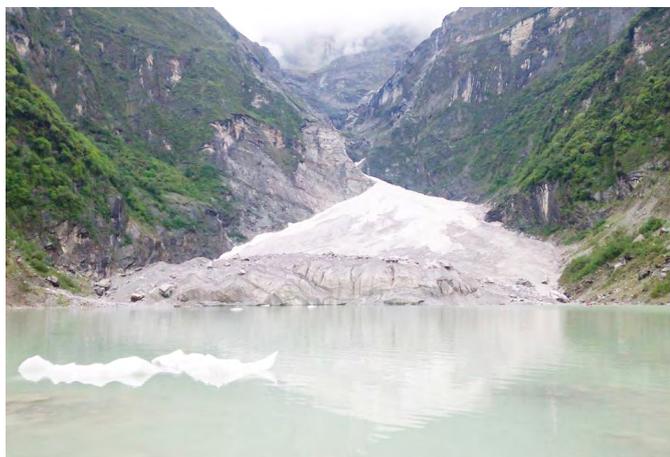
**Fig. 1: Kahphuche (Gopche) Glacial Lake**

The Kahphuche Lake is located at the source of the Madi River. The lake is situated about 12 km, and eight hours uphill walk, from Sikles village. The lake is located at 28°26'28" North latitude and 84°07'00" East longitude at an elevation of 2,435 m in upper Madi, Parche VDC, Kaski District (Fig. 1). The glacial lake is formed after ice sheets melted in the area, with the meltwater filling the space at a lower elevation. The local people have known about the existence of the lake for several years, but it was publicly recognized only recently.

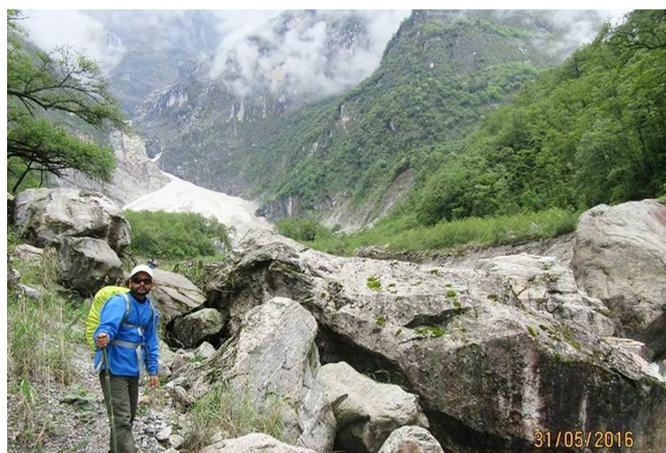
**Fig. 2: Dam of Kahphuche Lake.**

The outer slope of the moraine dam is covered with vegetation, while the inner slope is bare and unstable, a characteristic common to moraine dams in contact with a lake. The moraine dam expands about 348 m wide from the south-east bank of the lake. The natural outlet is at an elevation of 2,435 meters

to 2,429 meters, and the lowest point in the terminal moraine is covered by vegetation with the flow of Madi River on the surface. The Landsat imagery between 1990 and 2016 indicates that the Kahphuche glacial lake is increasing rapidly.

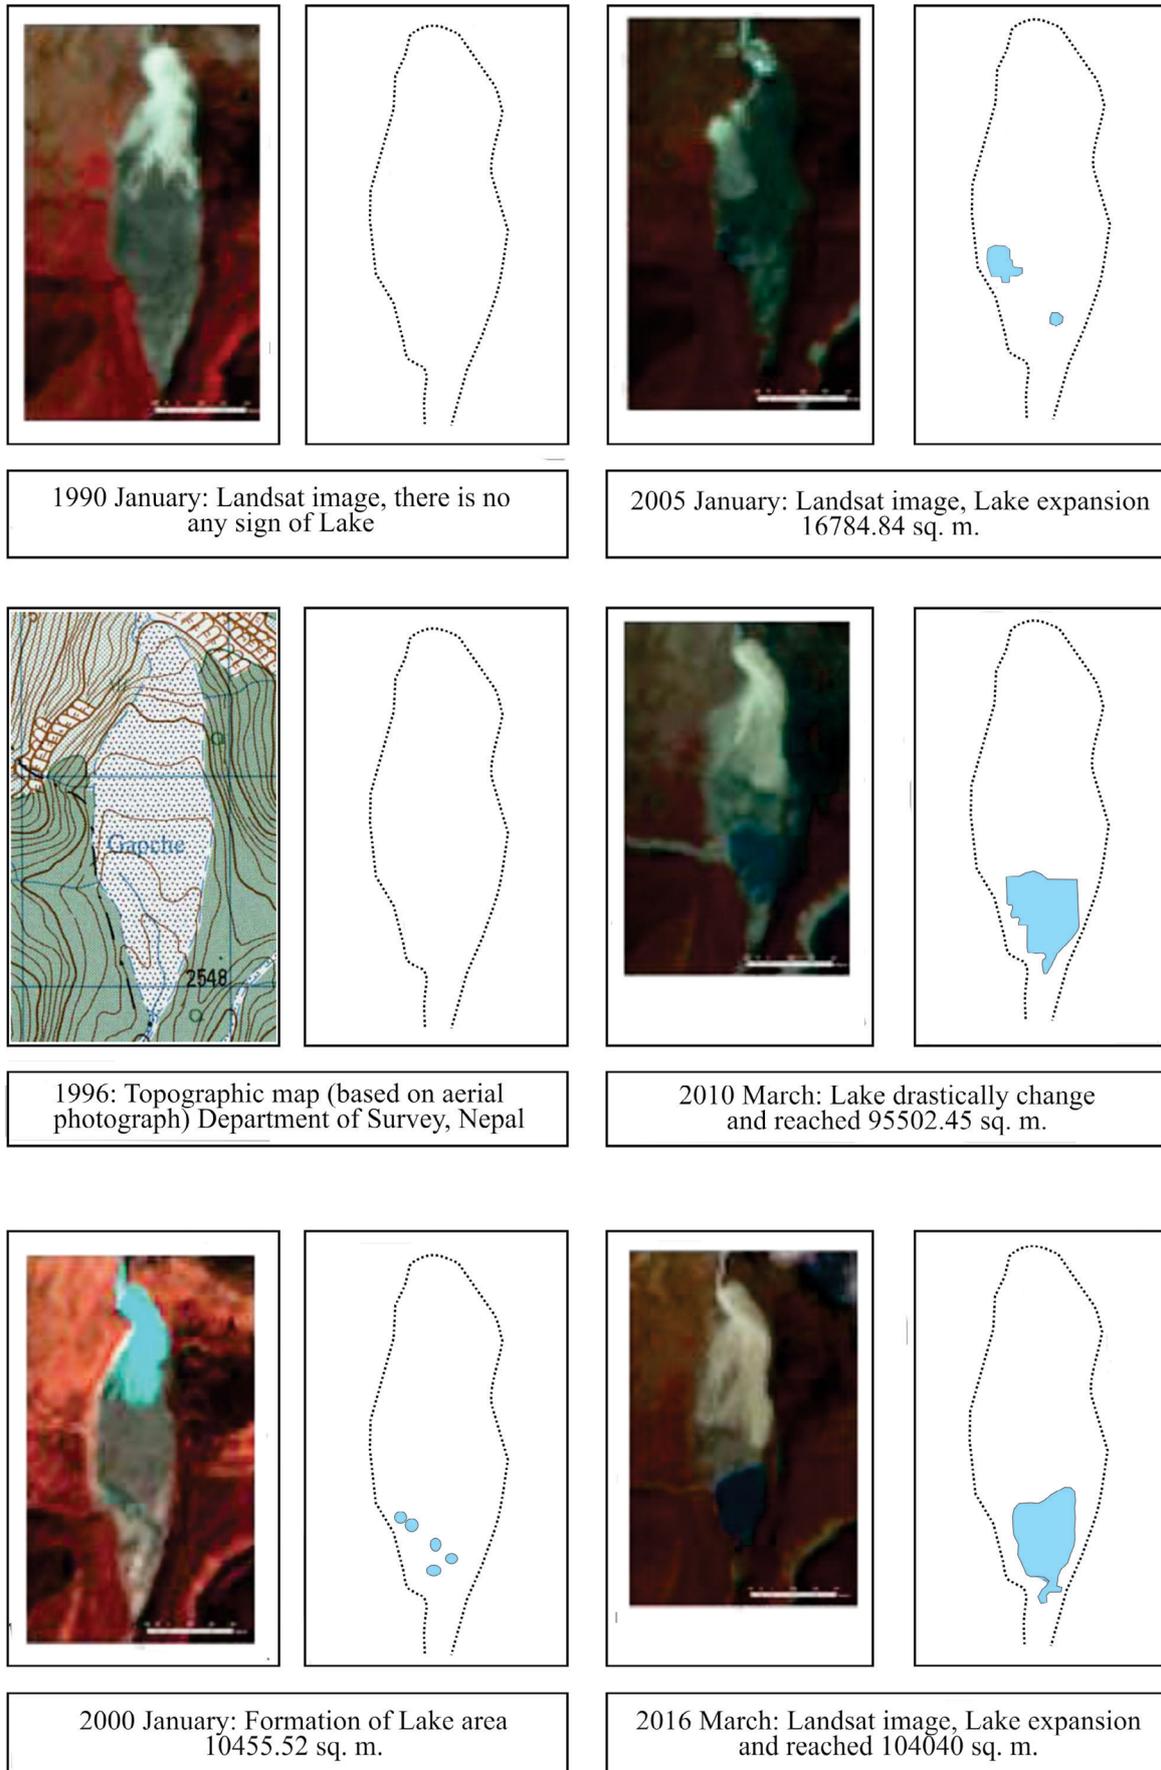
**Fig. 3: Change in Lake area over 1990 to 2016.**

The development history of the lake has been attempted by gathering information from local publications and anecdotal statements from local people. According to these accounts, small holes were seen between ice sheets in the summer season and day time before 1990. This, however, was not recorded in any documents. The topographic map produced in this study traced narrow plain topography with water without a lake name in 1998. Landsat imagery captured in 2000 demonstrates that, except for several small melt ponds on the glacier surface, the lake did not exist. By 2005, a lake approximately 16,784.84 m<sup>2</sup> had been formed. Since that time, the Kahphuche glacial lake has been in existence (Fig. 3). The area of Kahphuche glacial lake in different years was determined using the available satellite imagery from 2000, 2005, 2010 and 2016. The results showed a remarkable increase in the glacial lake over the period of 15 years (2000-2016). The area of the lake increased in a ten-year period from 10,455.52 m<sup>2</sup> to 104,040.69 m<sup>2</sup>. This increment is likely due to the melting of glacier ice and inflow from the small stream into the lake from the upstream end-glacier channel (Table 1)

S.N.	Date of Landsat images	Area of lake (m <sup>2</sup> )
1	1990	n/a
2	2000	10,455.52
3	2005	16,784.84
4	2010	98,602.45
5	2016	104,040.69
