## Mitigation and Bioengineering Measures for Prevention of the Surbhi Resort Landslide, Mussoorie Hills, Uttarakhand Lesser Himalaya, India

\*Vinod C. Tewari<sup>1</sup> and Victoria Z. Bryanne<sup>2</sup>

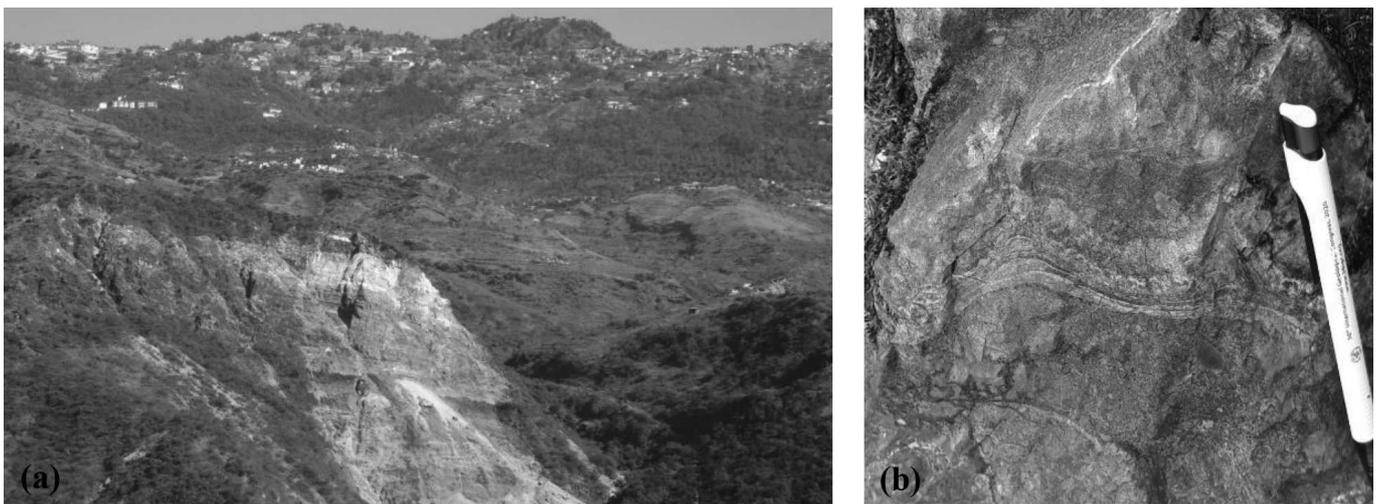
Fig. 1: (a) Panoramic view of Mussoorie Syncline showing bluish grey Upper Krol C Limestone; Mussoorie town is situated on Krol D at the top of the hill, and (b) Cherty intraclastic stromatolites.

The Surbhi Resort Landslide is located near the hill station of Mussoorie in the Garhwal Himalaya (Fig. 1) in the Krol C limestone. After intense rain in August 1998, the slope suddenly caved in as a deep-seated landslide, blocking the main Mussoorie-Kempton artery for 15 days. Following this incident, the landslide has been extensively studied by several authors. Revised Neoproterozoic stratigraphy and sedimentological studies of the Krol Formation has been given by Tewari (2010, 2012) and Tewari and Tucker (2011). The present work follows location and drainage map by Khanduri (2017) for the Mussoorie area, Uttarakhand (Fig. 2). The geotechnical strength parameters were studied by Gupta and Ahmed (2007). Pal et al. (2010) tried a distinct element stability analysis while Singh et al. (2015) applied both static and dynamic analyses to the slope. All these studies reached the same conclusion that the slope is inherently unstable due to a wedge formation in the crown portion which is accentuated when the pore water pressure increases during monsoon. Venkateswarlu and Tewari (2014), Bryanne and Tewari (2014), Singh et al. (2015) and Gupta et al. (2016) have used different models for failure analysis. Present study focuses on the geological and petrological aspects of the failure zone, i.e. Krol Formation, together with mitigation and bioengineering measures of the landslide based on previous work by the present authors. The possibilities of developing an Early Warning System for future mass wasting processes on a local and regional scale is discussed and suggested.

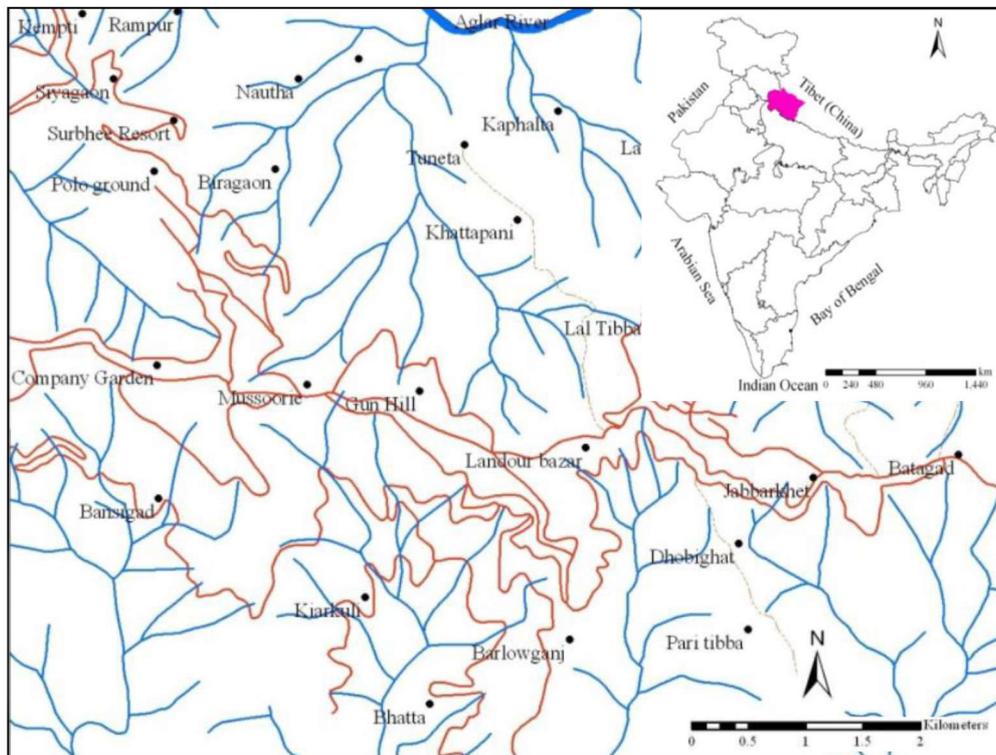
Fig. 2: Map showing drainage and location of Surbhi Resort Landslide

directions. (Gupta and Ahmed, 2007) The Surbhi Resort Landslide is located in the Krol Formation around the Mussoorie Syncline, Uttarakhand Lesser Himalaya. (Fig. 2).

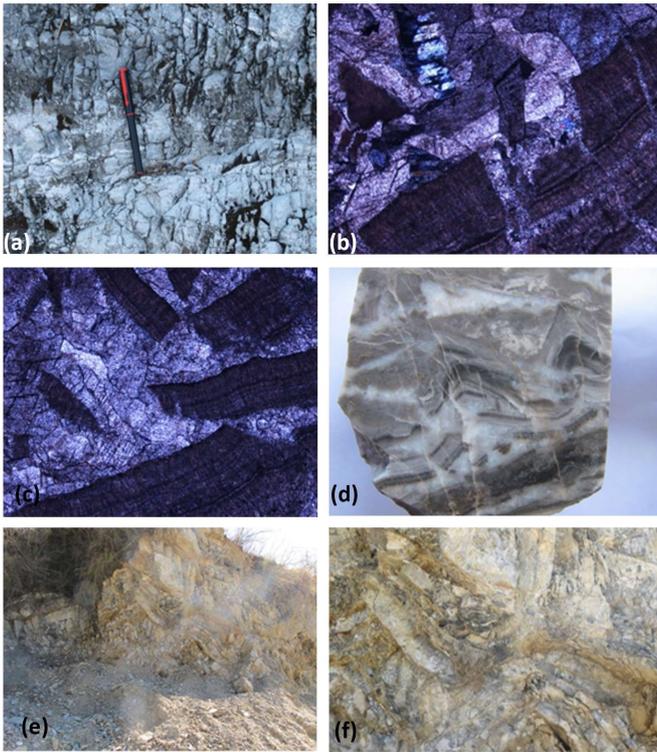
**Fig. 3: The highly folded, faulted, deformed and fractured Krol C Limestone on Mussoorie-Kemty road section, Mussoorie syncline: (a) highly fractured and jointed Krol C carbonate, (b) the tectonic desiccation of the limestone, (c) microfaults in brecciated limestone, (d) microfolds and recrystallized calcite veins, (e) folded and sheared limestone, and (f) landslide zone deformation.**

symmetrical ripples and shallow channel structures. Mud cracks are also present. Limestone has been severely faulted, folded, deformed and jointed and these structures can be seen on both the limbs of the Mussoorie syncline. Thus, from the macro- to the micro-scale, the tectonic processes and diagenesis are visible in the rocks. The Krol C limestone appears much more fragile and prone to landslides (Figs. 3, a-f) than the underlying Infra-Krol-Blaini-Nagthat or overlying Tal formation with many more observed landslides occurring in this belt.

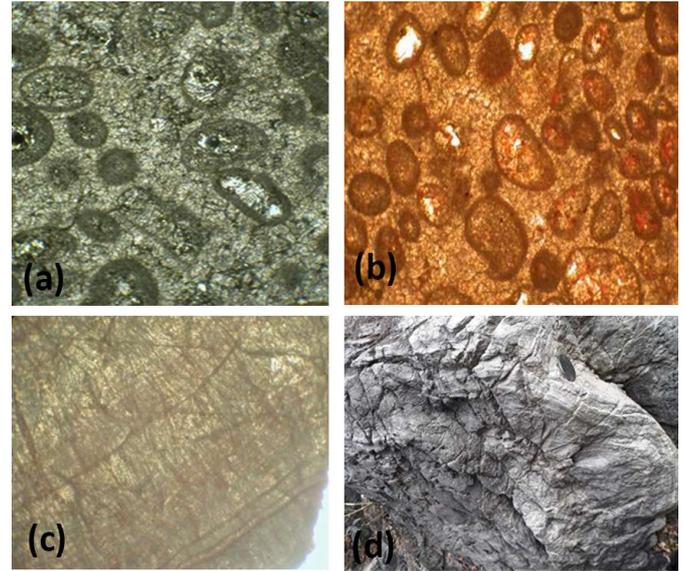
**Fig. 4: Photomicrographs of carbonate grains (oolites, intraclasts, coated grains, peloids, microbial grains, microbial laminations and stromatolites showing diagenetic and tectonic imprints. (a) diagenetically replaced oolite and intraclasts, (b) coated grains, peloids, and microbial grains, (c) highly fractured microbial mat laminations, and (d). Stromatolitic limestone in Krol C, Mussoorie area.**

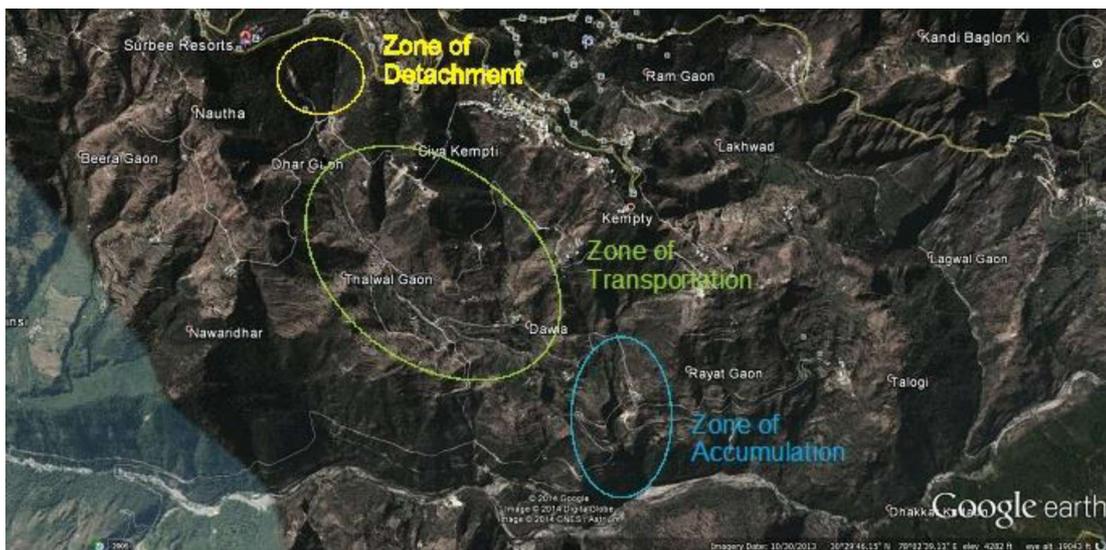
**Fig. 5. Google earth map of the Surbhi landslide area showing zones of detachment, transportation and accumulation**

The landslide is in total 3.5 km long, but can be divided into three parts on the basis of the dynamics of the landslide (Bryanne and Tewari, 2014) (Fig. 5):

It is the crown portion of the landslide as well as the main scarp. It is spoon shaped and is about 400 m long, 200 m wide and 30 m deep. The slope varies from 60–70°. Approximately,  $1.25 \times 10^6$  m<sup>3</sup> of quaternary deposits have been displaced but it has the potential to displace 5-6 times that

This zone follows the channel of Rangaon-ka-Khala and transports the detached materials from the scarp into the valley below. Since several villages are located here (Rangaon, Nawaridhar, Langwalgaon, Dabla Matela and Biragaon) most damages have been reported from this zone. It is the longest section of the landslide and the angle of the slope varies from 7–70°.

This zone is at the bottom of the slope and highly inaccessible. Here the slope angle again increases and the debris is remobilized as a debris flow before it finally fills the main valley and runs into the Aglar River.

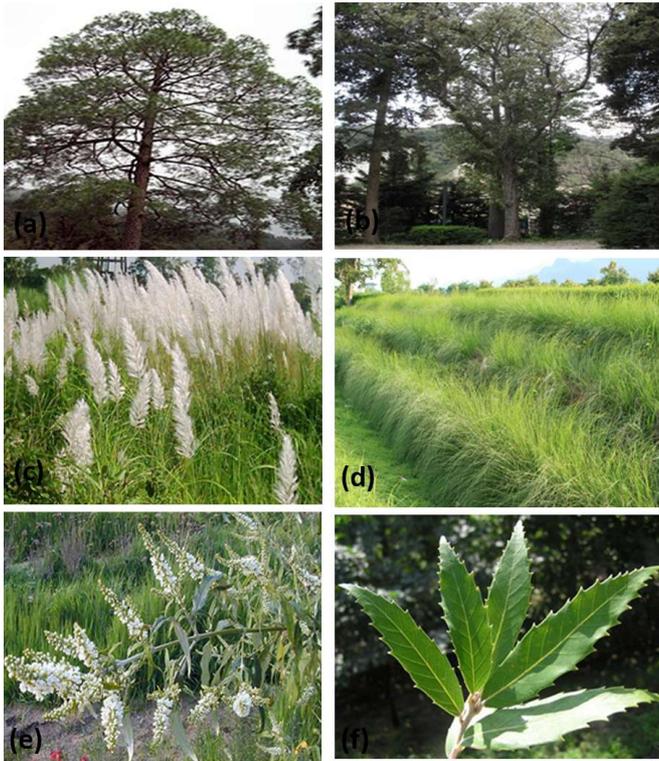
**Fig. 6. Trees, shrubs and grasses used for the bioengineering plantation. (a) *Pinus roxburghii*, (b) *Quercus leucotricophora*, (c) *Saccharum spontaneum*, (d) *Vetiver grass*, and (e) *Buddleja asiatica*, (f) *Quercus leucotricophora* leaves).**

6. Most tree species can be planted as saplings on the slope. An exception is *Quercus* (Himalayan Oak, Fig. 6) which is very difficult to transplant and has to be grown from seeds.

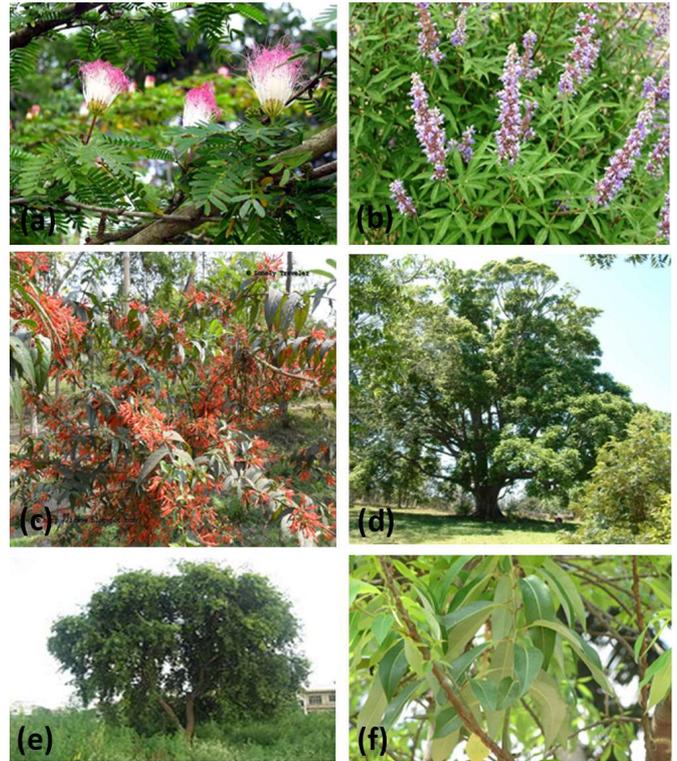
**Fig.7 : Plant species generally planted for bioengineering: (a) *Mimosa himalaya*, (b) *Vitex negundu*, (c) *Woodfordia fruticosa*, (d) *Toona ciliata*, (e) *Dalbergia sissoo* (Sheesham), (f) *Salix tetraasperma***
