## Geophysical study of land subsidence: example from Pokhara basin

\*M. Yoshida<sup>1,2</sup>, S. R. Pant<sup>3</sup>, P. C. Adhikary<sup>3</sup>, V. Dangol<sup>1</sup>, and S. Shrestha<sup>3</sup>

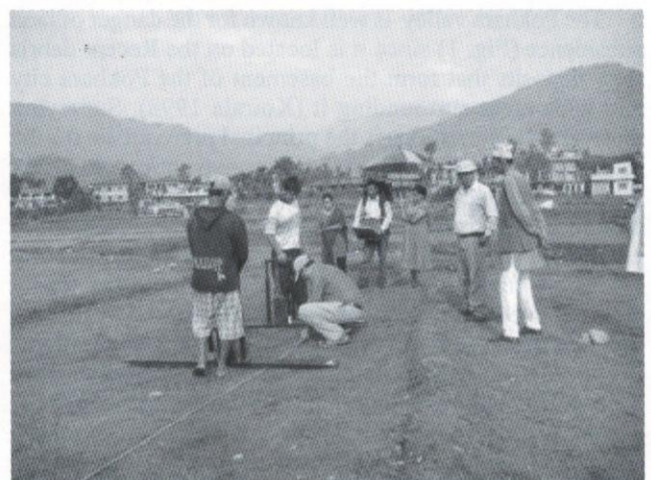
**Fig. 3:** GPR measurement (with 25 cm spacing) on Line A at Davi's Fall site

The GPR survey (Fig. 3) was carried out in reflection and common mid-point (CMP) modes. The Davi's Fall site was investigated by two reflection profiles and three CMP profiles while the Mountain Museum site was investigated only by two reflection profiles. The antenna centre frequency was 50 MHz and the step size of the measurement was 0.25 m. Details of the method are given in Annan (2000). The equipment for the measurement was pulse EKKO100A, manufactured by Sensor & Software Inc., Canada.

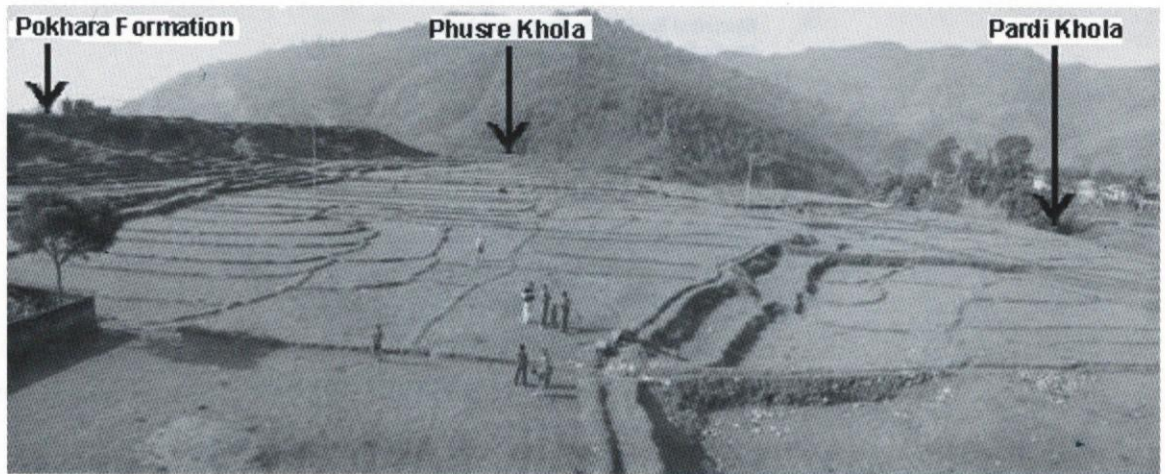
**Fig. 4:** The Davi's Fall site showing the Pokhara terrace (indicated as the Pokhara Formation) and the Ghachok terrace. A depression is seen to the right side of the picture.

Geological survey was conducted on the terrace surface and in the Phusre Khola to the south and the Pardi Khola to the west of the geophysical survey sites (Figs. 4, 5). The area is composed principally of the Recent deposits of the Pokhara Formation with a thickness of 10 to 15 m. It constitutes the uppermost flat-lying gravel consisting of 10 cm to a few metres thick beds of poorly to weakly consolidated conglomerate (Fig. 6), silt, and pebbly silt (Koirala 1998). The Pokhara Formation unconformably overlies about 15 m thick late Pleistocene Ghachok Formation

amplitude, a few metres in wavelength, and running generally in the N-S direction parallel to the Pardi Khola demarcating the western margin of the area (Fig. 4).

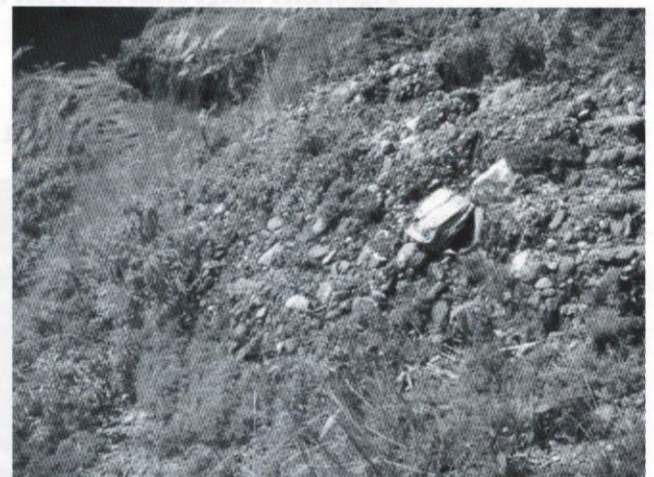
**Fig. 6:** Basal conglomerate of the Pokhara Formation exposed to the west of the survey area. The step at the left top of the picture is the reflection of the Ghachok terrace (i.e. unconformity surface).

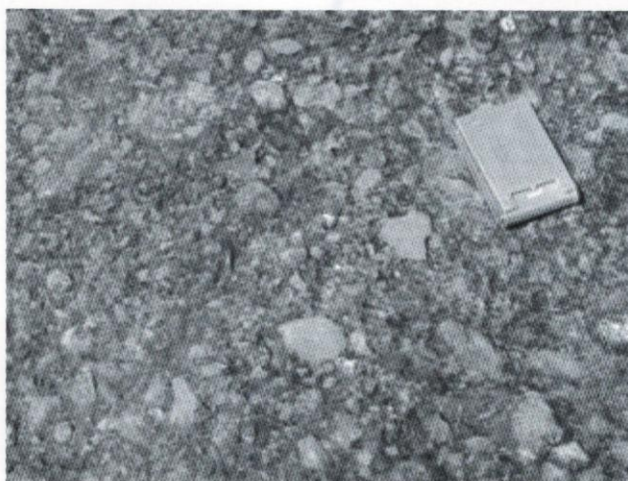
**Fig. 7:** Conglomerate of the Ghachok Formation

made up of gently inclined conglomerate containing angular pebbles and cobbles (Fig. 7) intercalated with 10 cm to a few metres thick sandstone and silt layers (Koirala 1998). The Ghachok Formation rests unconformably on the phyllites of the Precambrian Lesser Himalayan metasediments occurring several meters below the riverbed.

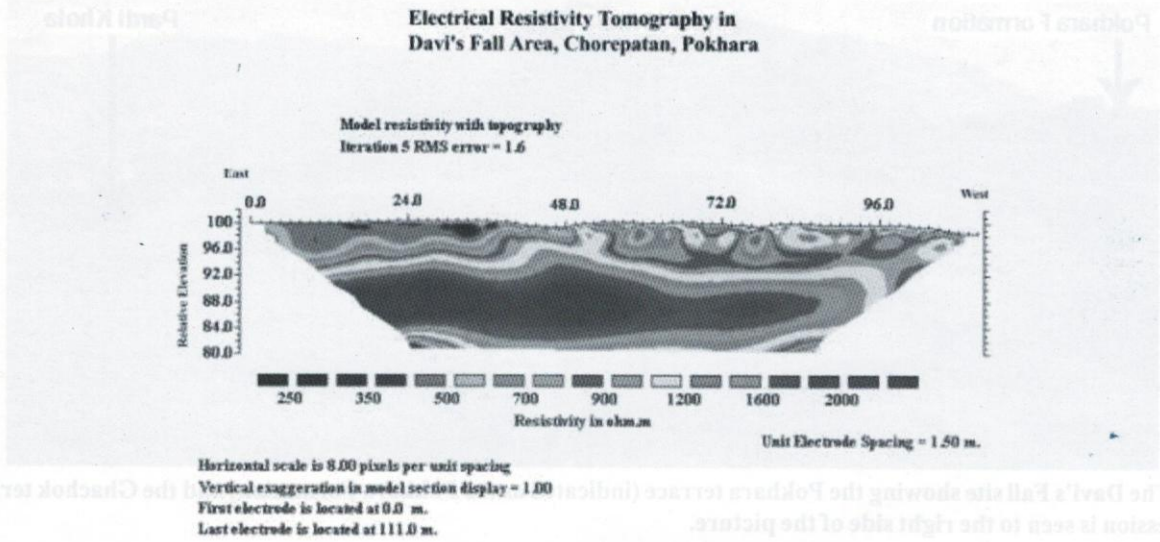
Fig. 8: ERT image of the line A (see Figs. 2 and 3) from the Davi's Fall site

The ERT section shows a very high level of cave development between relative elevations of 84 and 94 m. It is indicated by light to dark colour shades (Fig. 8): Higher the electrical resistivity in the section higher the intensity of cave development.

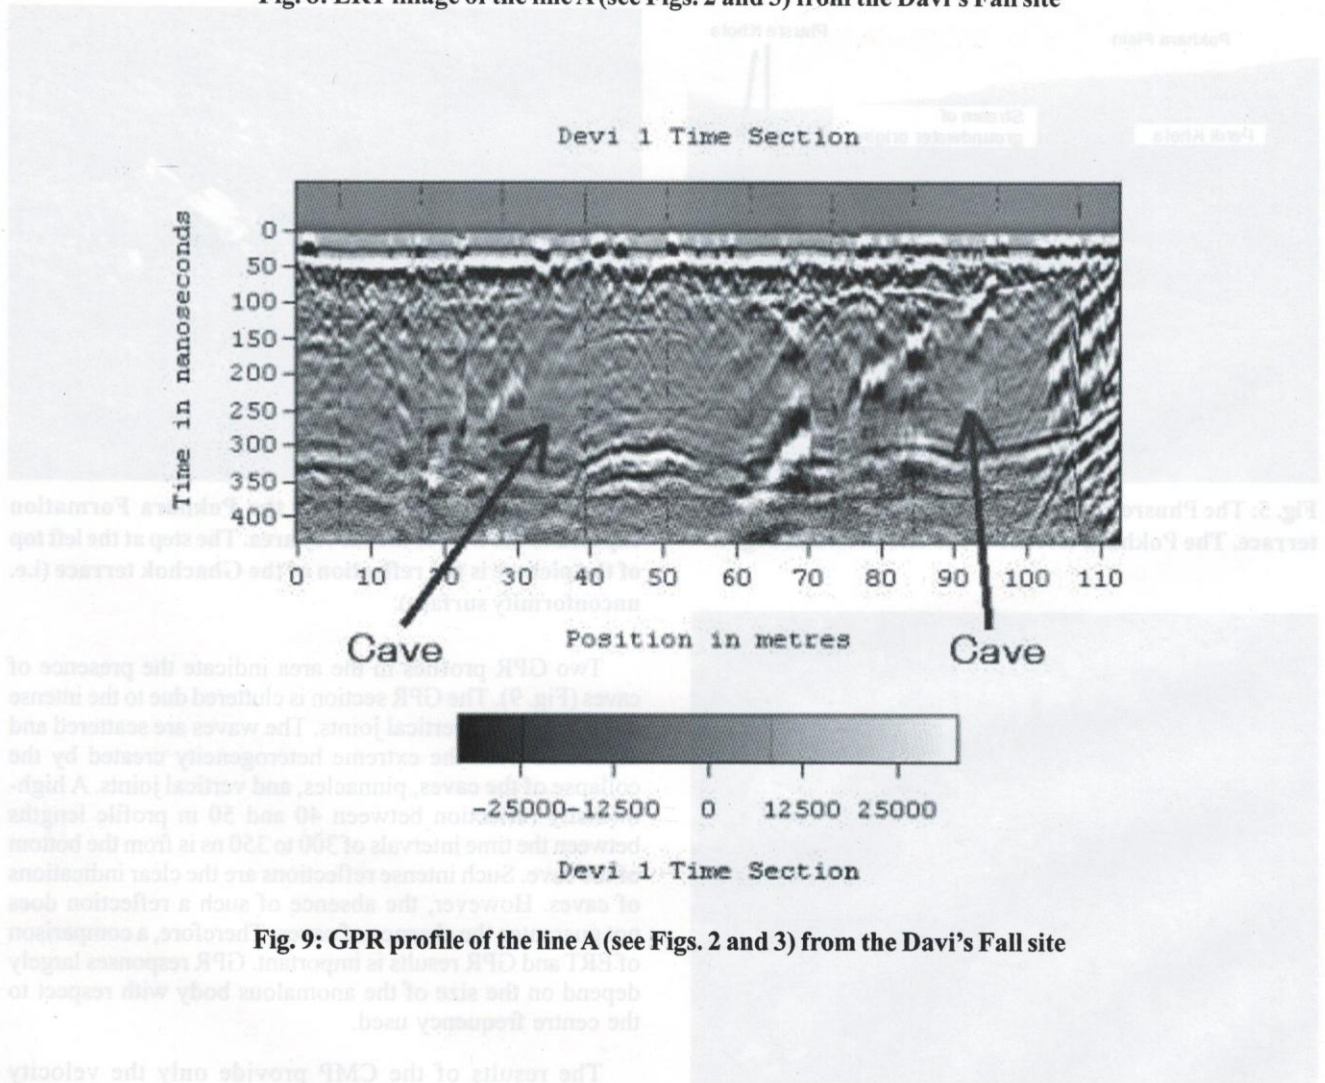
Fig. 9: GPR profile of the line A (see Figs. 2 and 3) from the Davi's Fall site

Two GPR profiles in the area indicate the presence of caves (Fig. 9). The GPR section is cluttered due to the intense development of vertical joints. The waves are scattered and diffracted from the extreme heterogeneity created by the collapse of the caves, pinnacles, and vertical joints. A high-intensity reflection between 40 and 50 m profile lengths between the time intervals of 300 to 350 ns is from the bottom of the cave. Such intense reflections are the clear indications of caves. However, the absence of such a reflection does not guarantee the absence of caves. Therefore, a comparison of ERT and GPR results is important. GPR responses largely depend on the size of the anomalous body with respect to the centre frequency used.

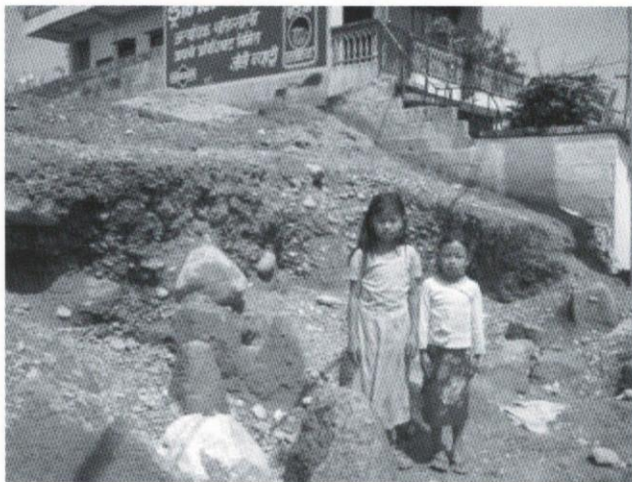
Fig. 12: Unconformity between the Ghachok (grey pinnacles below) and the Pokhara (gravel bed above) Formations observed on the roadside about 100 m north of the Mountain Museum

The geological survey was conducted on the terrace surface and in the Seti Khola about 50 m east of the site (Figs. 10, 11). The area is composed of the uppermost flat-lying gravel bed (poorly to weakly consolidated conglomerate layer) of about 1.5 m in thickness, identified as the Pokhara Formation unconformably overlying the gently inclined conglomerate bed (with angular pebbles and cobbles intercalated with sandstone and silt layers) of about 15 m in thickness identified as the Ghachok Formation (Fig. 12). The ground surface is covered mostly by less than 1 m thick Pokhara Formation.

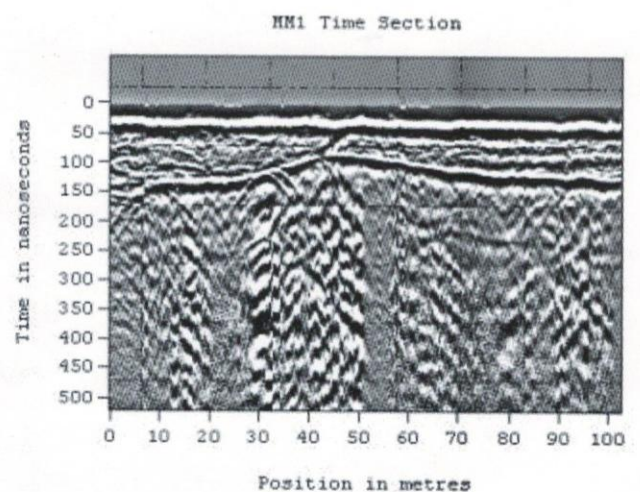
Fig. 13: GPR profile of the Line A of the Mountain Museum area. Notice on the extensive development of vertical crevasses, which is also seen on the photo view of Fig. 11.

The radargrams from the Mountain Museum site indicate a very strong reflection horizon whose two-way travel time is around 150 ns. This range is for a depth of about 5 m to a maximum of 7.5 m. The radargrams show zones of vertical dislocation. The radargram MM1 (Fig. 13) shows tuning

effects from several vertical crevasses. This tuning (ringing) effect is sensitive to the size of the crevasse. The Mountain Museum site seems to have a large number of vertical joints and dislocations. They may have favoured the formation of underground voids.
