Depositional and erosional landforms in the Lothar Khola watershed, Central Nepal

V. Dangol and P. D. Ulak

Department of Geology, Tri-Chandra Campus, Tribhuvan University, Kathmandu, Nepal

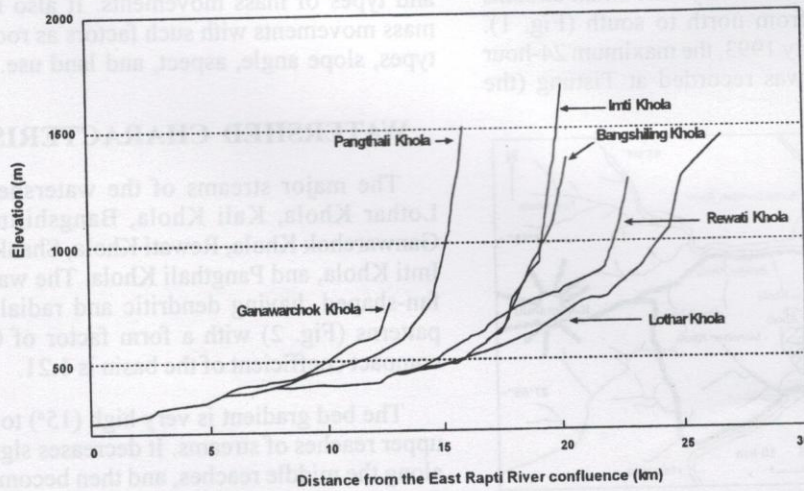
Fig. 3: Longitudinal profiles of the main streams from the Lothar Khola watershed

The bed gradient is very high (15°) towards the upper reaches of streams. It decreases significantly along the middle reaches, and then becomes almost flat (Fig. 3). Figure 4 shows the slope conditions in the watershed. The slopes are classified into the
