A Study on Subsidence Problem in Kusma Area, Parbat District.

U. SHAKYA

Iteco Nepal (p) Ltd.

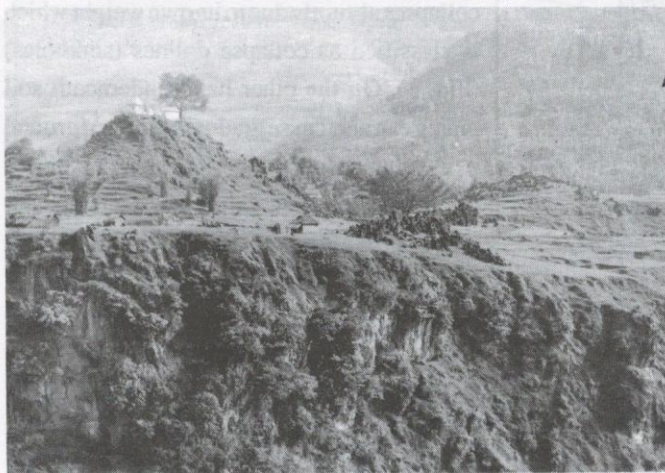
Plate 1. Residual karst hills and karst landscape in Kusma terrace.

The residual karst hills are raising out of the terrace surface as in the cone shaped mound in isolated form. These karst hills are nothing but group of tower karst and pinnacles of conglomerate with the same solution chimneys and fissures but filled up with slope wash deposit.

Karstification has been maturely developed in the conglomerate deposit of the Kusma terrace. As the conglomerate is composed of inhomogeneous rock fragments of various rock types, karstification is also inhomogeneous and mostly controlled by regional lineaments, joints and distribution of rock fragments. The terrace surface exhibits doline karst landscape

with residual karst hills (Plates 1 and 2). The dolines (sinkholes) of different sizes have been observed. These are distributed sparsely in the compound of Chief District Office, Kusma Hospital and Jail area (Plate 3). The most significant karst features are tower karst and pinnacles with solution chimneys, vertical shaft and solution fissures which are distributed in a complex labyrinth form. These towers and pinnacles with open fissures are clearly exposed at the knick of

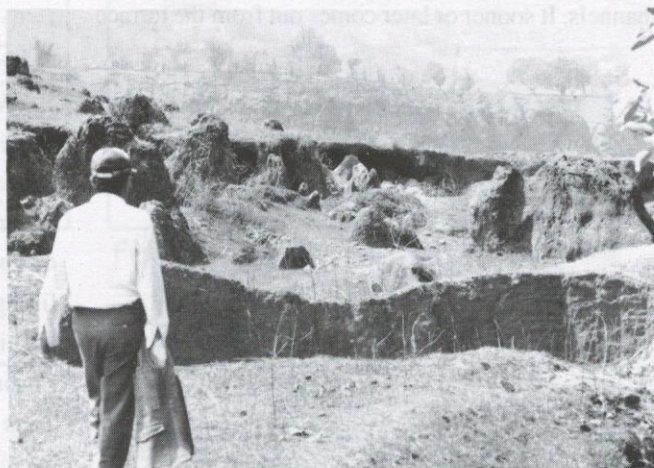
Plate 2. Doline formation karst towers and pinnacle.

the terrace. Their surface exhibits various solution sculpture of smoothed runnel (rinnenkarren) and spongework of solution groovings and pittings. The depth of fissures seem more than 10m and less than 15m.

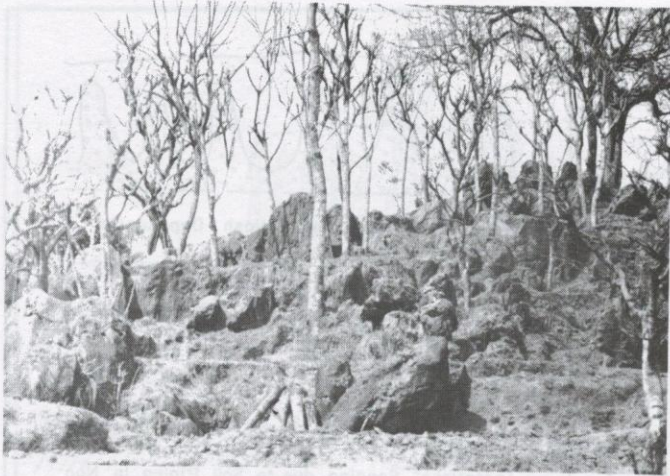
Plate 4. Residual karst hillock with karst towers and pinnacles with slope wash deposit.

Slope wash deposits are referred to such deposits as talus, colluvial and scree deposits brought from the upper mountain slope to the downslope commonly by means of heavy rainfall action. It has filled all the narrow and deep openings like solution chimneys and fissures. Such filling materials are the youngest deposit and varies in composition from place to place. It is unconsolidated sediment and normally a light yellow to orange coloured, non plastic to low plastic sandy silt. At the mountain side, it is coarser and contains pebbles, cobbles and sandy silt matrix with some occasional boulders. It is more finer sediment towards the Kaligandaki River valley side. Its depositional slope has maintained a smooth change of slope from the mountain slope to the terrace plane.
