Landslide-dammed lakes: a case study of the Lamabagar and Chaunrikharka landslide deposits, Dolakha and Solukhumbu districts, eastern Nepal

ABSTRACT

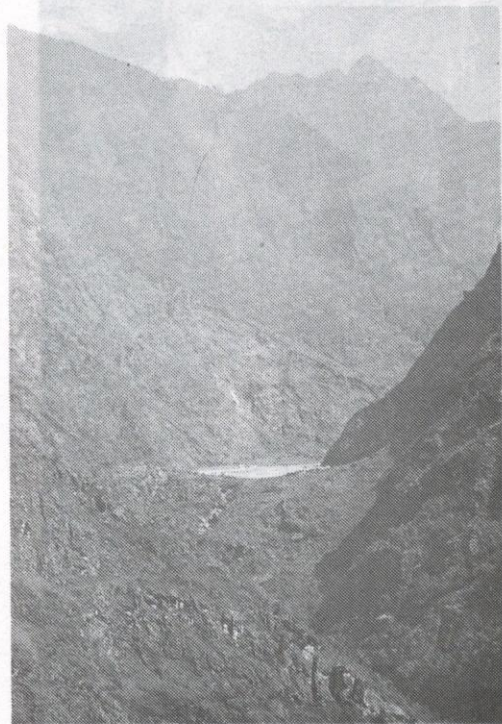
Fig. 3: The Lamabagar landslide dam (Dolakha district, eastern Nepal), showing a boulder armed spillway and a part of the entirely silted impoundment.

The Lamabagar landslide (Dolakha district, eastern Nepal, longitude 86°13' E, latitude 27°55' N) occurred within the paragneiss and migmatite series of the Higher Himalayan tectonic unit about 10 km north of the MCT (Schelling, 1992) and originated from the very steep eastern slope along the Tama Koshi. The volume of the dam is around 30 million m³ and it is nearly 300 m high having an average frontal slope dip of 17°. The dam with a crown elevation of 1970 m asl, having a boulder-armed spillway (Fig. 3), is still stable, for more than three generations (according to witness accounts).

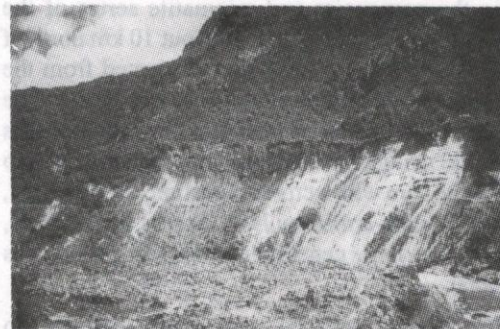
Fig. 5: Bottom- and top-set sediments, covered by landslide debris near Gath (Solukhumbu district, eastern Nepal).

intake, uniform silty sand is formed as bottom-set (Fig. 5). Finally, the lake is silted up by top-set sediments consisting of well graded medium to fine grained gravel and sand.

They are laterally interfingered with coarse grained sediments of torrential debris cones. The tilting and folding of the fine grained lake sediments, interpreted by Panniza (1975) as signs of recent tectonics are typical phenomena of consolidation of silty and clayey sediments due to pressure of the overlying debris cone. The well sorted top-set sediments (medium grained gravel) at Gath show the maximum sedimentation of about 40 m above the current river bed, showing that the lake was entirely silted up after a previous outbreak. A small rockslide of about a half a million m^3 , originated from the eastern slope north of Gath, postdates the final stage of sedimentation (Fig. 5).

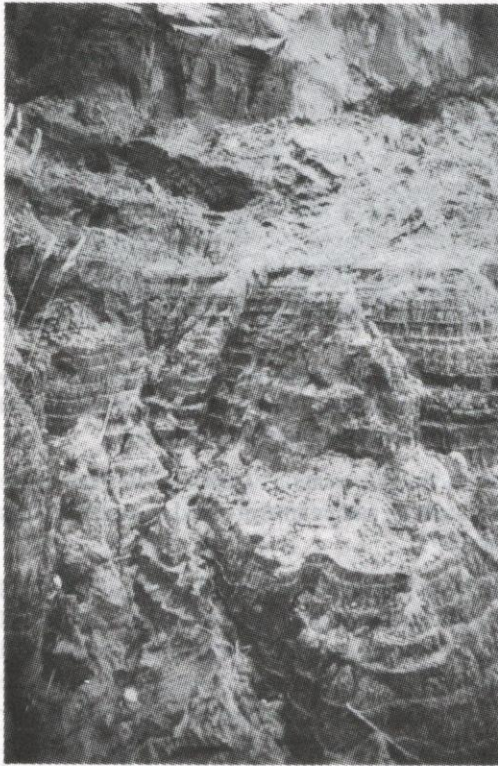
Fig. 8: The "varved clays" south of Gath (Solukhumbu district).

undisturbed sedimentation of around 120 years, if the visible banking can be interpreted as annual cycles (Uhlir, 1997).
