## Effectiveness of in situ P-wave measurements in monuments: examples from Greece

**B. Christaras**

### ABSTRACT

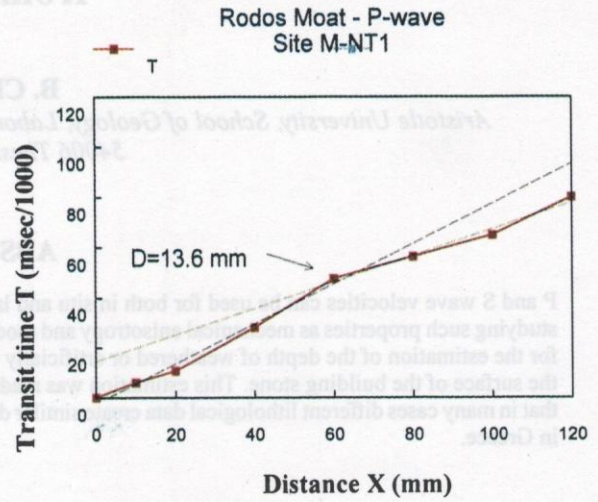
Fig. 3: Transit time versus distance plots measured on untreated surface of calcarenite blocks. The change of the regression slope corresponds to the depth of the weathered zone.

The study was carried out on the walls of the medieval city of Rhode and some representative results are presented in Fig. 3 and 4. These diagrams correspond to measurements on two neighbouring sites at the moat of the city (Plates 1 and 2).

A comparison of Fig. 3 with Fig. 4 reveals that there was an increase in the velocity at the external layer of the stone, corresponding to the consolidated zone after treatment. An intermediate, non-treated/damaged zone is also observed. The precise evaluation of the thickness of this zone depends on the spacing of the successive points of measurement. However, the offset of the regression line is directly related to the thickness of the non-consolidated/damaged zone.

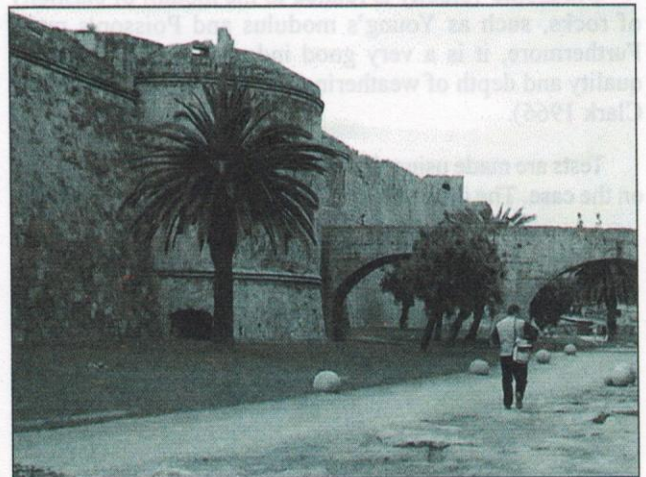
Plate 1: The moat around the medieval city of Rhode, where the tests of Fig. 3 and 4 were carried out.

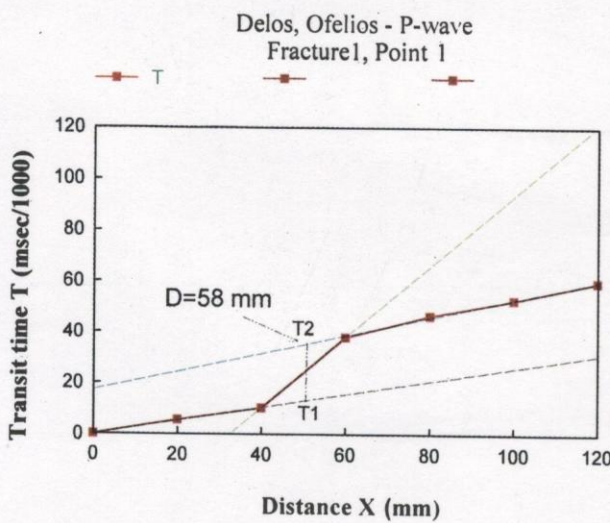
Fig. 6: Transit time measurements on the surface of the Ophelios marble statue (see Plate 3) and estimation of the depth of a crack along its left leg

Fig. 6 depicts the transit times measured along the leg of the statue of Gaios Ophelios on the Delos Island (Plate 3).
