Landslide dams of Tal, Latamrang, Ghatta Khola, Ringmo, and Darbang in the Nepal Himalayas and related hazards

Johannes T. Weidinger and Horst J. Ibetsberger

Institute of Geology and Palaeontology, University of Salzburg, Hellbrunnerstr. 34/III, A-5020 Salzburg, Austria

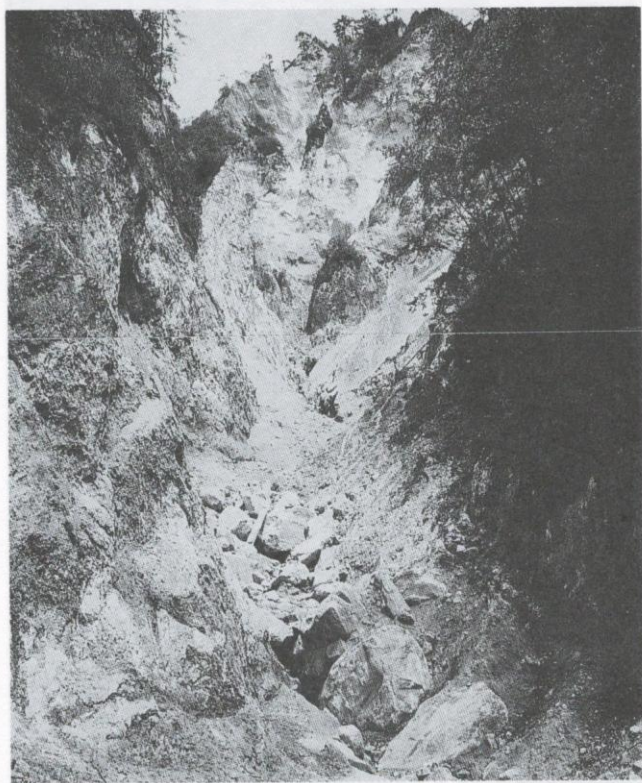
Plate 3: Heavily shattered and brecciated rock, partly mixed up with "schlieren" of the ground moraine along the base of the landslide deposit of Latamrang, generated by mechanical stress during the rapid movement. It is very susceptible to erosion. Location: a gully NE of the village Latamrang, altitude: 2,540 m (Photo: J. T. Weidinger 1995)

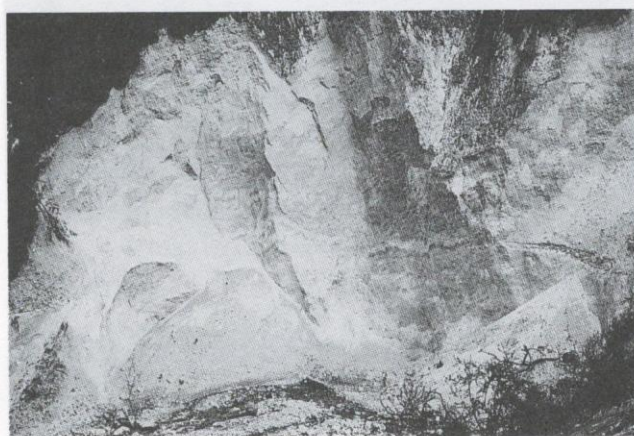
Plate 4: Heavily shattered and brecciated rocks - quartzites of the Annapurna Formation - with a thickness of several tens of metres, originated from the crown of the landslide of Latamrang, generated due to mechanical stress during the movement. Location: right bank (southern side) of the Marsyangdi River, about 3 km W of the village Latamrang, altitude: 2,500 m (Photo: J. T. Weidinger 1993)

- A wide range of heavily shattered and brecciated rock fragments making up a thickness of about 30 m along the base of the landslide (Plate 4). Probably they were generated due to mechanical stress during the movement, and contain not only clasts of gneisses from the surrounding area but also huge (tens of metres in diameter) dislocated quartzite boulders from the Annapurna Formation.

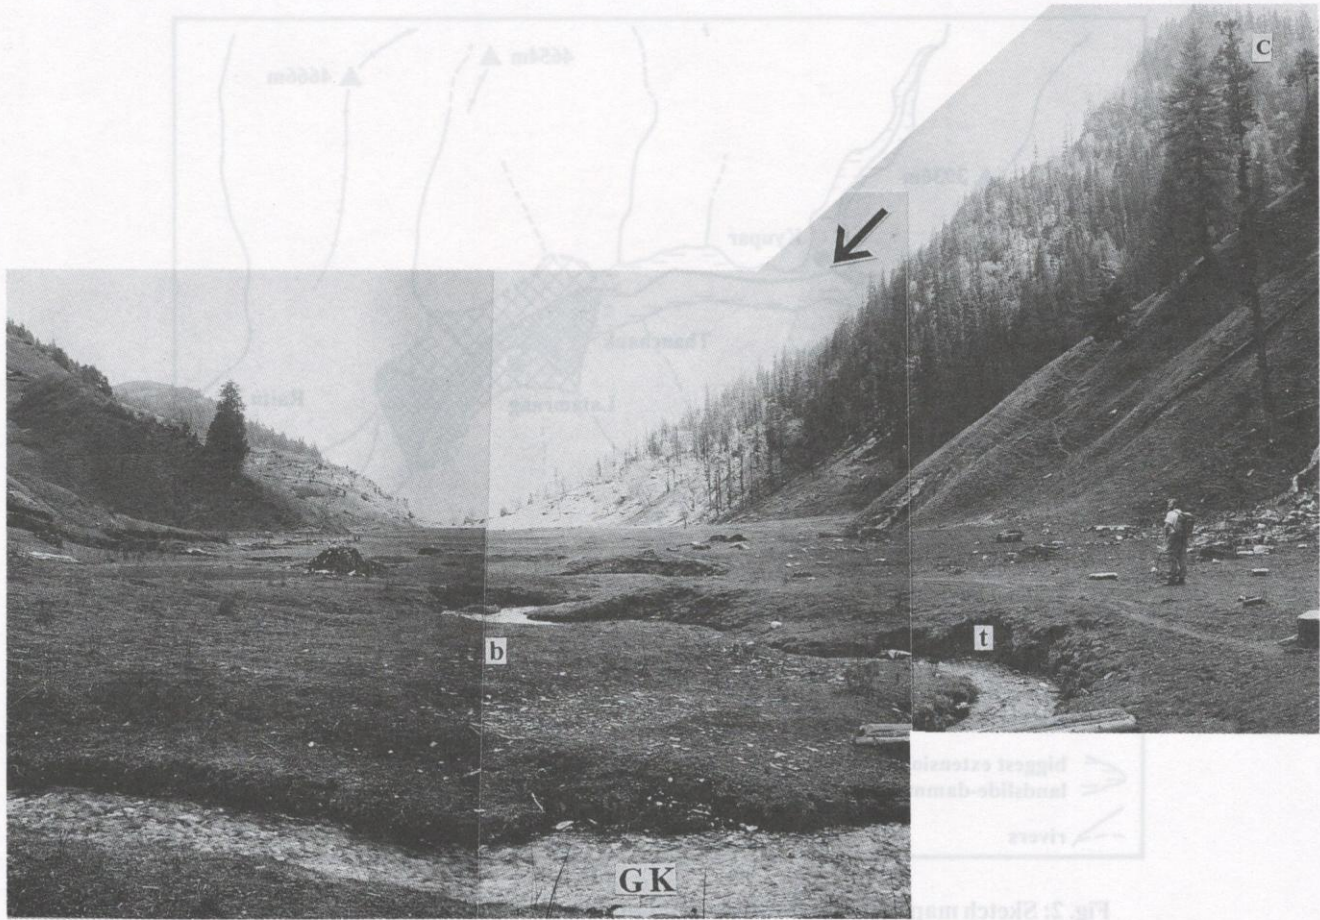
Plate 6: Former basin of the lake, dammed by the landslide of Ghatta Khola. The landslide (rock avalanche) occurred in a direction from W to E. This view towards S shows the crown (c) in the right upper corner and the partly eroded deposit of the landslide material (d) in the background. The basin (b) was filled up with the alluvial deposits of the Ghatta Khola (GK), today covered by thick turf (t) (Photo: J. T. Weidinger 1994).

in summer monsoon. The valley trends due NNW-SSE, whereas the direction of the mass movement (i.e. a rock avalanche) that dammed the Ghatta Khola at an altitude of 3,010 m was at a right angle to the course of the river (i.e. from WSW to ENE). The previous valley bottom might have had the depth comparable to that of the southernmost course of today's valley, which is about 200 m below the level of lake sedimentation. That means the volume of the displaced masses was about 4.8 million cubic metres (Plate 6).
